**Asbestos Periodic Surveillance Inspection
Winter 2010
New Milford Schools/Buildings**

New Milford Public Schools

Re: Periodic Surveillance Services – Winter 2010
Five New Milford Schools and Two Administration Buildings
EnviroScience Project No. 20071230.A3E

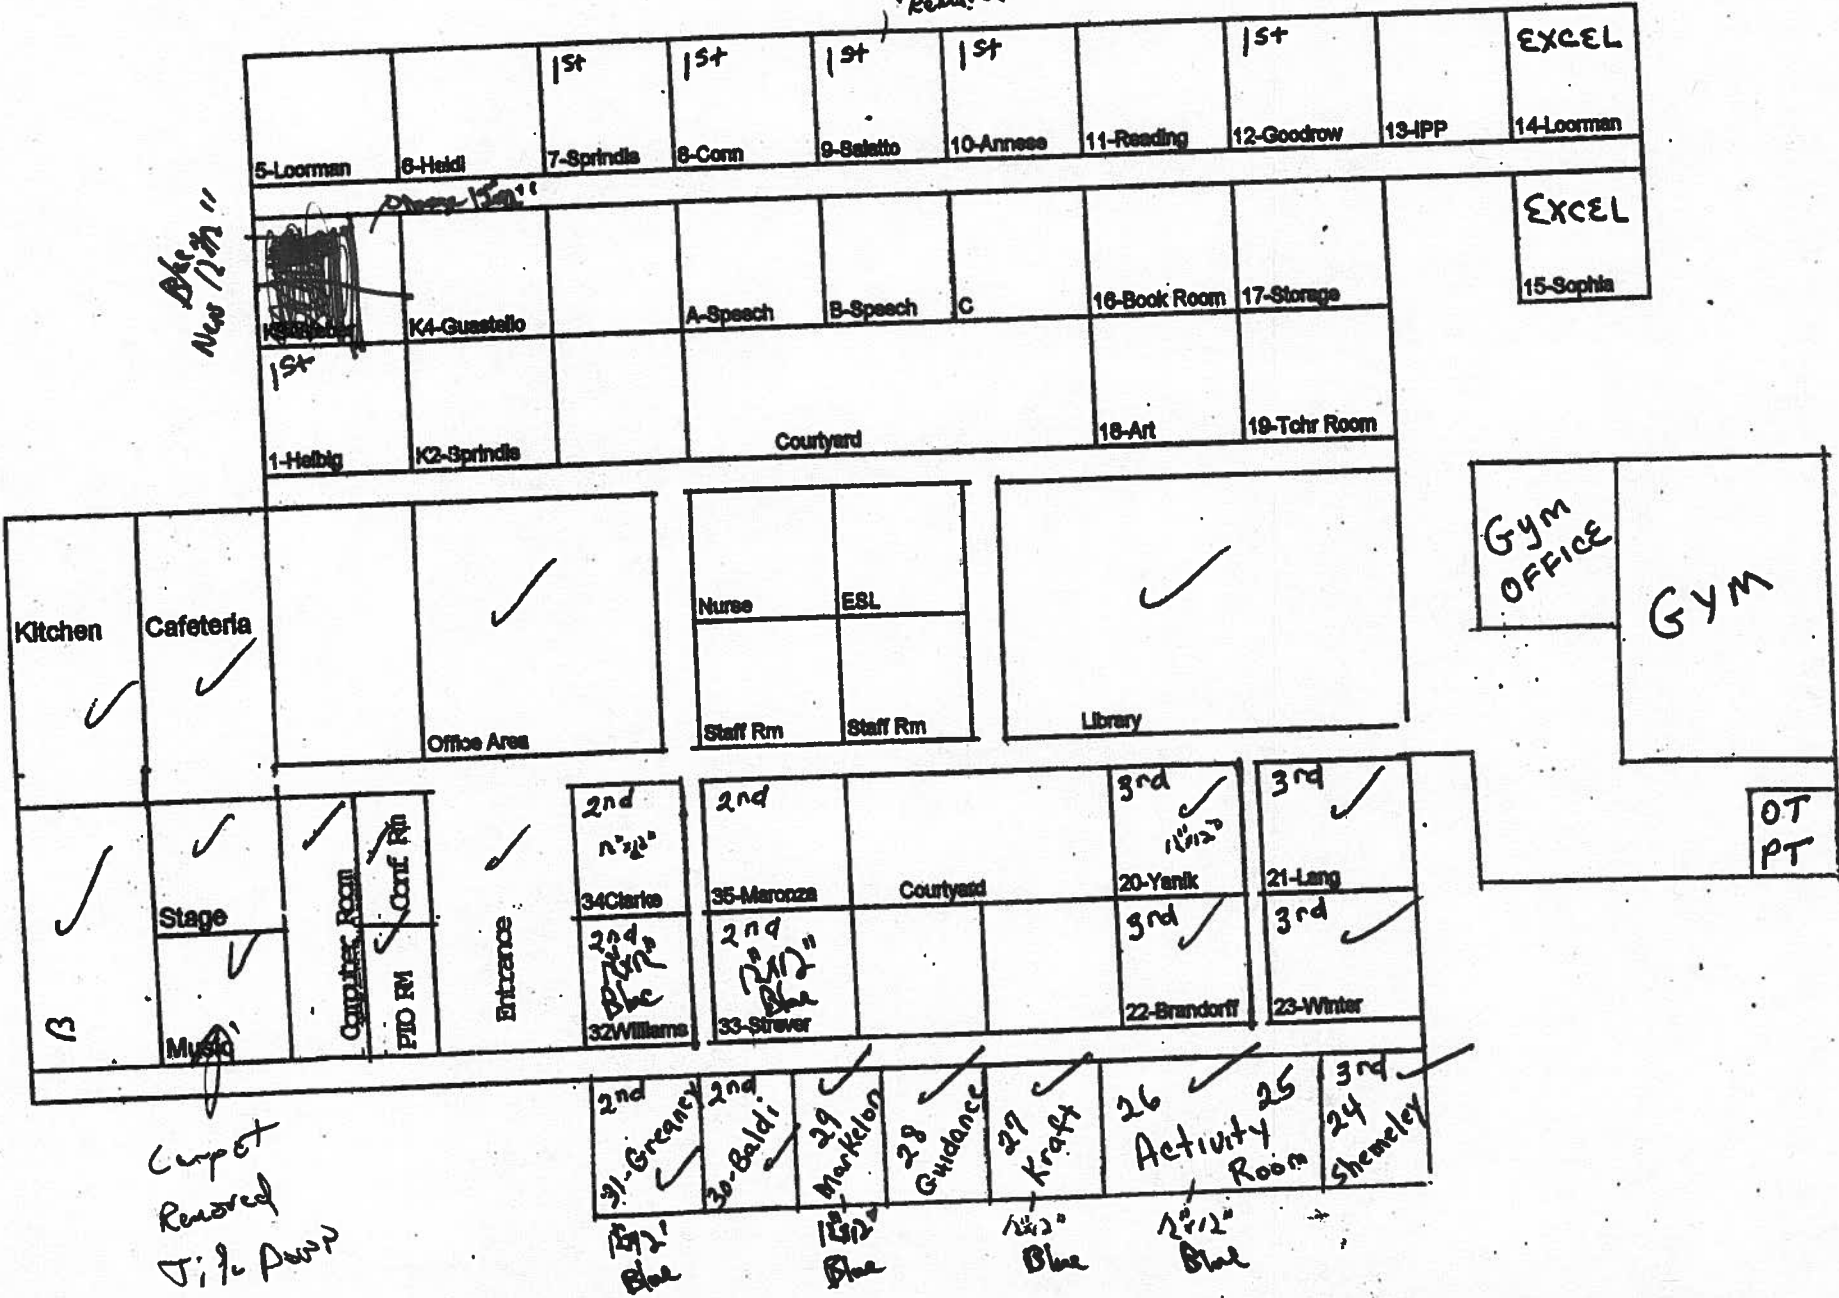
Northville School Map

Carpet Replaced Tiled

Carpet Replaced Tile Area

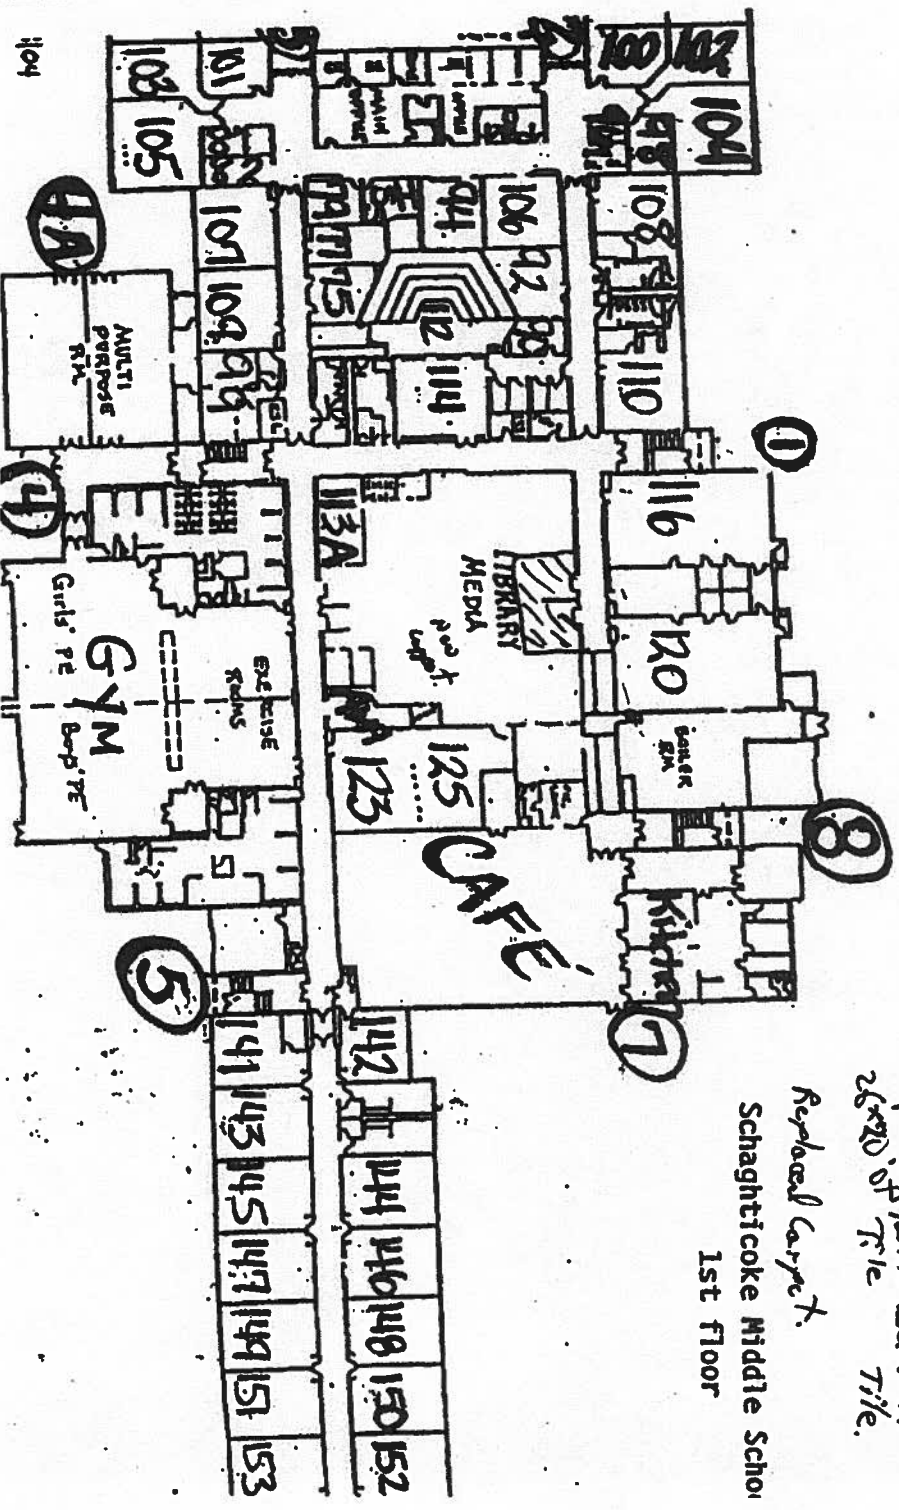
Replaced Carpet.
Schaghticoke Middle School
1st Floor

Removed
26'x20' of Tile and 8'x29'
Tile.
