**Asbestos Periodic Surveillance Inspection  
Summer 2009  
New Milford Schools/Buildings**

**New Milford Public Schools**

**Re: Periodic Surveillance Services – Summer 2008**  
**Five New Milford Schools and Two Administration Buildings**  
EnviroScience Project No. 20071230.A3E

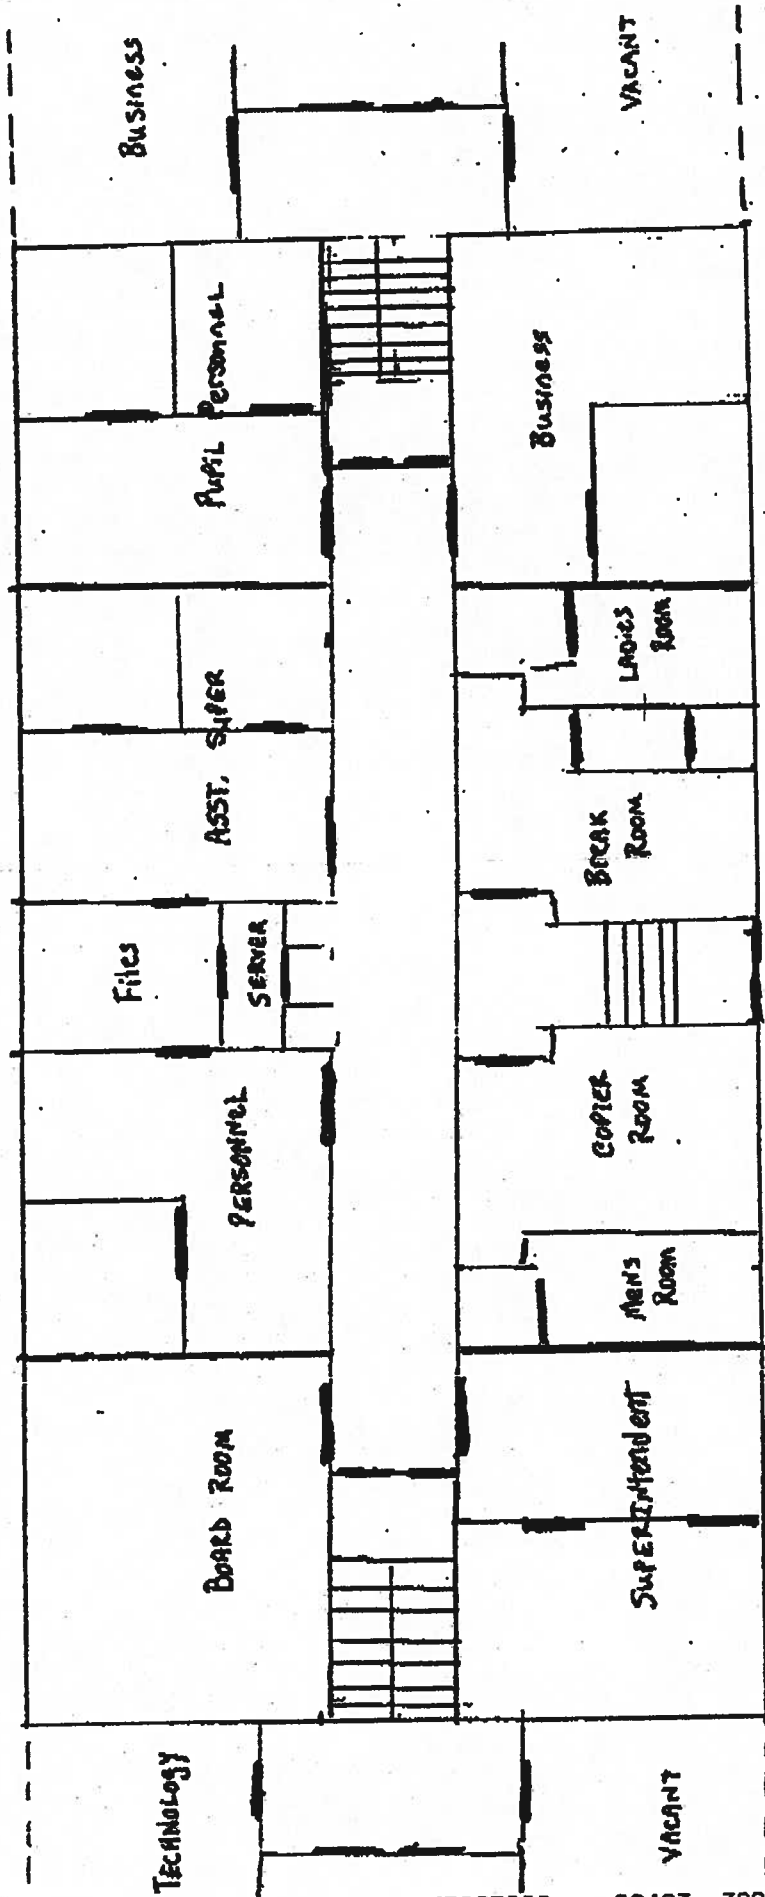
CENTRAL OFFICE 50 EAST STREET  
 EVACUATION PLAN  
 2nd Floor

<b>LOCATION</b>	<b>ASSESSMENT</b>
Second Floor Copier Room	Damaged Floor Tiles under Carpet
Office Between Room 6 and 7	Damaged Floor Tiles under Carpet
Gymnasium Storage Room	Damaged Ceiling Tiles
Gym Kitchen	Damaged Cement Board
Basement	Damage White Foundation Paint

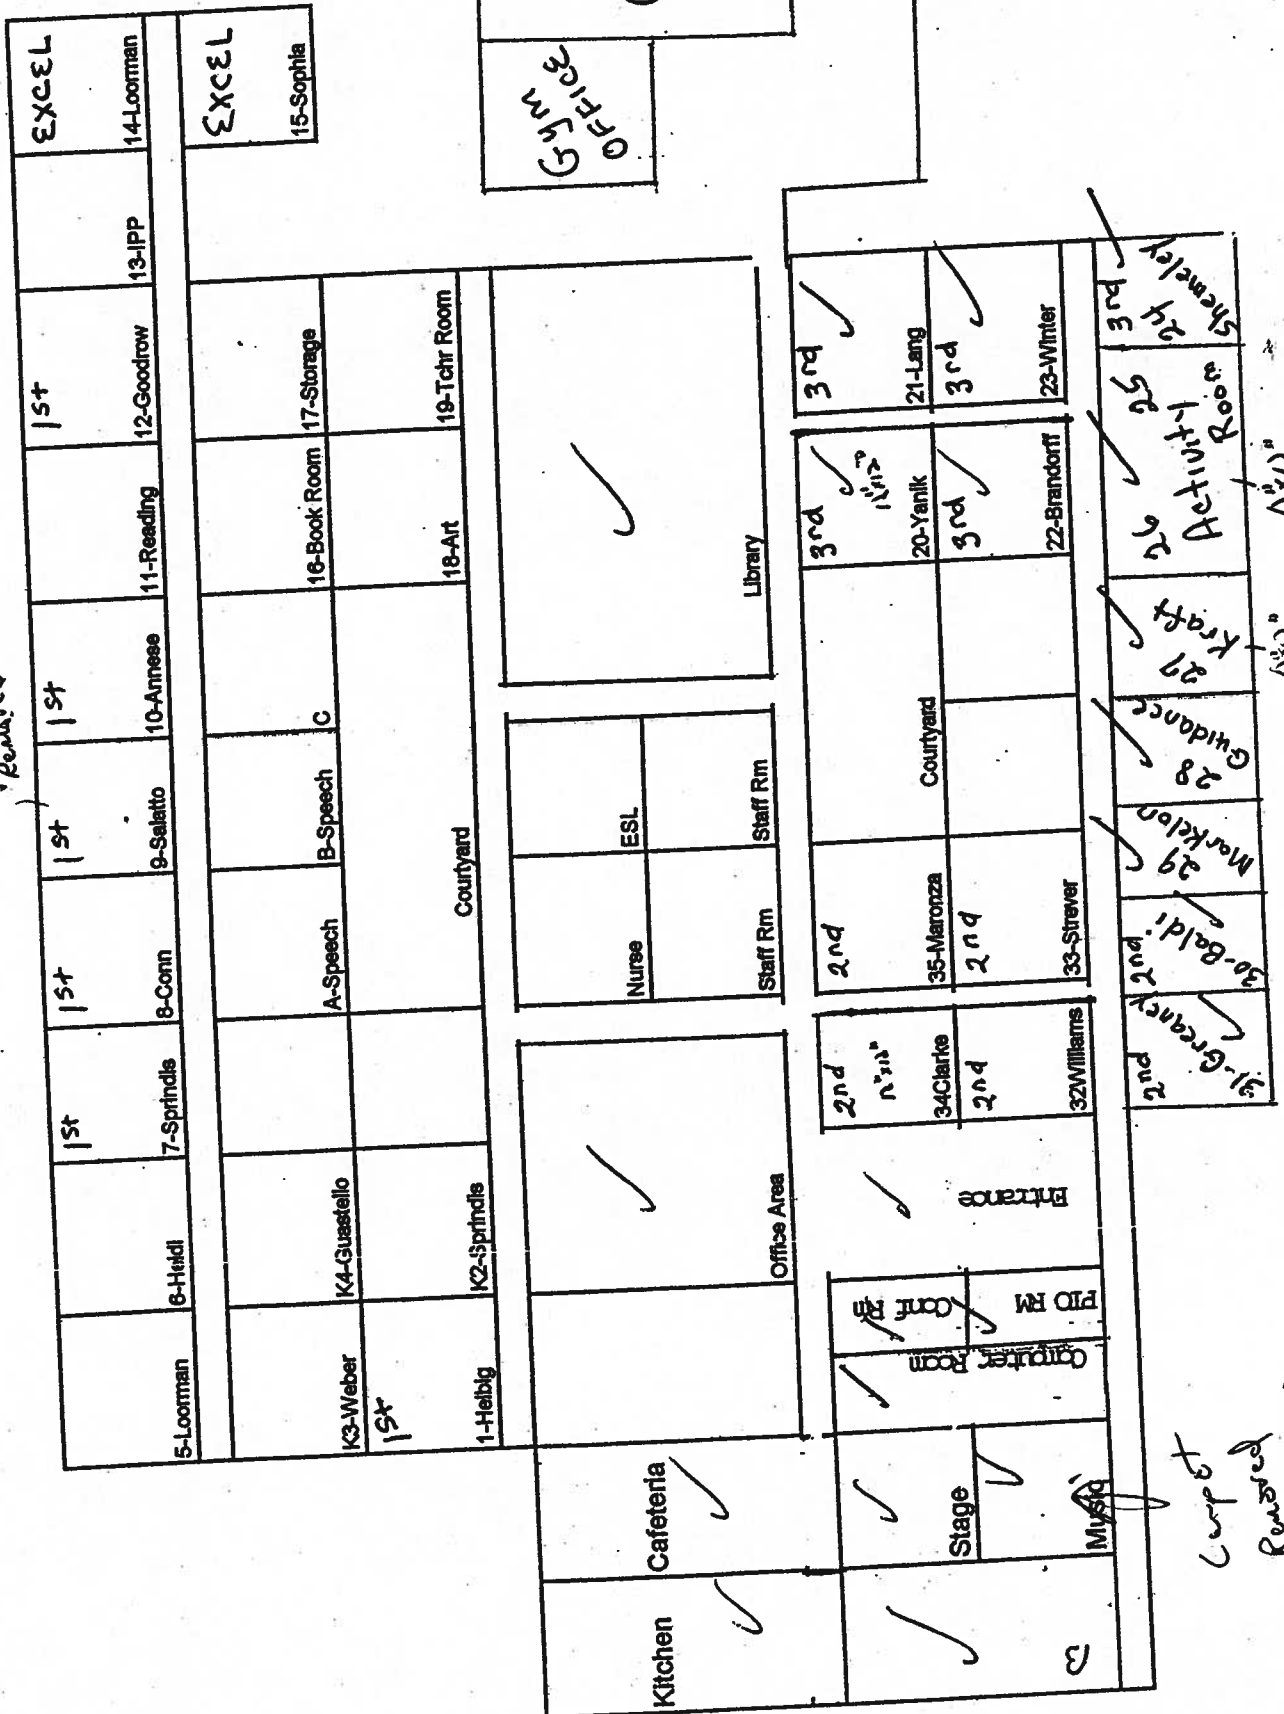
# Northville School Map

<b>LOCATION</b>	<b>ASSESSMENT</b>
Chapter One Room, Classrooms 20, 25/26, 27, 34	Carpeting and Carpet Mastic reported to have been removed April Vacation and Summer 2008. 12"x12" Floor Tile now present in these areas.

*Computer Room removed tiled*

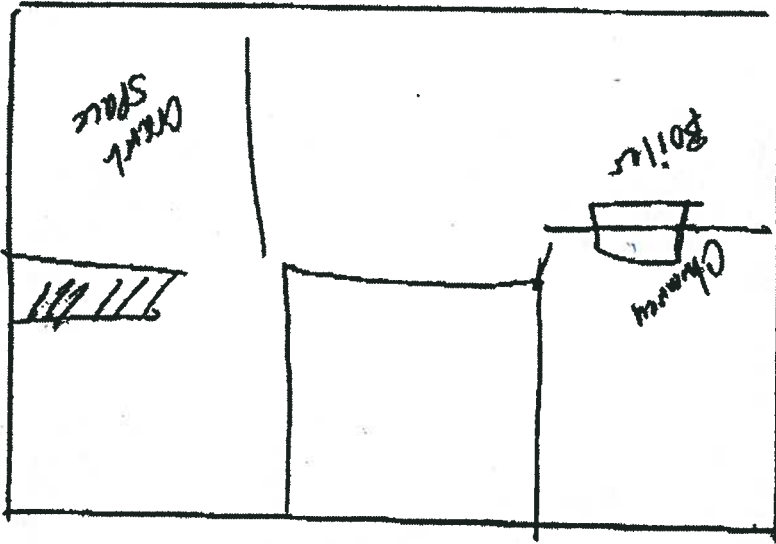
<b>LOCATION</b>	<b>ASSESSMENT</b>
Basement	End Caps of Pipe Insulation are exposed.
Second Floor – Office	1'x1' Ceiling tiles are water damaged and falling from ceiling glue daubs.
