JACKSON COUNTY CENTRAL SCHOOL DISTRICT

2018 Facilities Assessment

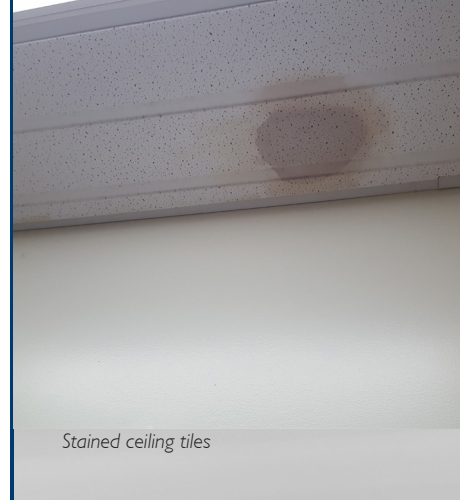
Stained ceiling tiles

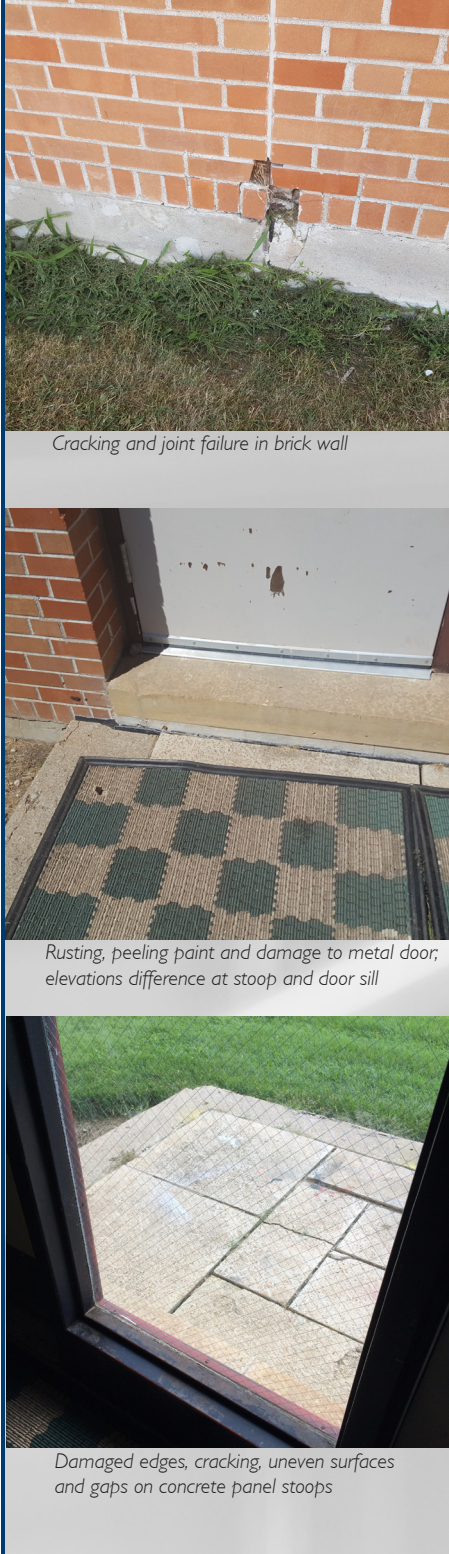
Cracking and joint failure in brick wall

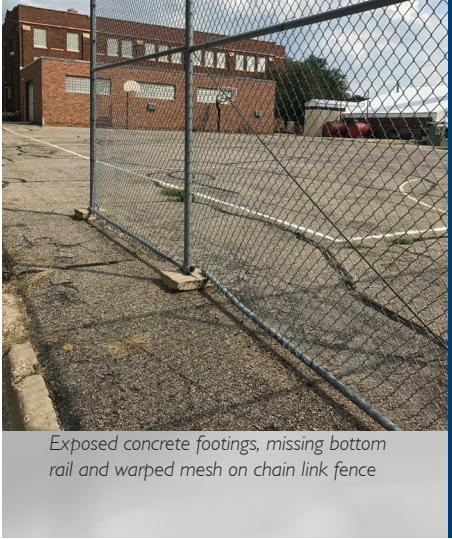
Exposed concrete footings, missing bottom rail and warped mesh on chain link fence

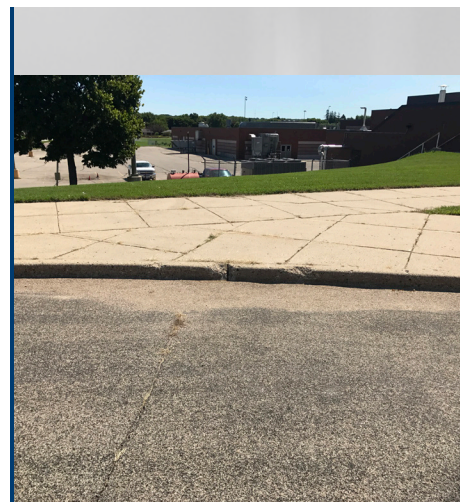
Sediment collection in circulation access of parking lot B

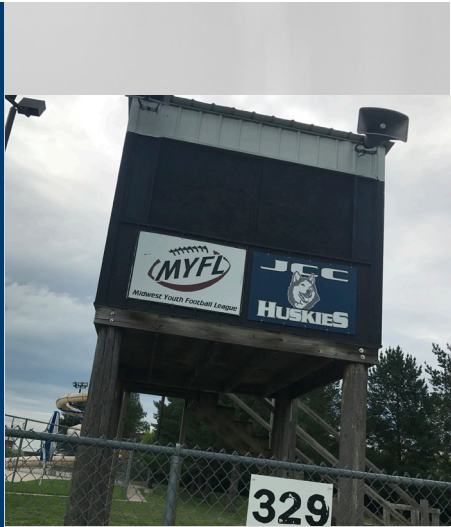
Weathered wood and cracking in press box support posts

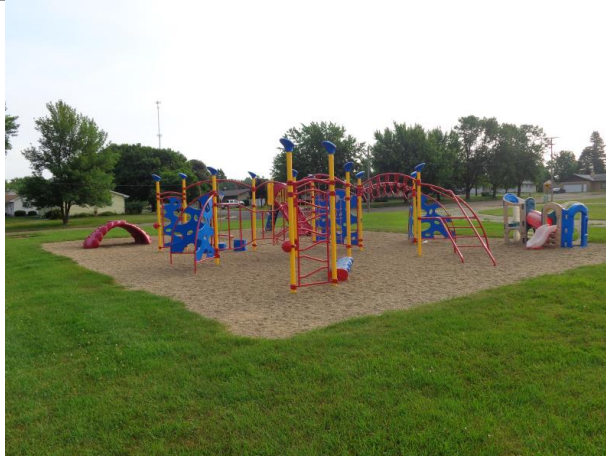
Priority	Hazard	Photo
1	No priority 1 hazards were identified at the time of the inspection.	N/A
2	There is damage to the slide on the home play equipment creating a sharp edge at the bottom. In addition, home play equipment is not recommended on public use playgrounds. The home play equipment was not fully inspected during the audit as manufacturers have different CPSC and ASTM standards to follow for this type of equipment.

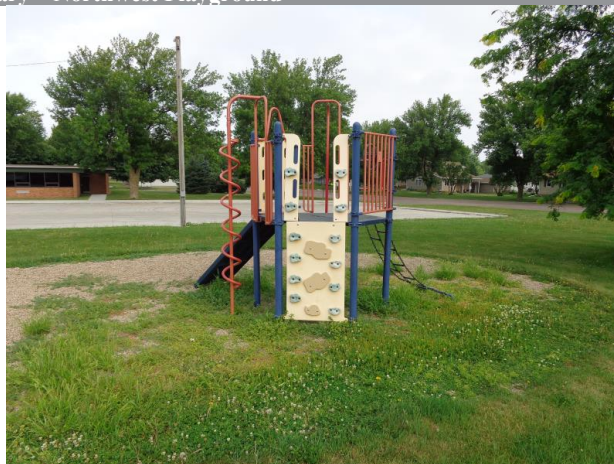
Priority	Hazard	Photo
1	The pea rock surfacing material is approximately zero to one inches throughout the play area. Pea rock should be maintained at a minimum depth of nine inches throughout the play area and raked to prevent pack down. Grass and weeds were also observed growing throughout the play area.	N/A
1	The concrete footers are exposed at the base of the play structure. Footers should be covered with an appropriate amount of surfacing material.

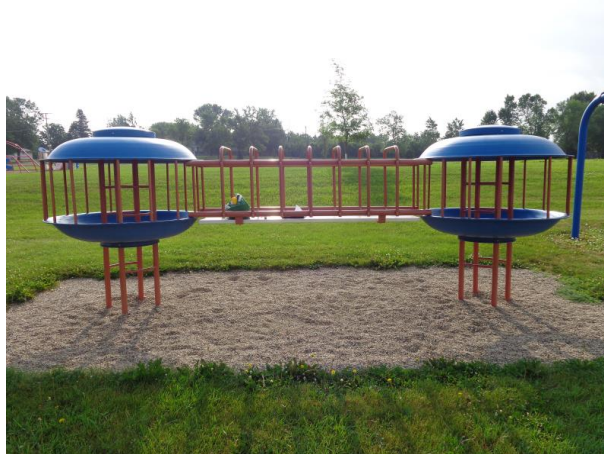
Priority	Hazard	Photo
1	The pea rock surfacing material is approximately two to three inches throughout the play area. Pea rock should be maintained at a minimum depth of nine inches throughout the play area and raked to prevent pack down. Grass and weeds were also observed growing throughout the play area.	N/A
1	The opening between the bars on the south dome creates a head entrapment hazard.
