Asbestos Periodic Surveillance Inspection
November 2007
New Milford Schools/Buildings

New Milford Public Schools
386 Danbury Road
New Milford, Connecticut

Re: Periodic Surveillance Services -- Fall 2007
Five New Milford Schools and Two Administration Buildings
EnviroScience Project No. 20071230.A1E

JOHN PETTIBONE ELEMENTARY SCHOOL
PERIODIC SURVEILLANCE REPORT
NEW MILFORD, CONNECTICUT

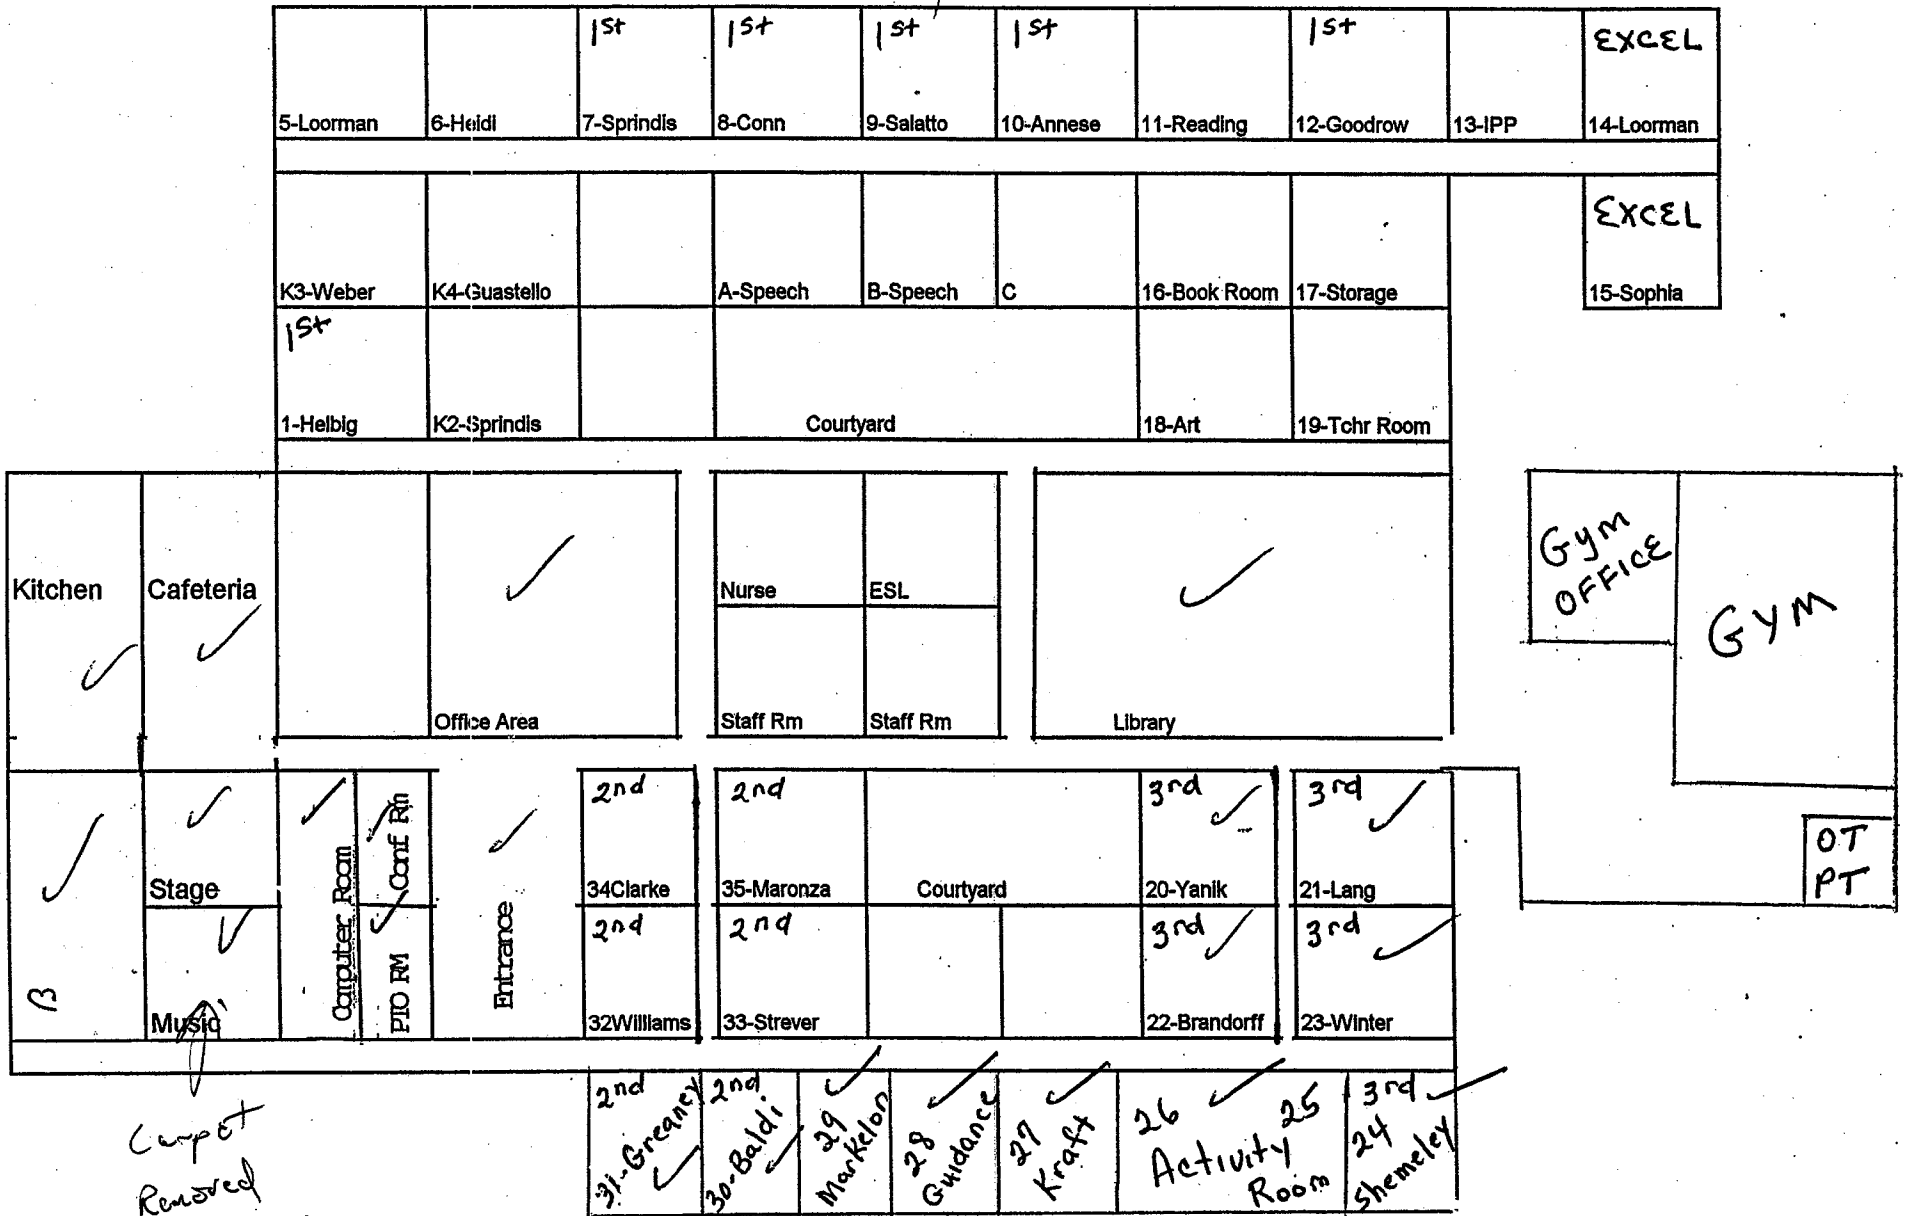
Northville School Map

LOCATION	ASSESSMENT
Room 9 and Music Room	Carpeting and Carpet Mastic reported to have been removed Summer 2007.

Carpet Removed Tiled

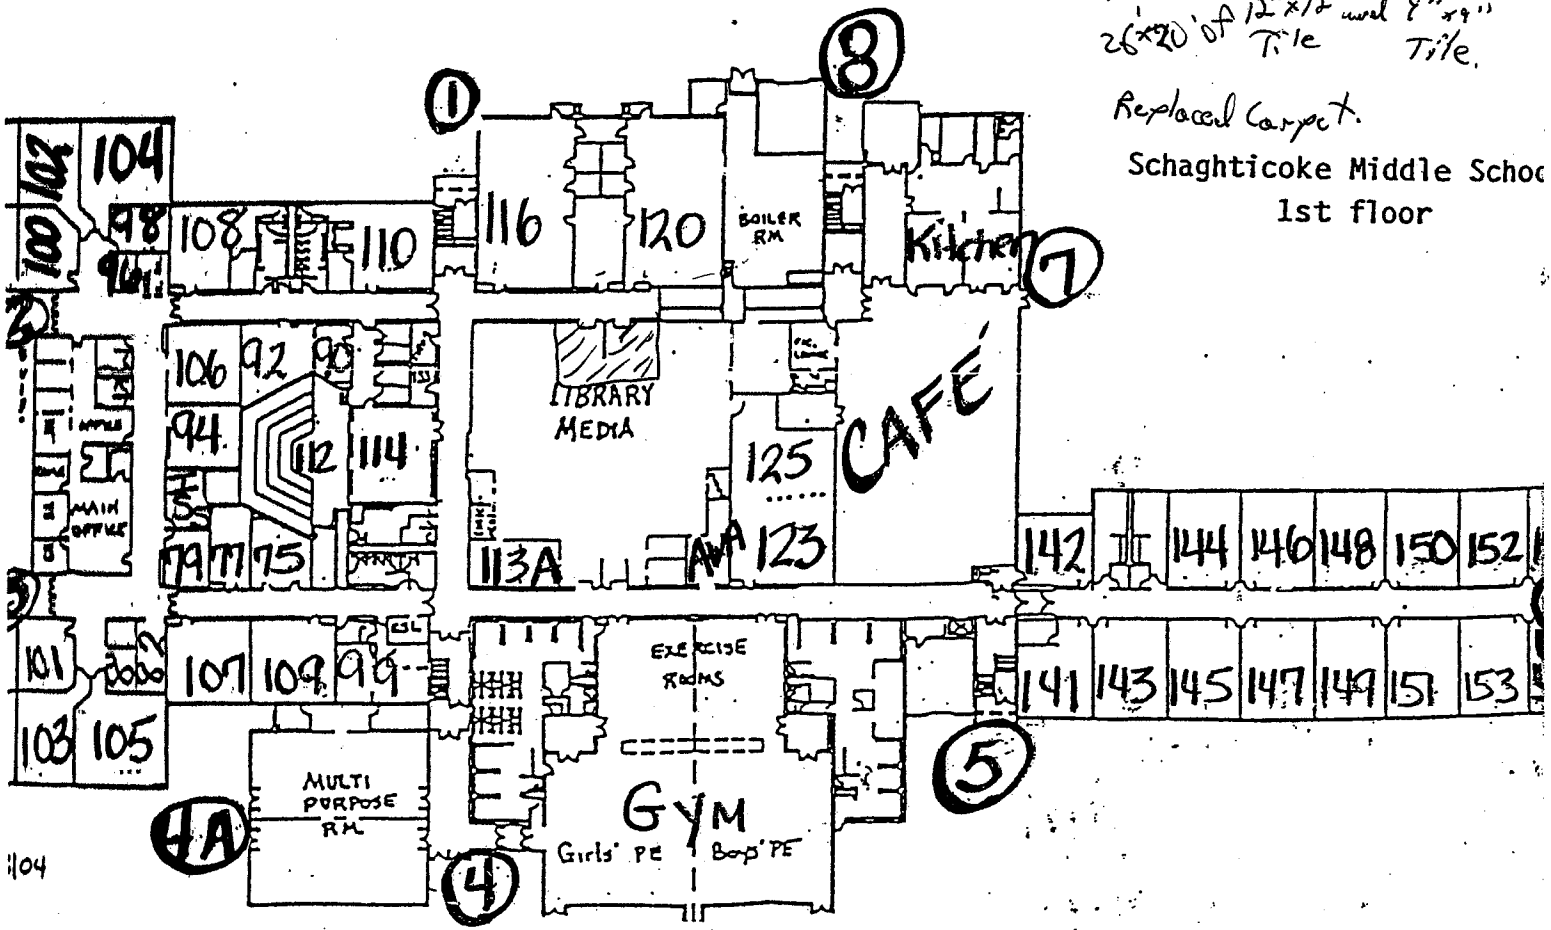
Schaghticoke Middle School
1st floor

LOCATION	ASSESSMENT
Library	520 SF of Floor Tile reported to have been removed Summer 2007.

Removed
26'x20' of 12"x12" and 8"x8"
Tile Tile

Replaced Carpet.

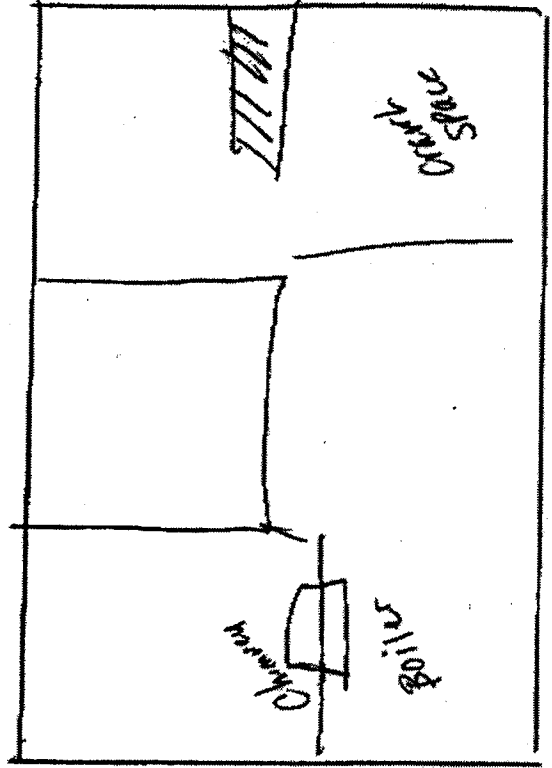
Basement

LOCATION	ASSESSMENT
Basement- North Room from boiler to brick wall.	15 LF of thermal system pipe insulation ("air cell"). This material has been removed.
