# ASBESTOS MANAGEMENT PLANS

NEW MILFORD PUBLIC SCHOOLS

ASBESTOS MANAGEMENT PLAN  
HILL AND PLAIN SCHOOL

Prepared By :  
Jack S. Kozuchowski  
Consulting Services  
November, 1986

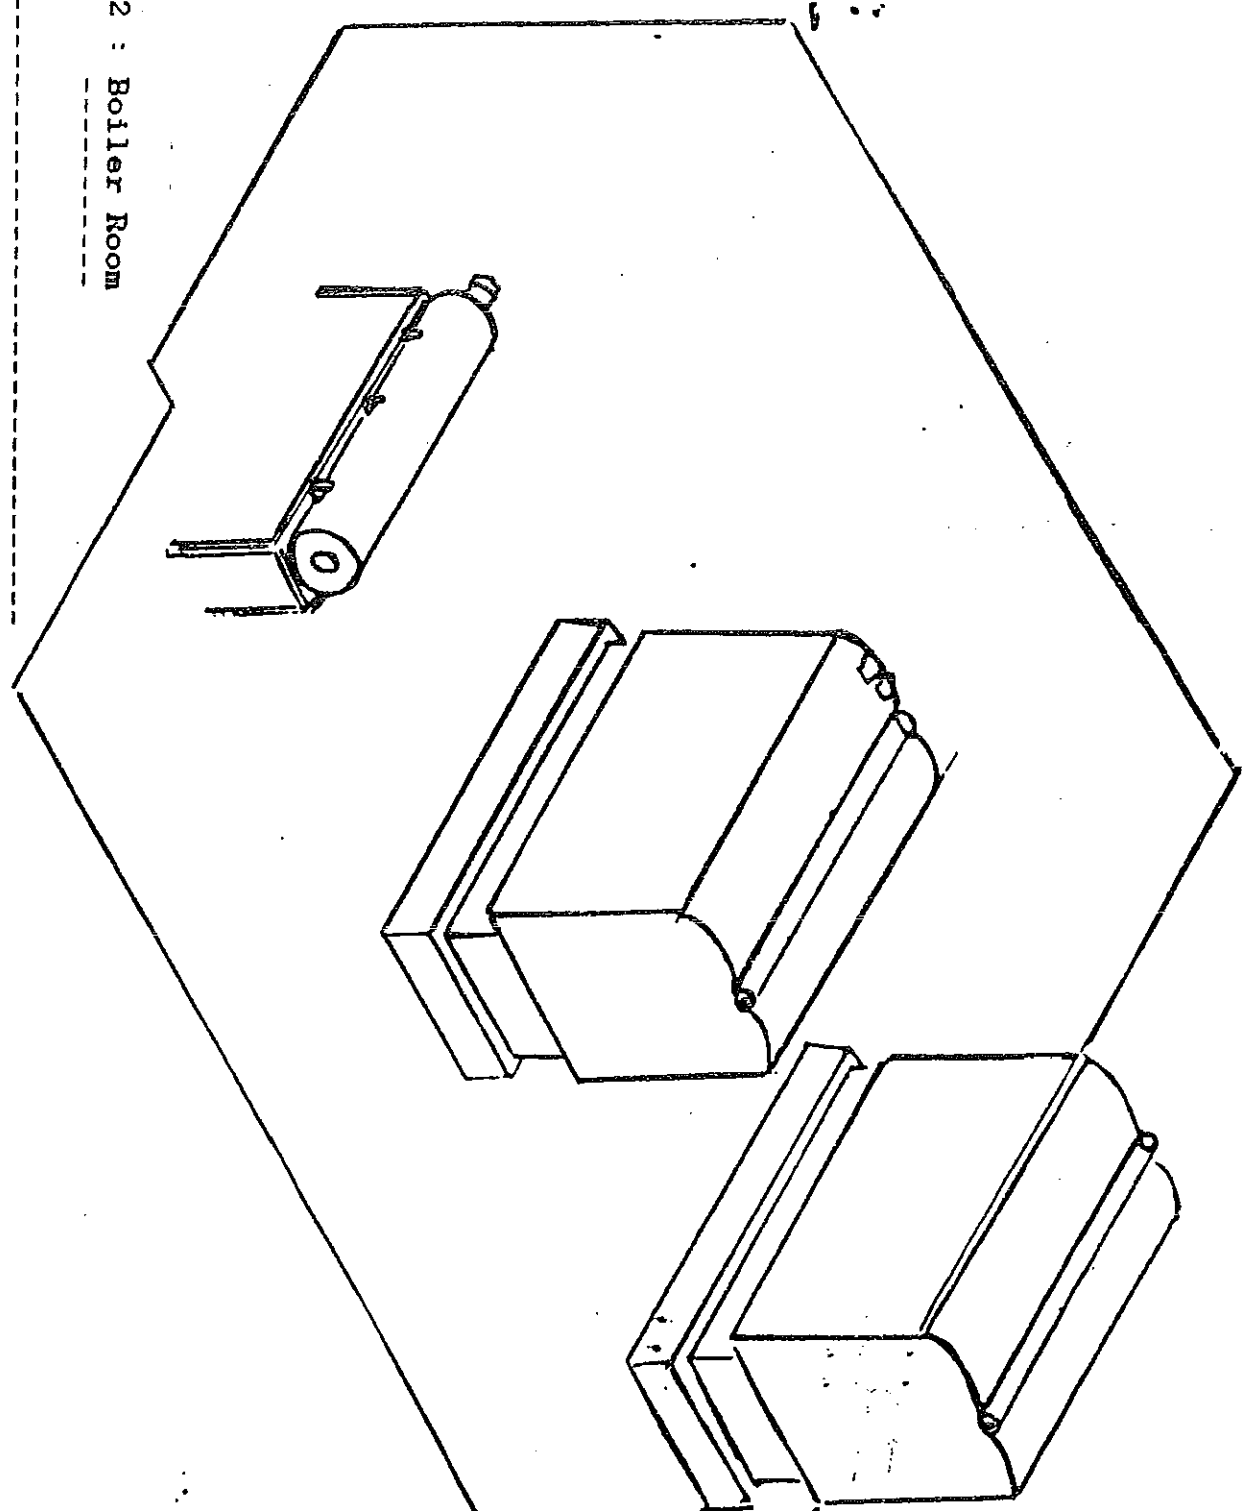
FIGURE 2 : Boiler Room

Comments: ASBESTOS INSULATION ON BOILERS AND TANK IS CRACKED, LOOSE, DELAMINATED AND, HENCE, HIGHLY FRIABLE INSULATION ON ELBOWS IS WRAPPED WITH NON ASBESTOS OUTER CLOTH, WITH ALL OF WHICH ARE IN GOOD CONDITION.

Conclusions (Recommendation Derived from the Detailed Asbestos Decision Protocol):  
ASBESTOS ON BOILERS AND TANK IS IN BAD CONDITION. ASBESTOS INSULATION ON PIPE ELBOWS IS NOT IN BAD CONDITION, BUT POTENTIAL EXISTS FOR FUTURE IMPACT DAMAGE.

Boilers	-	245
Hot water tank	-	100
Pipe elbows	-	50
Total		395

ASBESTOS MANAGEMENT PLAN SPECIFIES REMOVAL AND REPLACEMENT. INTERIM MANAGEMENT MEASURES TO BE IMMEDIATELY IMPLEMENTED.

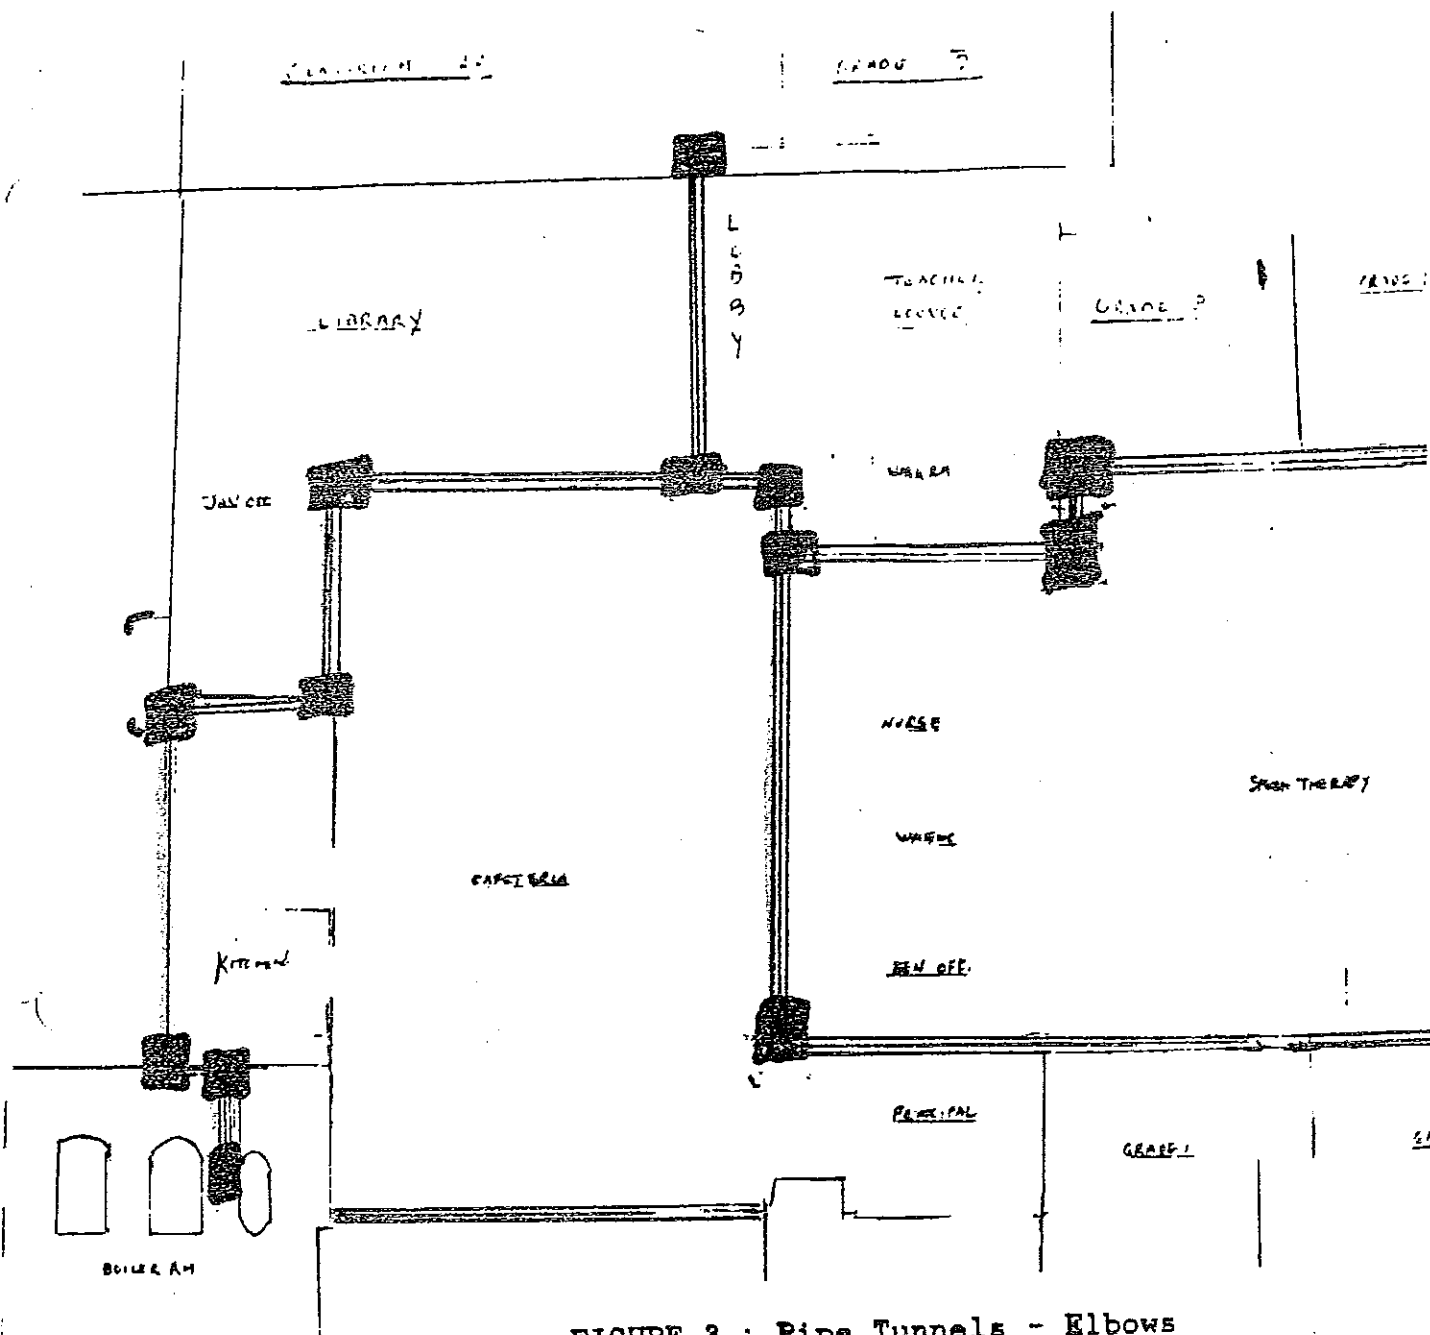
FIGURE 3 : Pipe Tunnels - Elbows

Comments: INSULATION ON PIPE ELBOWS OBSERVED WAS INTACT  
WHICH IN A NON FRIABLE CONDITION. HOWEVER, THERE IS  
A STRONG PROBABILITY THAT THE INSULATION ON SOME  
ELBOW IN THE VAST TUNNEL AREA HAS BECOME DAMAGED.

Conclusions (Recommendation Derived from the Detailed Asbestos Decision Protocol):  
ASBESTOS ON PIPE ELBOWS OBSERVED WAS NOT IN BAD  
CONDITIONS. NO CURRENT HAZARD WAS FOUND, HOWEVER, THE  
CONDITIONS IN THIS AREA SUGGEST A STRONG POTENTIAL FOR  
MOISTURE DAMAGE.

Tunnels highlighted, elbows shown in red.

ASBESTOS MANAGEMENT PLAN SPECIFIES IMPLEMENTATION OF A  
MANAGEMENT/MONITORING PROGRAM.

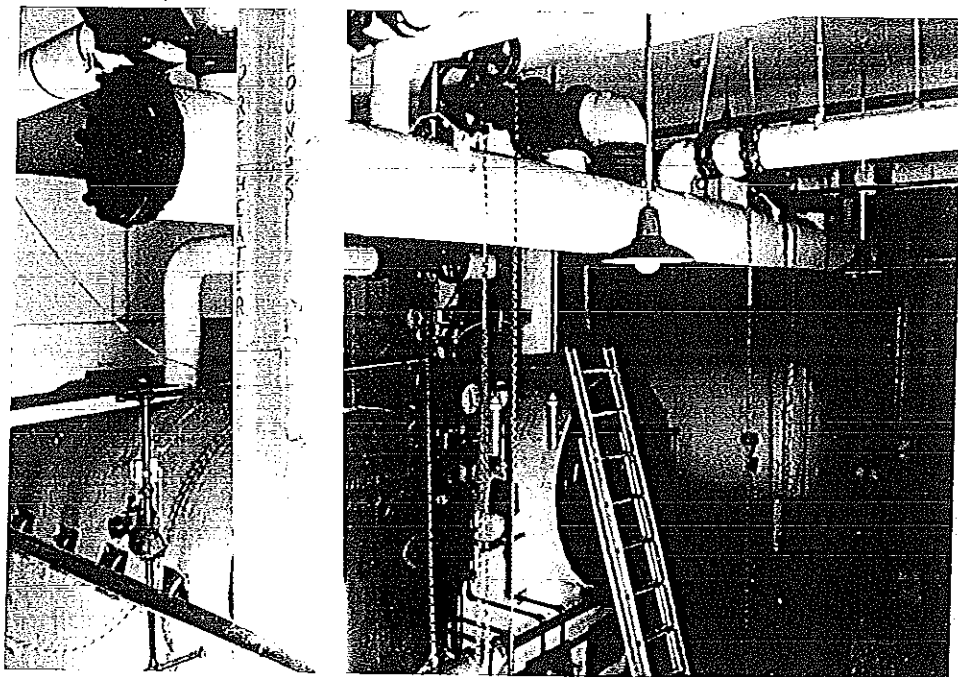
2B : Photograph illustrating front view of boilers and hot water tank.

Area of Asbestos :	Boilers	: 530 square feet
	hot water tank	: 160 square feet
	pipes	: 410 square feet

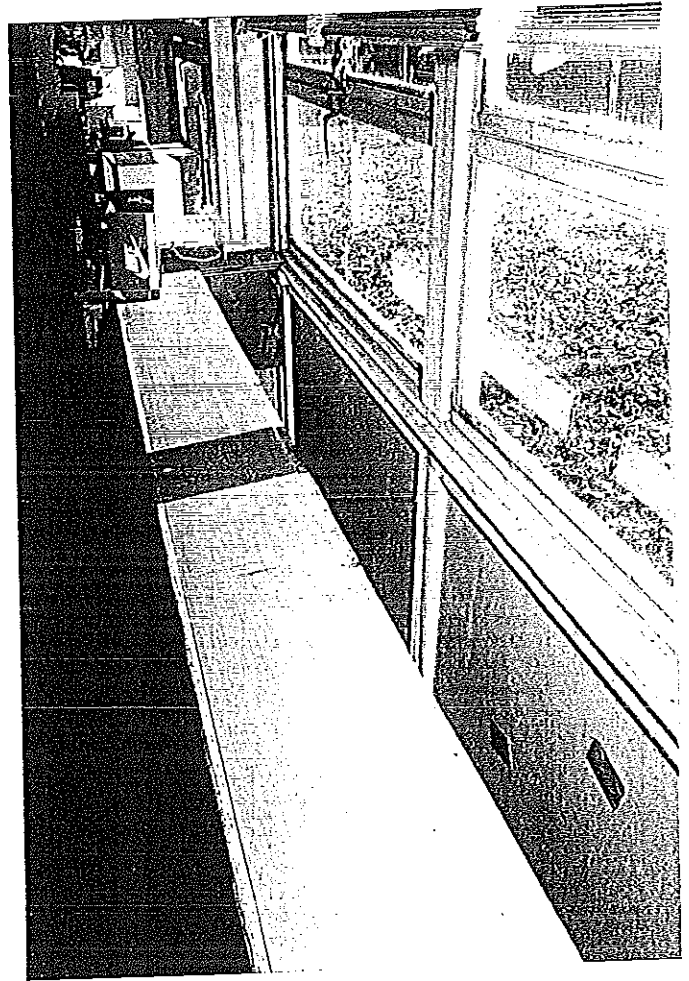
6B :

Close-up of asbestos wall showing chipped areas of wall covered by tape

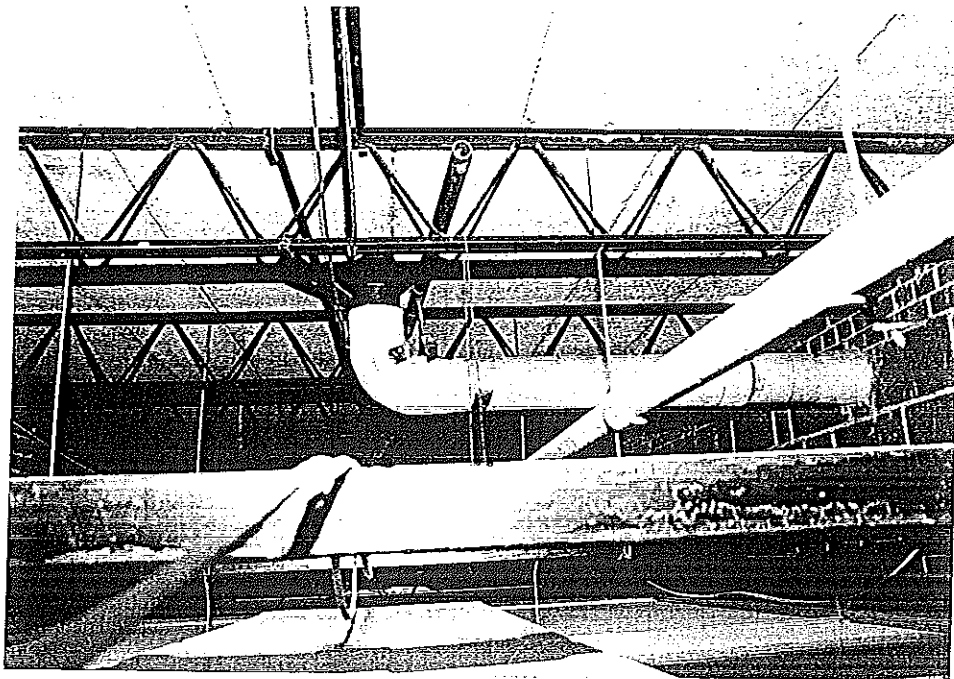
5A : Photograph showing asbestos insulated roof drain

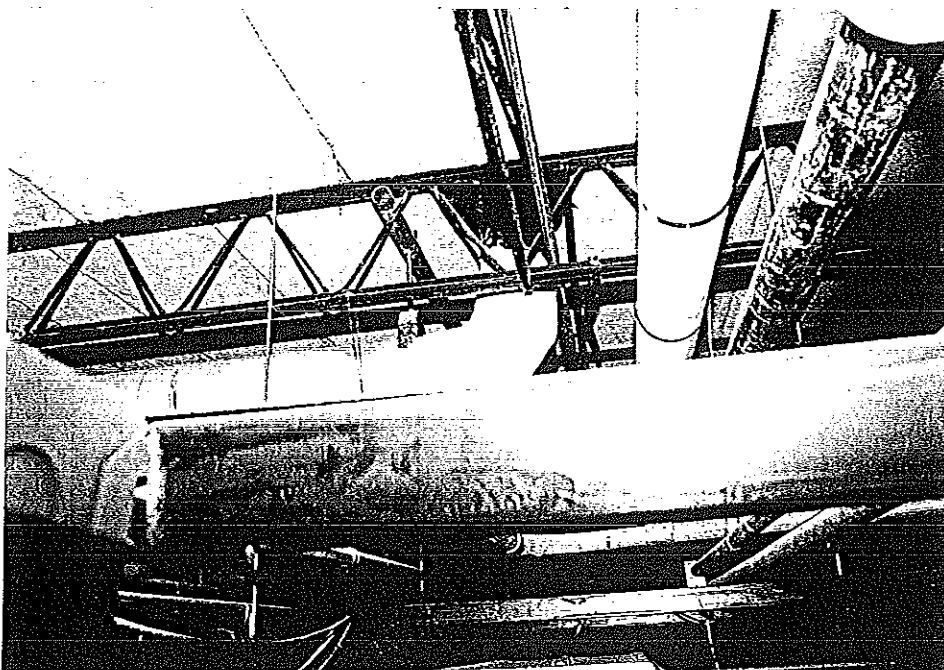
5B: Insulated roof drain (left) and steam pipe (right)

Area of Asbestos	: Roof Drains	: 300 square feet
	Pipe insulation	: 330 square feet

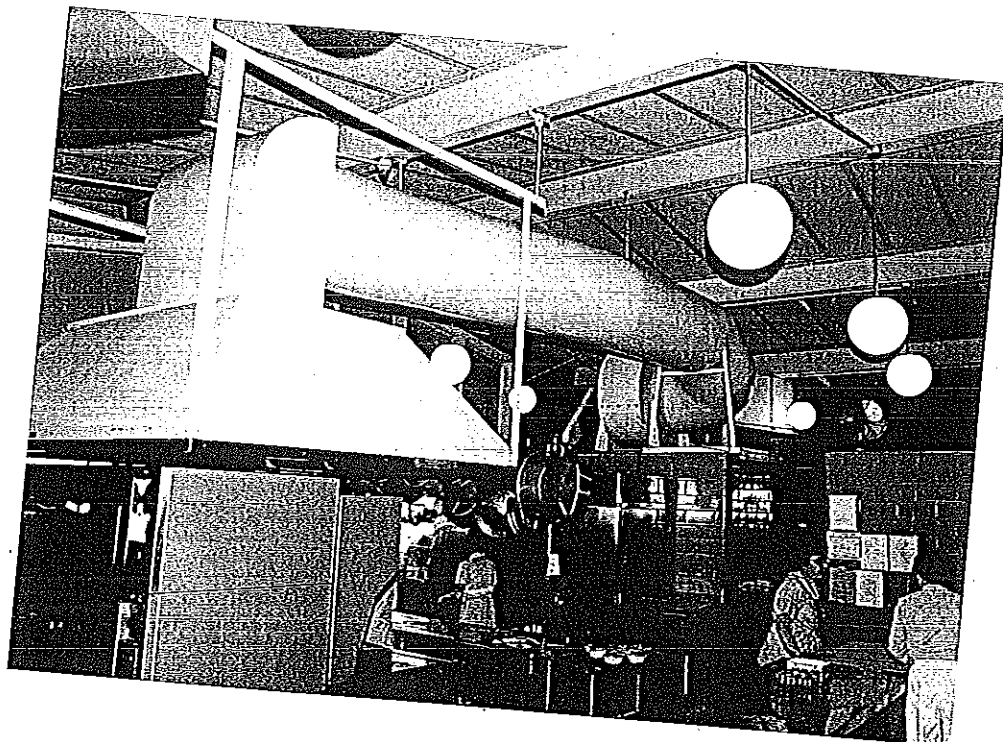
4B : Photograph showing broiler duct.

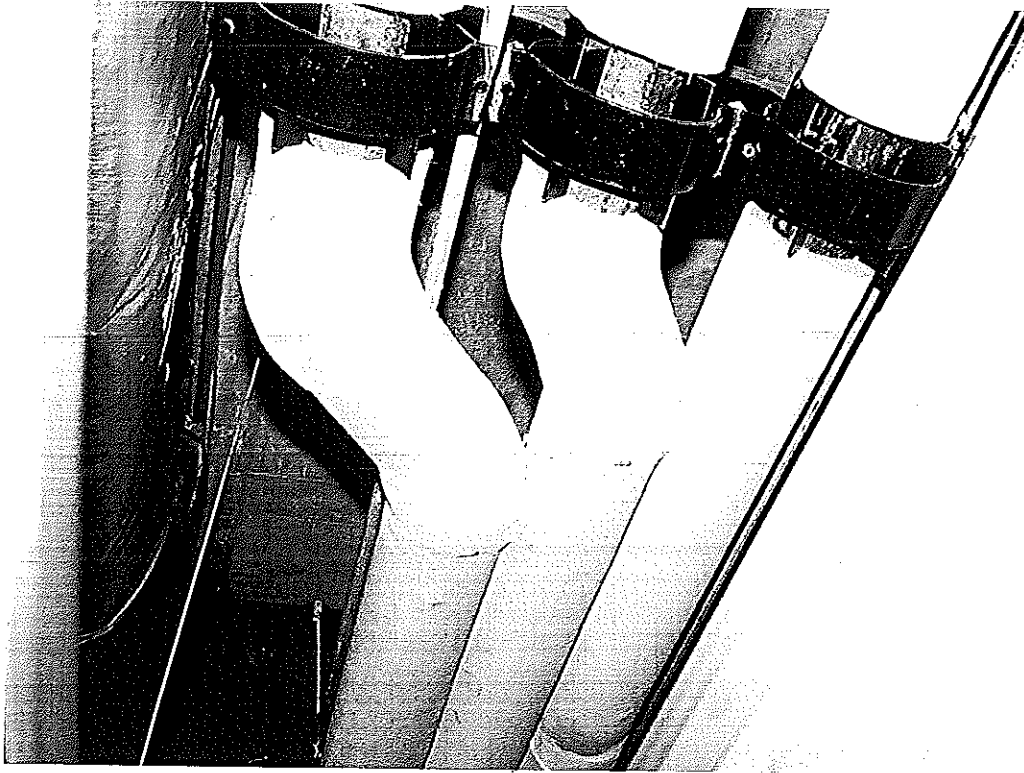
6A : Photograph showing pipe elbows above ceiling.

Area of Asbestos : 20 elbows and valves

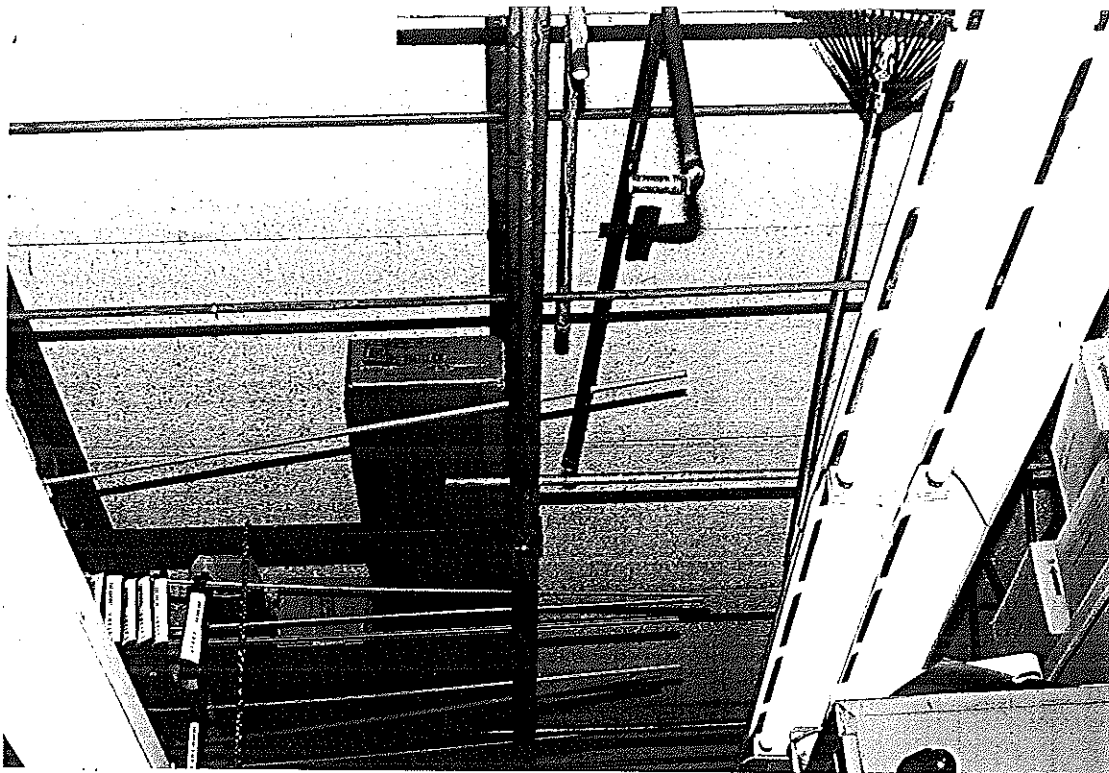
7A : Photograph of textured ceiling.

Area of Asbestos : 1387 square feet

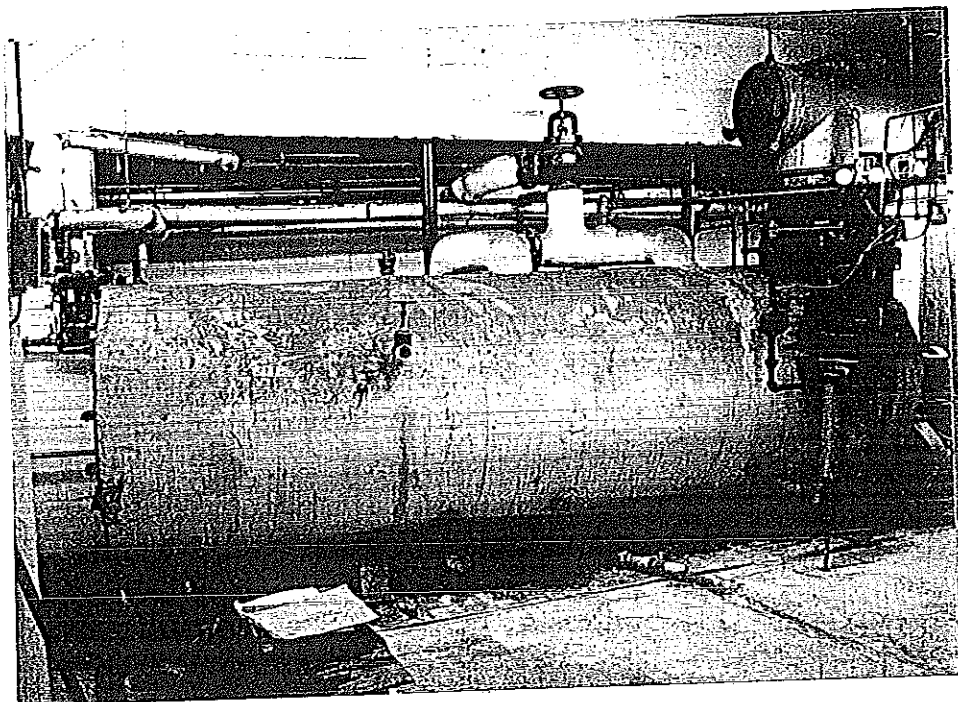
FIGURE 1 : BOILER ROOM  
----- Total Area of Asbestos : 500 square feet

Fig. 1A : Photograph showing boilers, stack, and pipes covered with asbestos insulation.

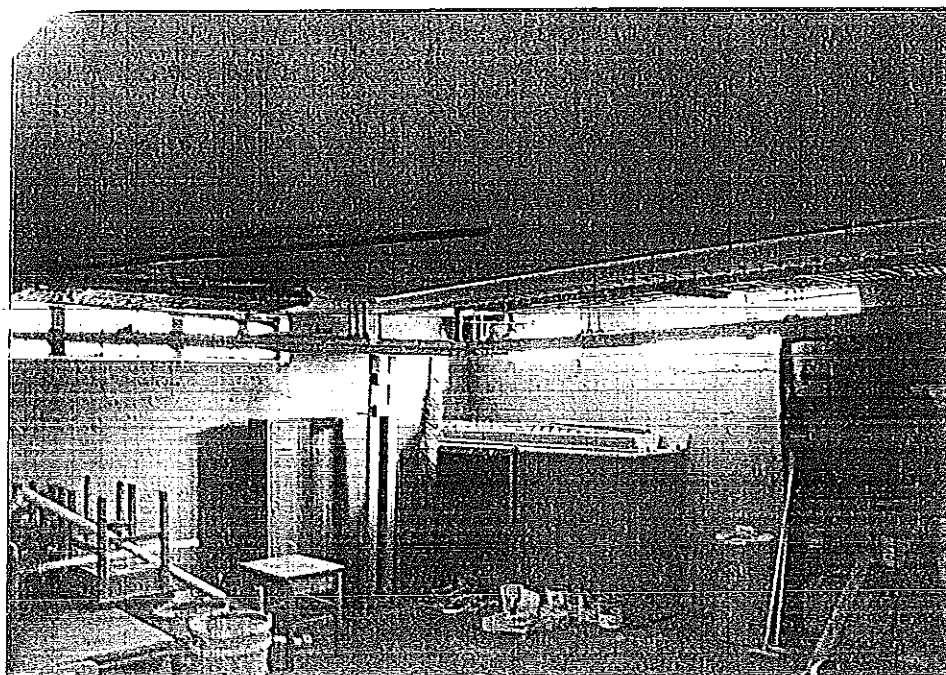
Area of Asbestos : 20 square feet

Fig. 2A : Photograph of basement storage room showing pipes.
