**Asbestos Periodic Surveillance Inspection  
Summer 2009  
New Milford Schools/Buildings**

**New Milford Public Schools**

**Re: Periodic Surveillance Services – Summer 2008**  
**Five New Milford Schools and Two Administration Buildings**  
EnviroScience Project No. 20071230.A3E

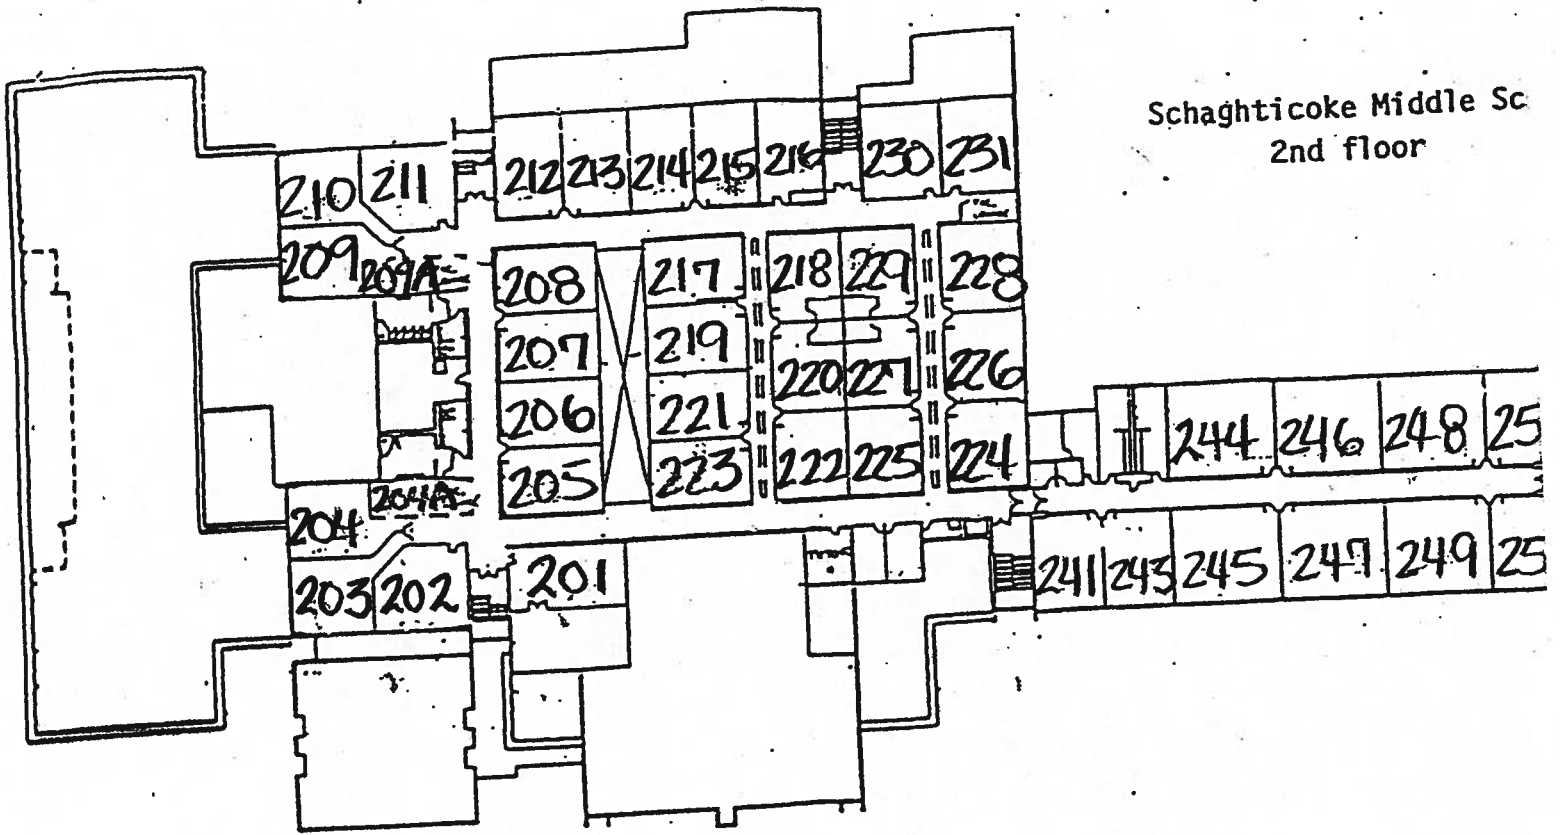
Schaghticoke Middle Sc  
2nd floor

Replaced Carpet.

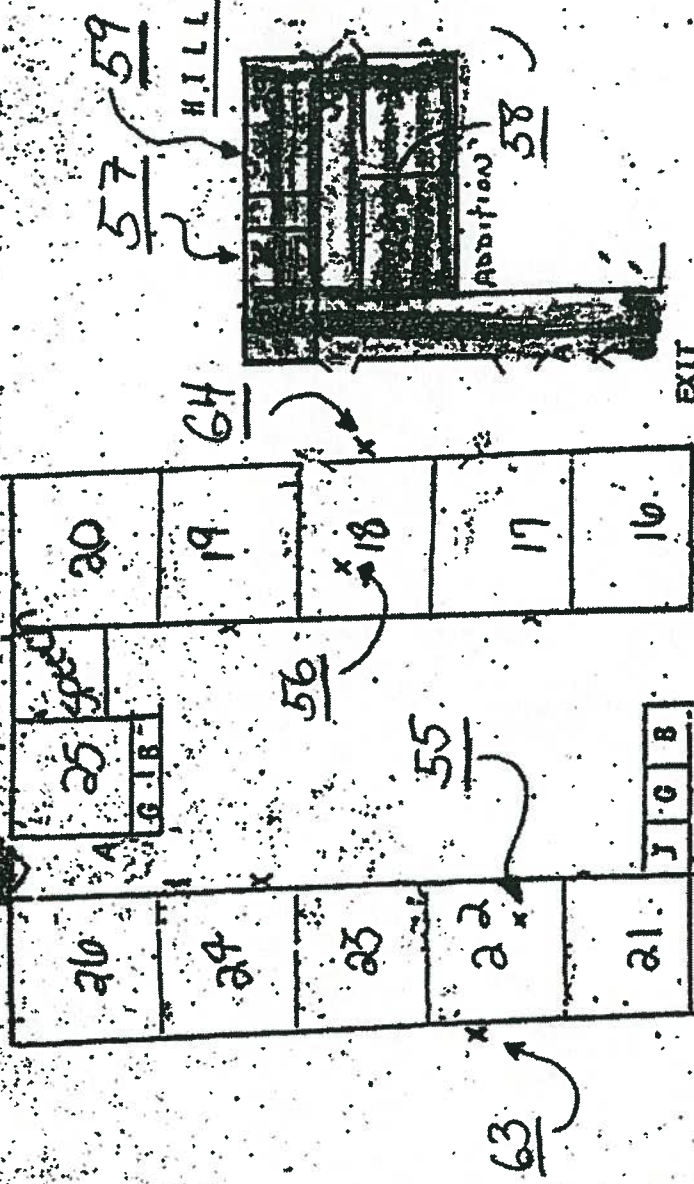
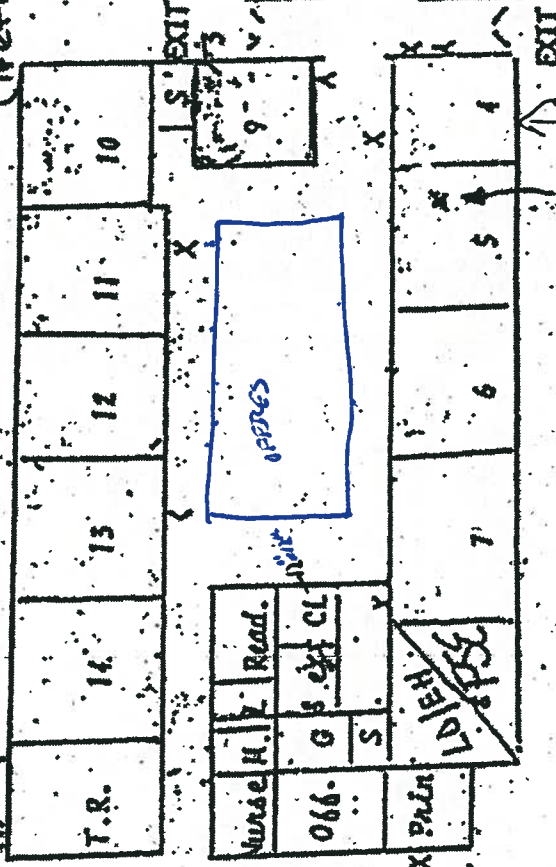
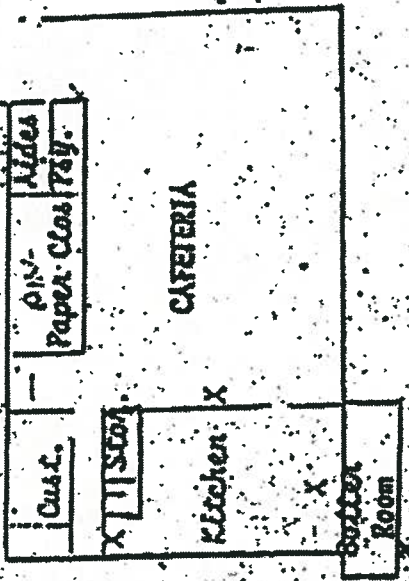
LOCATION	ASSESSMENT
Kindergarten Room 1	Damaged Pipe Insulation
Storage Room near Paraprofessional Office	New 12"x12" Floor Tiles are now present.
