# ASBESTOS MANAGEMENT PLANS

NEW MILFORD PUBLIC SCHOOLS

ASBESTOS MANAGEMENT PLAN  
HILL AND PLAIN SCHOOL

Prepared By :  
Jack S. Kozuchowski  
Consulting Services  
November, 1986

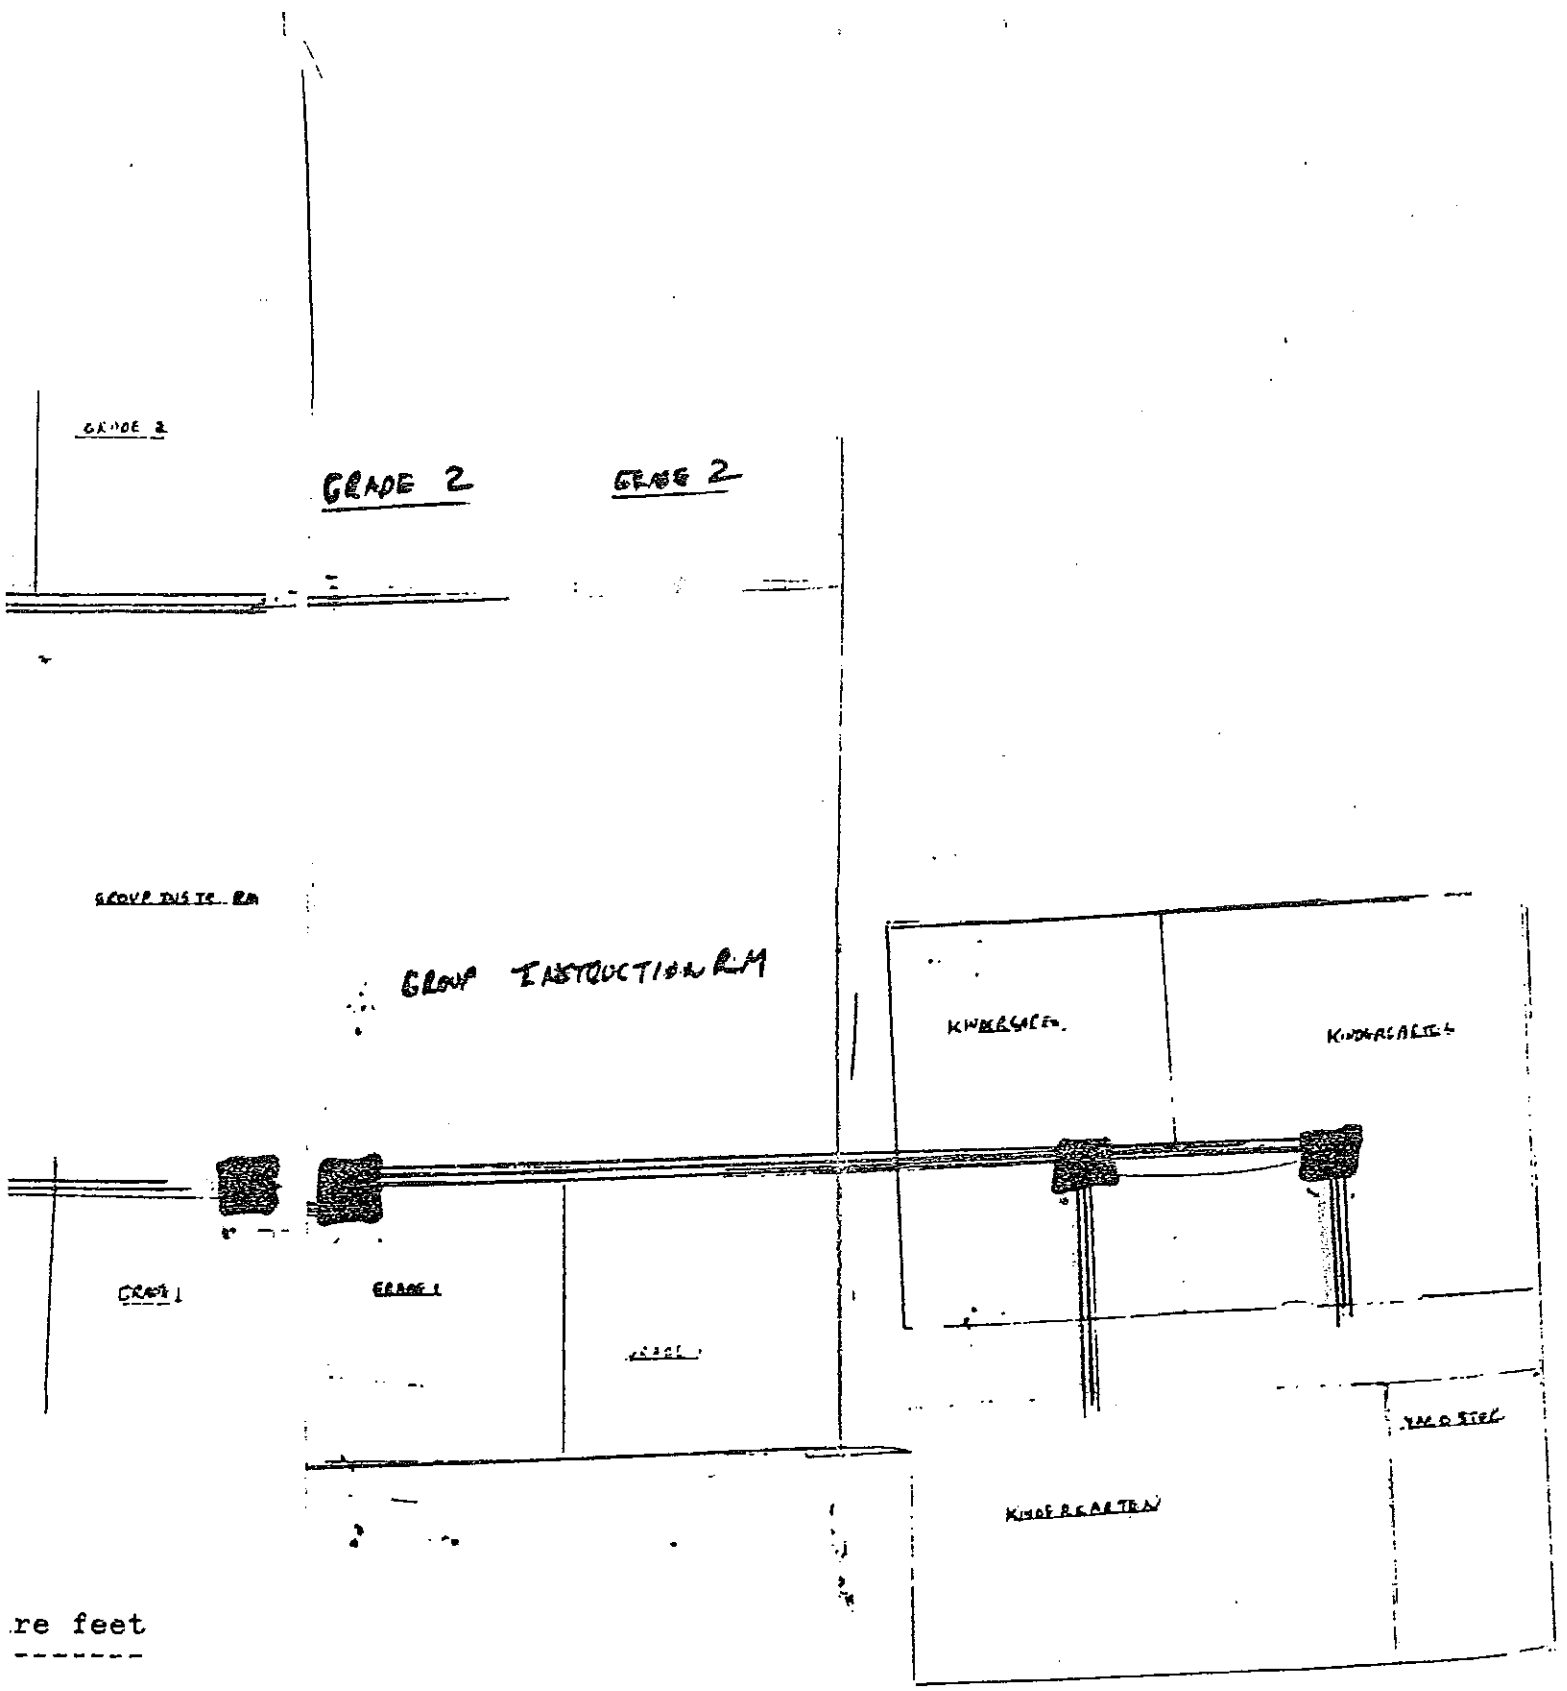
PIPE ELBOW (#1947-1)

Conclusions (Recommendation Derived from the Detailed Asbestos Decision Protocol):  
ASBESTOS ON PIPE ELBOWS OBSERVED WAS NOT IN BAD  
CONDITIONS. NO CURRENT HAZARD WAS FOUND, HOWEVER, THE  
CONDITIONS IN THIS AREA SUGGEST A STRONG POTENTIAL FOR  
MOISTURE DAMAGE.

ASBESTOS MANAGEMENT PLAN SPECIFIES IMPLEMENTATION OF A  
MANAGEMENT/MONITORING PROGRAM.

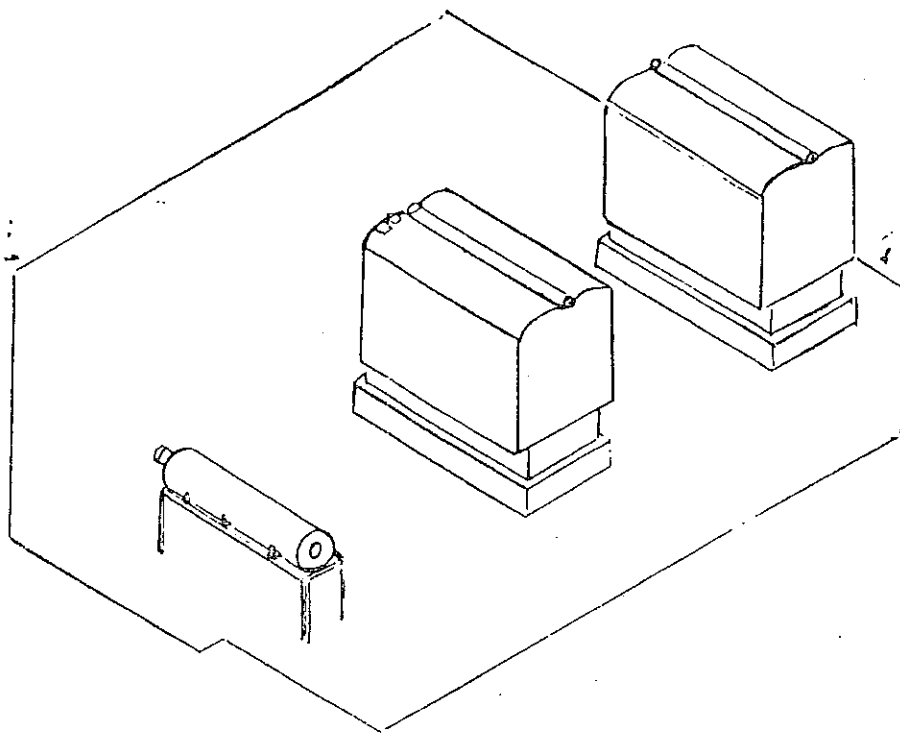
2A : Sketch of boiler room

Area of Asbestos :	Boilers	: 530 square feet
	hot water tank	: 160 square feet
	pipes	: 410 square feet

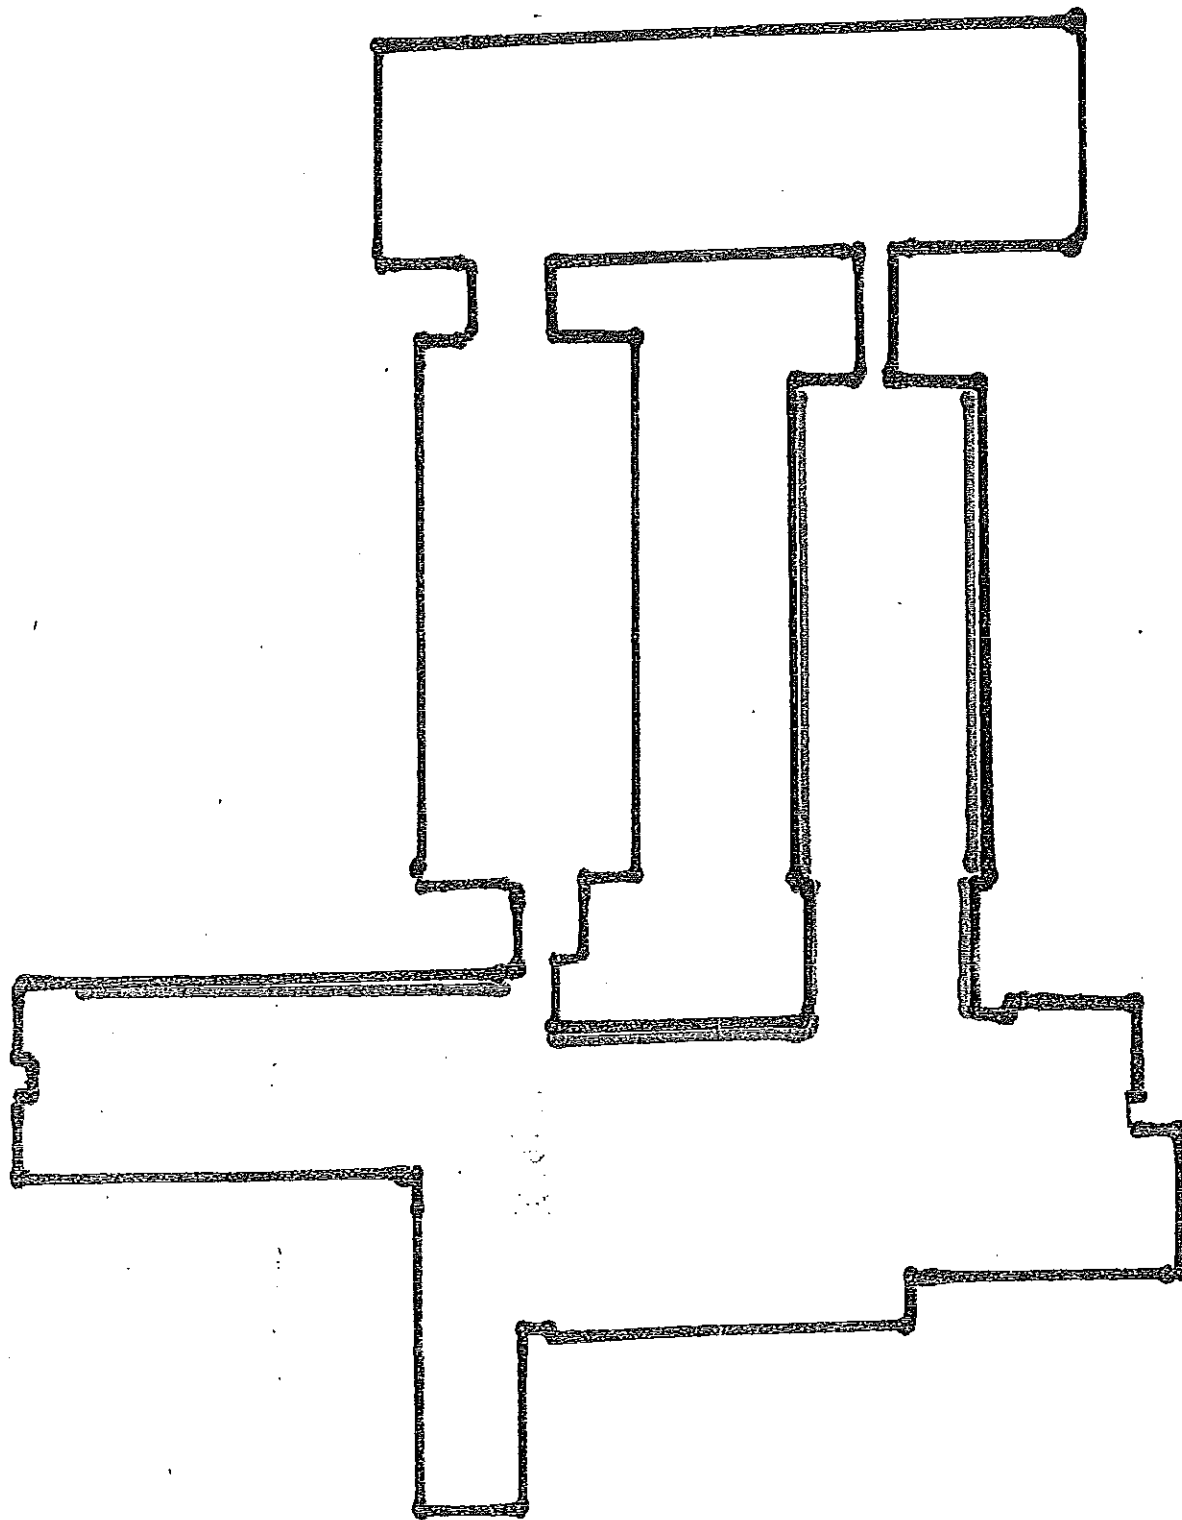
Outer asbestos wall illustrated in red

The outer wall of the original wing of the building, illustrated on figure 6, is constructed of asbestos. The contractor

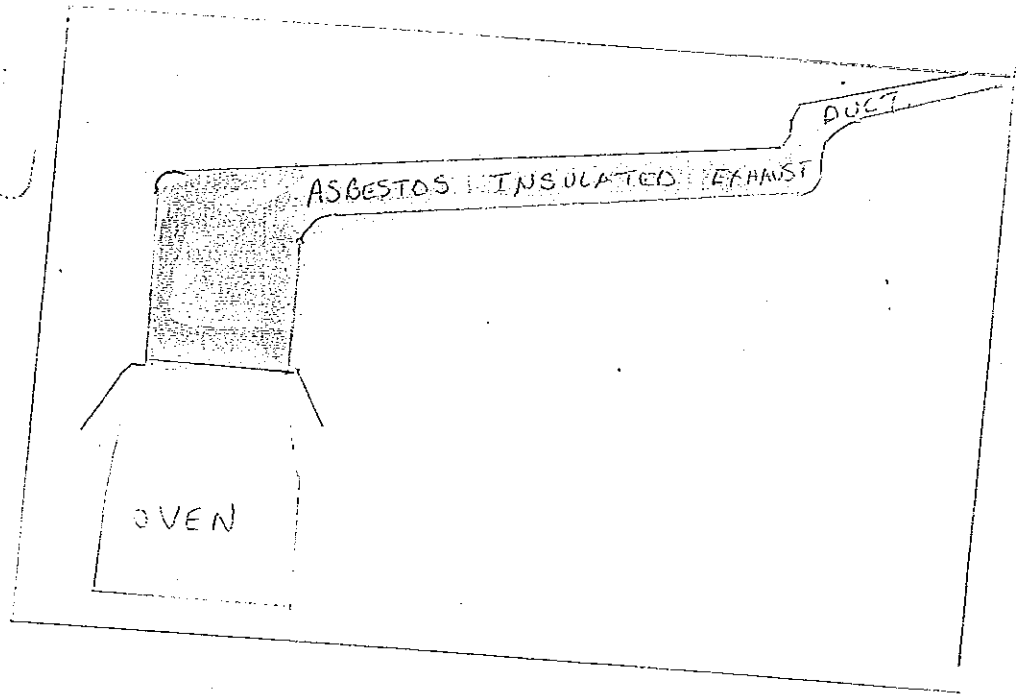
4A : Sketch of kitchen area

Figure 4 shows the approximate location of asbestos in the kitchen. Asbestos is present on the exhaust duct located across the ceiling, leading from the broiler to the end of the room.

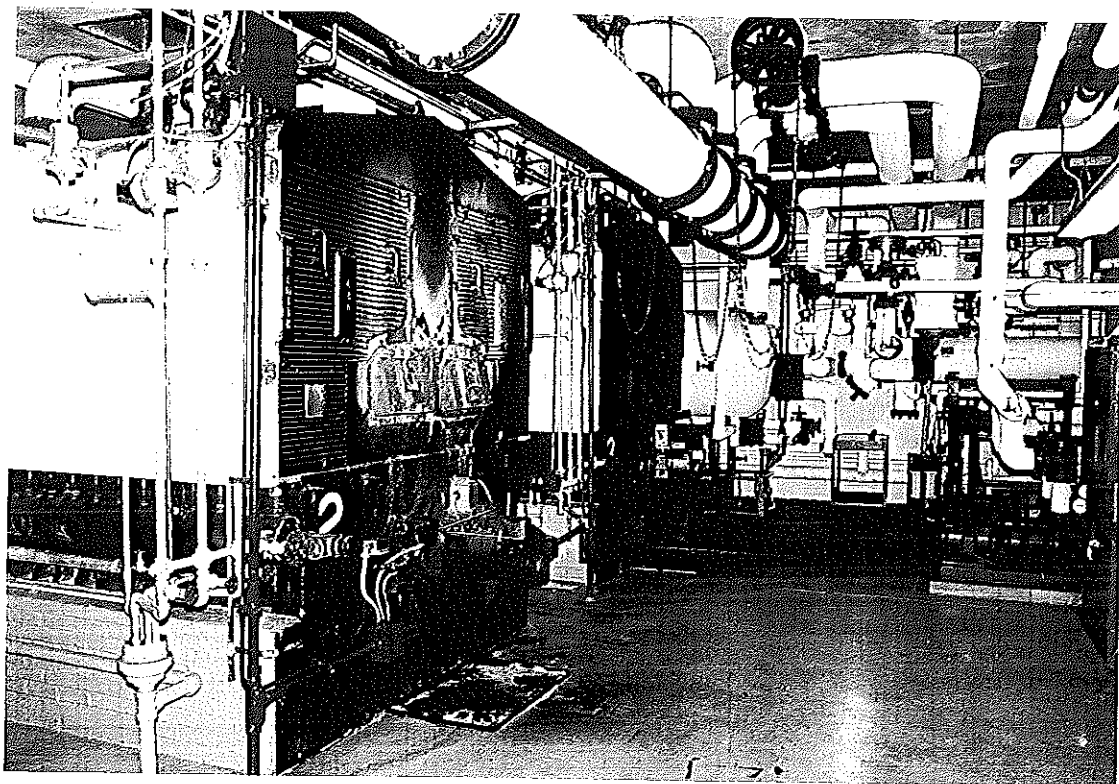
FIGURE 2A : Photograph of Boiler Room

Area of Asbestos : 400  
(square feet)

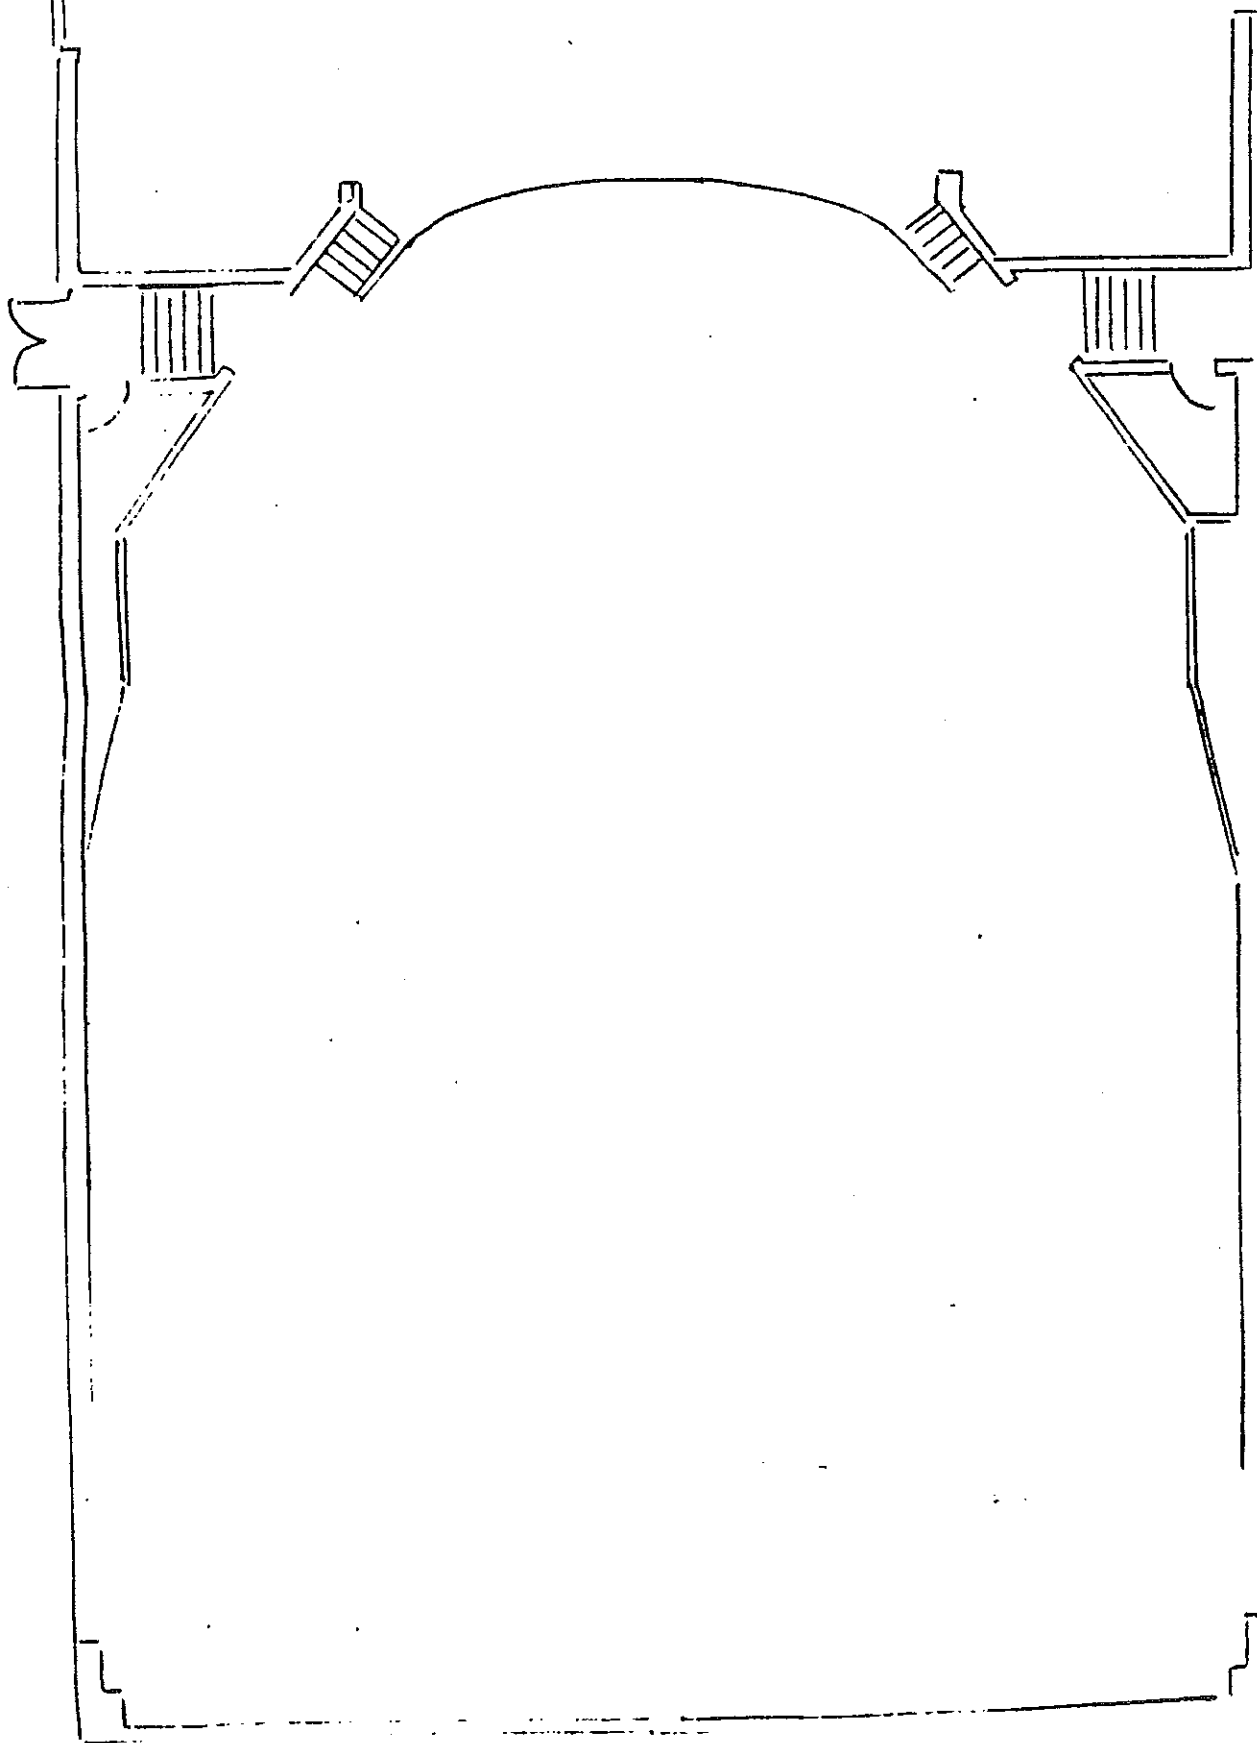
FIGURE 5 : MUSIC AREA - WALLBOARD IN CHORAL ROOM, MUSIC  
----- OFFICE AND MUSIC PRACTICE ROOMS.

Area of Asbestos : 2500 square feet

The wallboard which is present in the music lecture room, the practice rooms and the music room office contains 1 - 3 % asbestos. This wallboard is not friable unless it becomes chipped, cracked or mechanically perforated. With one exception, all of the wallboard is non-friable. The one exception is a small area in the "tuba room" (see highlighted location illustrated on figure 5), where the wallboard is cracked.

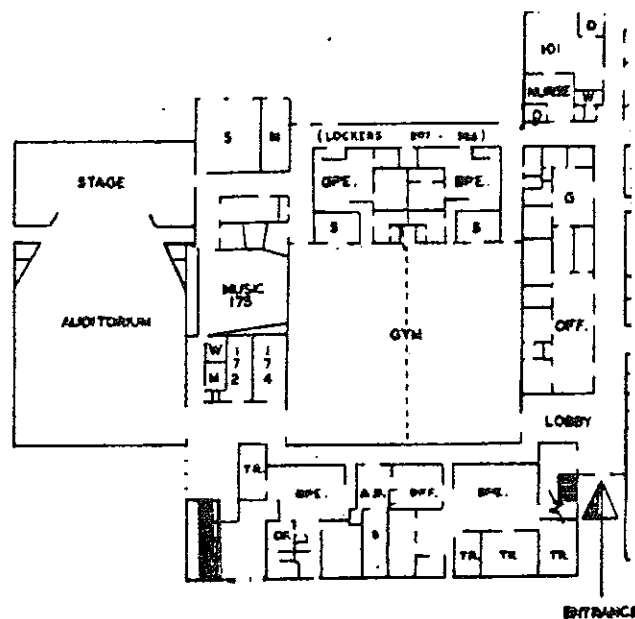
FIGURE 6 : CEILING SPACE ABOVE HALLWAY OUTSIDE LOCKER ROOMS

6A : Photograph showing pipe elbows above ceiling.

Area of Asbestos : 20 elbows and valves

Figure 6 depicts the ceiling space in the 1969 addition of

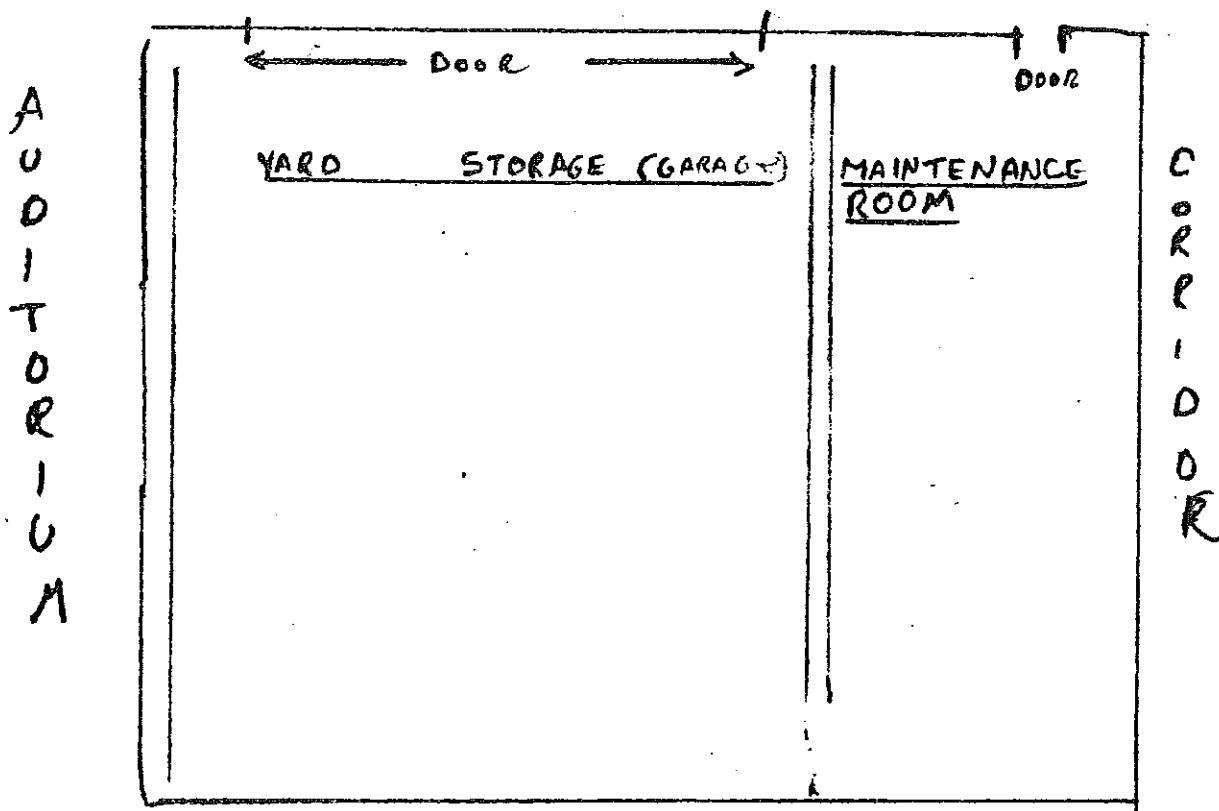
FIGURE 7 : TEXTURED CEILING ABOVE MAINTENANCE WORKSHOP AREA

7A : Photograph of textured ceiling.

Area of Asbestos : 1387 square feet

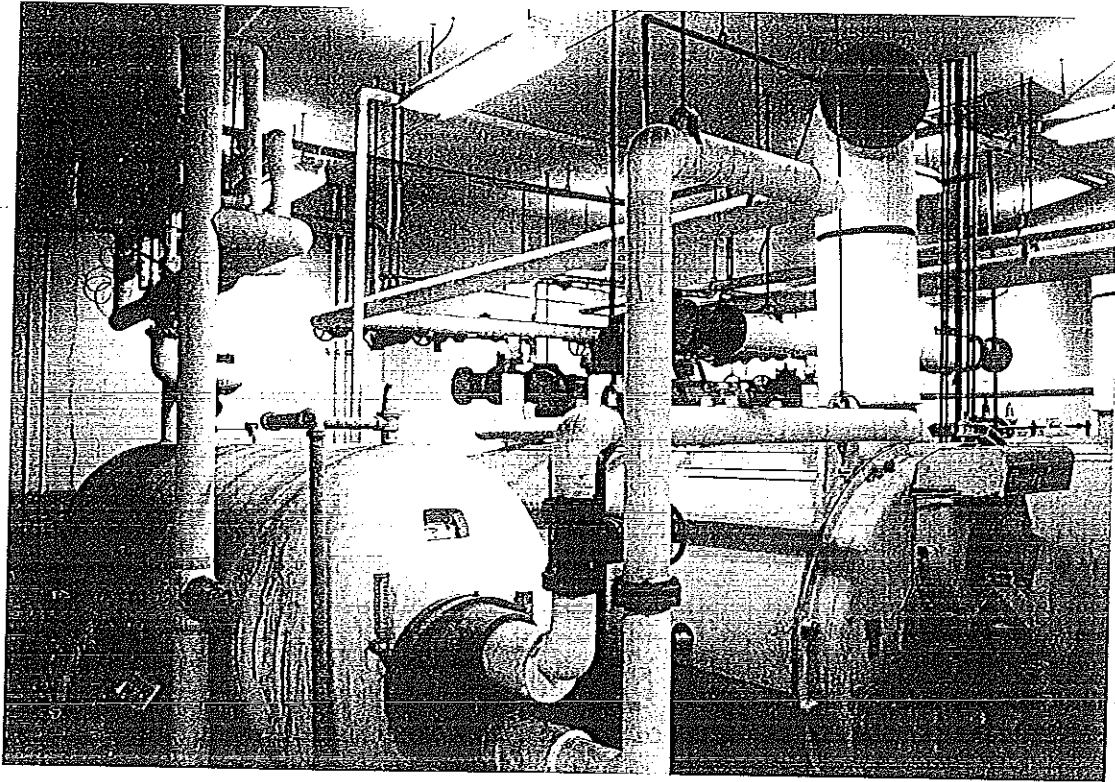
FIGURE 1 A : Photograph of Boiler Room

Area of asbestos : 226 square feet

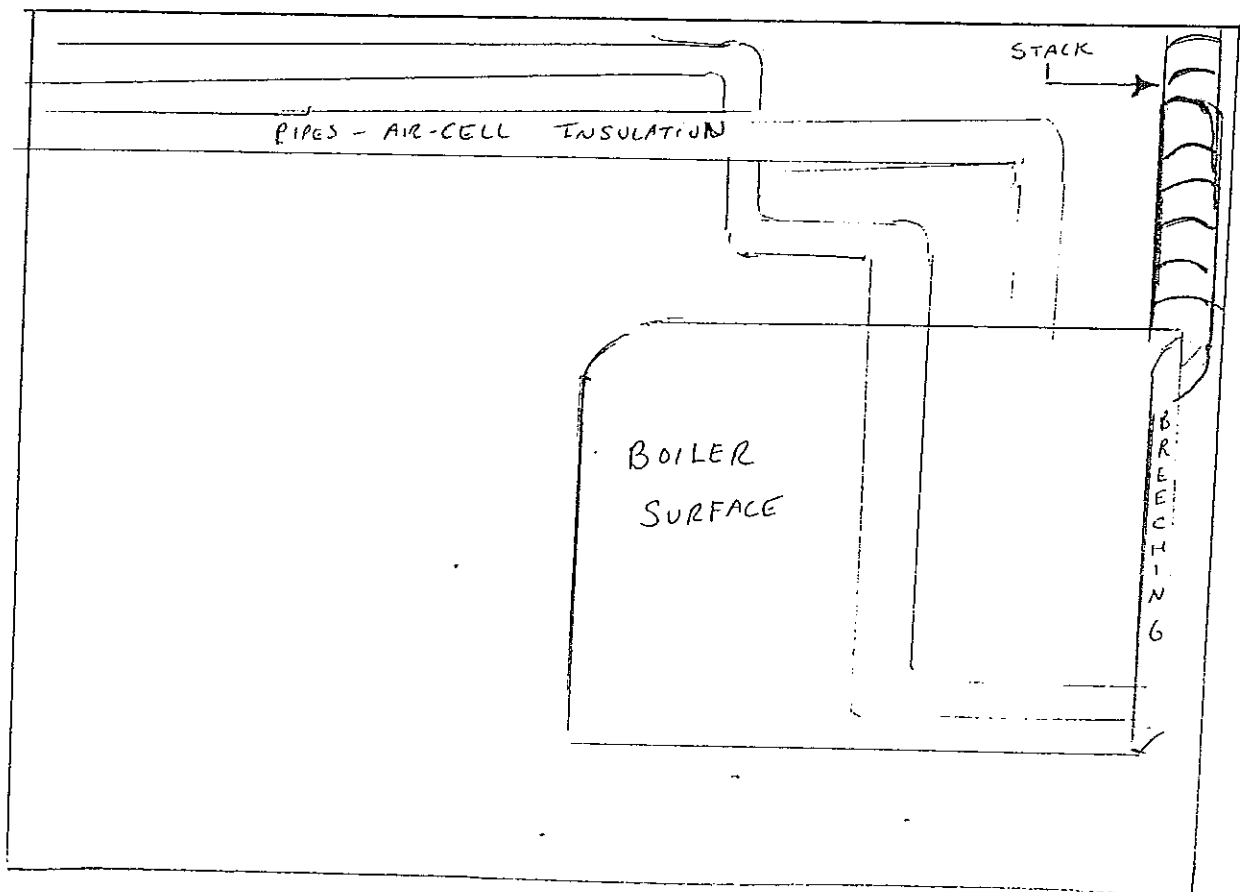
Fig. 1B: Sketch of boiler room. Not to scale.

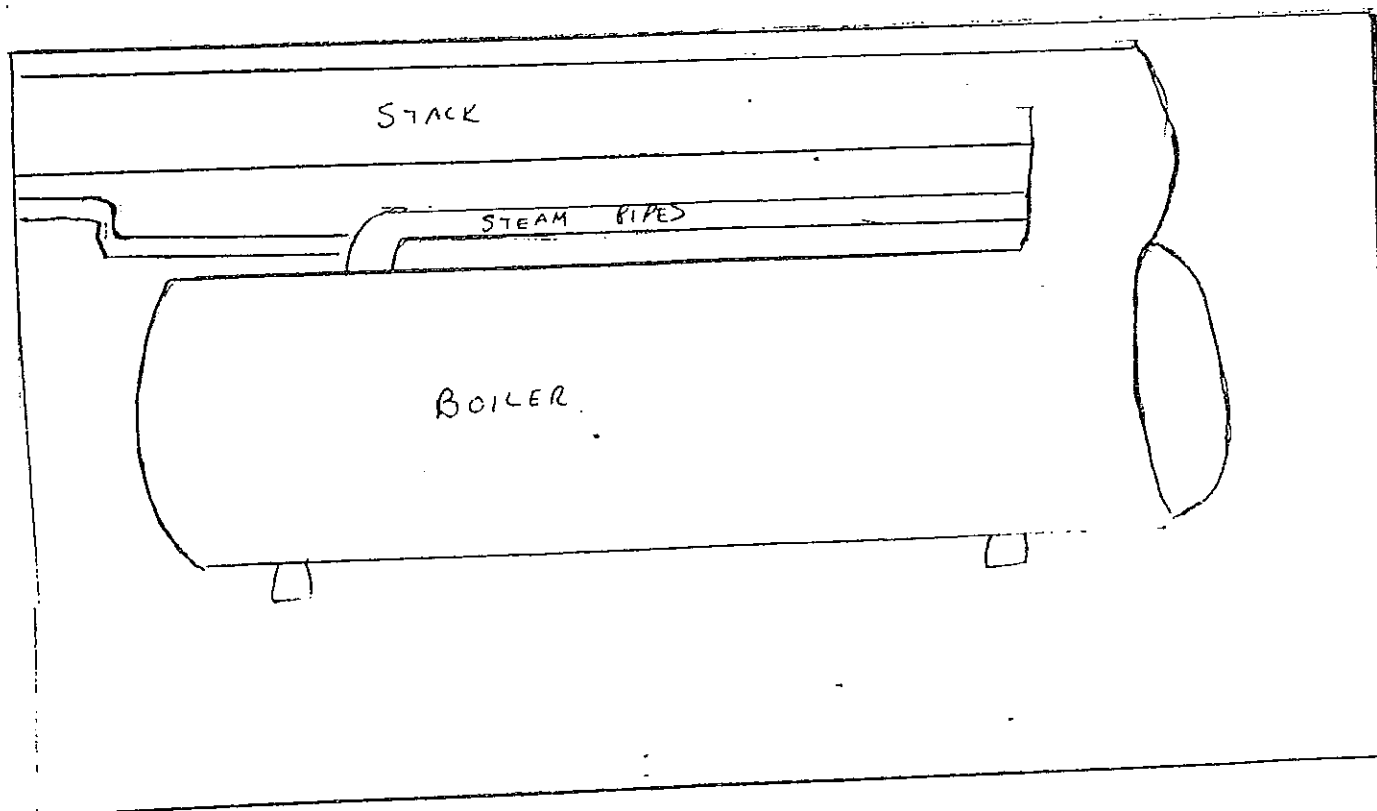
Fig. 1A : Photograph showing boilers, stack, and pipes covered with asbestos insulation.

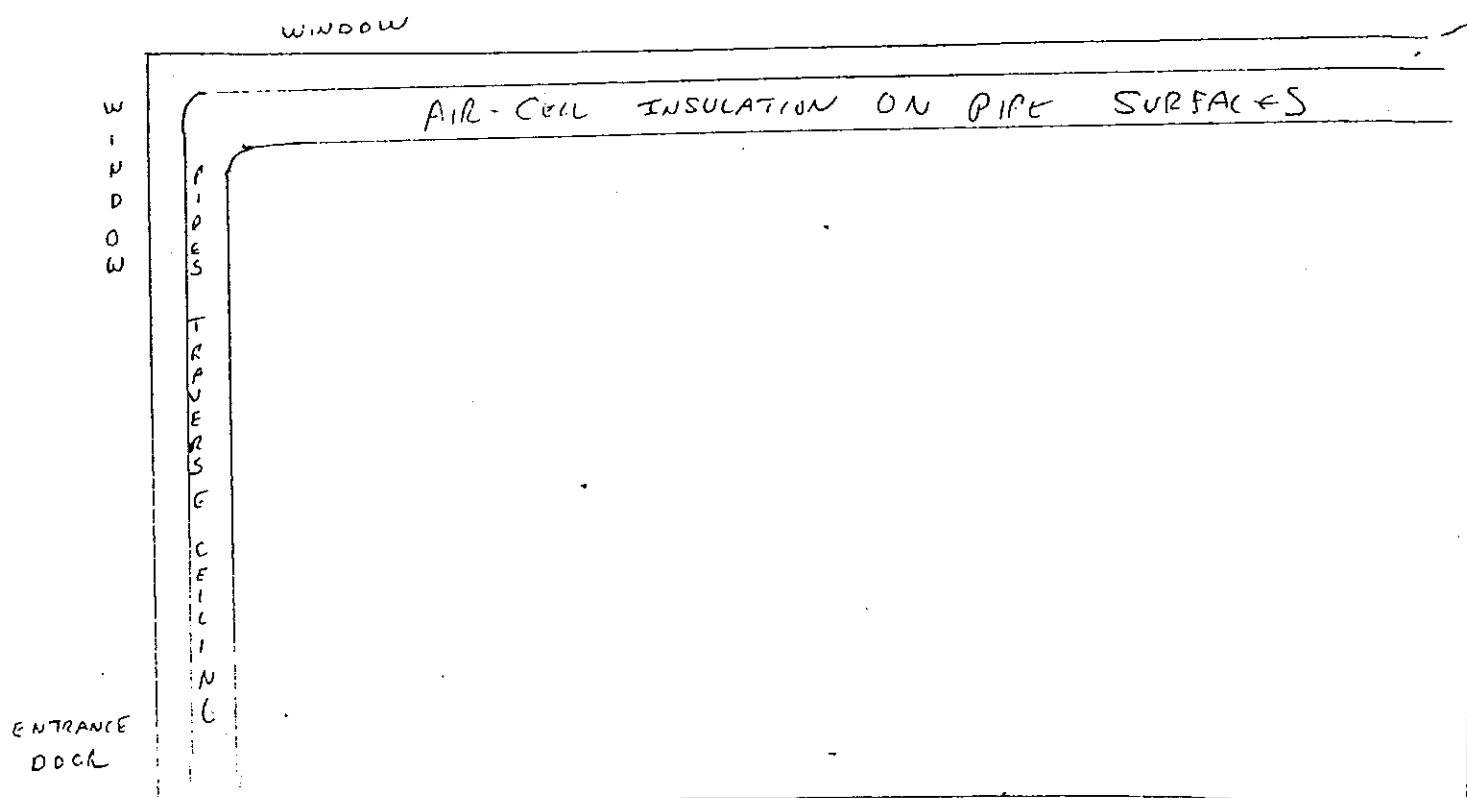
Fig. 2A : Photograph of basement storage room showing pipes.
