Wolcott High School

2 Executive Summary

Stories	Two
Area	179,167
Address	457 Bound Line Road, Wolcott
Original Construction	1965
Addition(s)	1976
Grades	9-12
Description	School

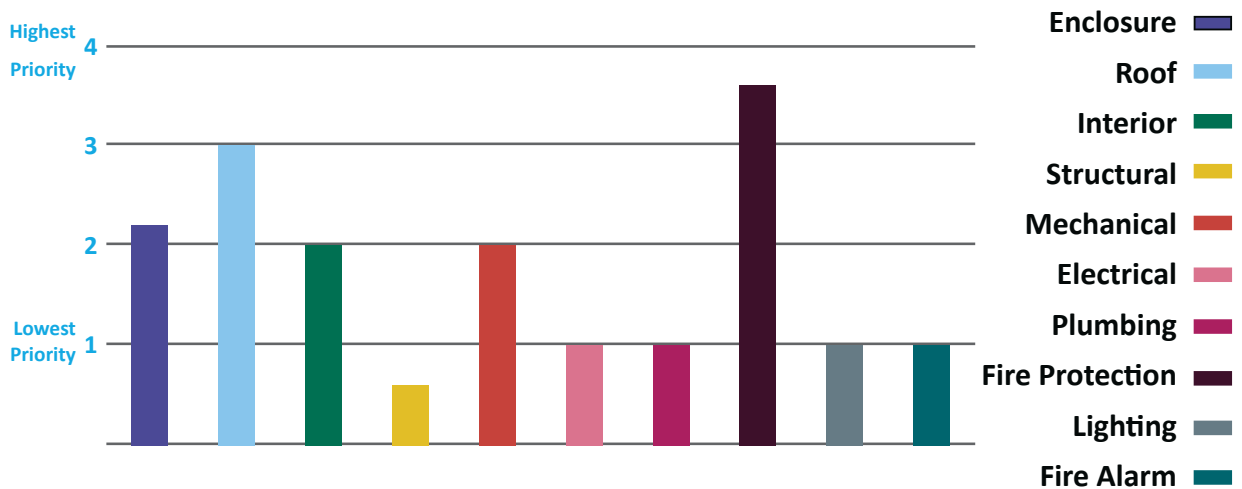
Prioritization of Required Work

Each of the elements that were reviewed under this assessment was ranked on a scale of 1-4, with a 4 rating equating to the highest priority. Components that received a ranking of 3 should be considered to be moderate priorities, while rankings of 2 and 1 are considered to be low priorities. The following chart graphically presents the survey results (reference Section 4 for a detailed description for each category).

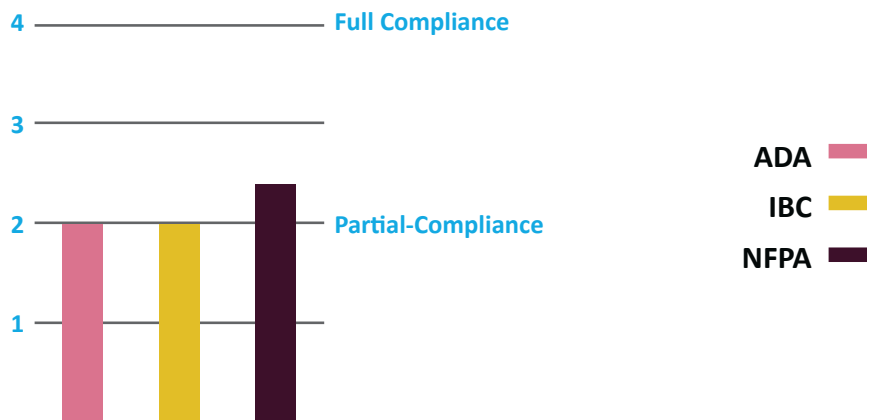
Code Compliance Evaluation

The graph below represents the building's overall conformity with IBC, NFPA and ADA requirements. Compliance was rated on a scale of 1-4, with a 4 rating equating to full compliance. A rating of 2 or under indicates that the building requires moderate to substantial code compliance updates in order to protect the safety of the building's occupants.

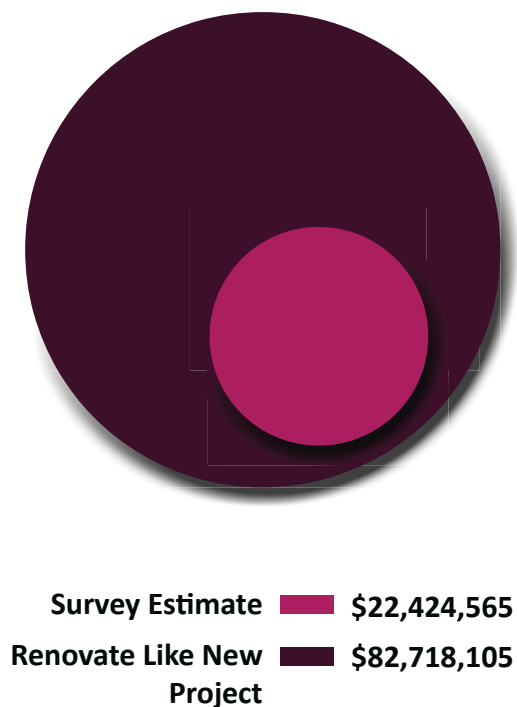
Executive Summary Chart

The chart below indicates the estimated value of the required work addressed by the building survey alongside the potential replacement cost. The replacement cost is provided as a guideline for comparative purposes and is based on replacing the building as is, i.e. size and use. Information considered includes the type of structure, year built and existing area for the building.

The required Alteration work addressed in this survey equates to approximately 27% of the construction cost of a Renovate Like New project. Comparative Replacement costs for a new building would be \$95,400,000. Site acquisition costs were not factored into this comparison.
