# Wakelee Elementary School

## 2 Executive Summary

### Wakelee Elementary School

<b>Stories</b>	Two
<b>Area</b>	85,155
<b>Address</b>	12 Hempel Drive, Wolcott
<b>Original Construction</b>	1960
<b>Addition(s)</b>	2000
<b>Grades</b>	Kindergarten - 5th Grade
<b>Description</b>	School

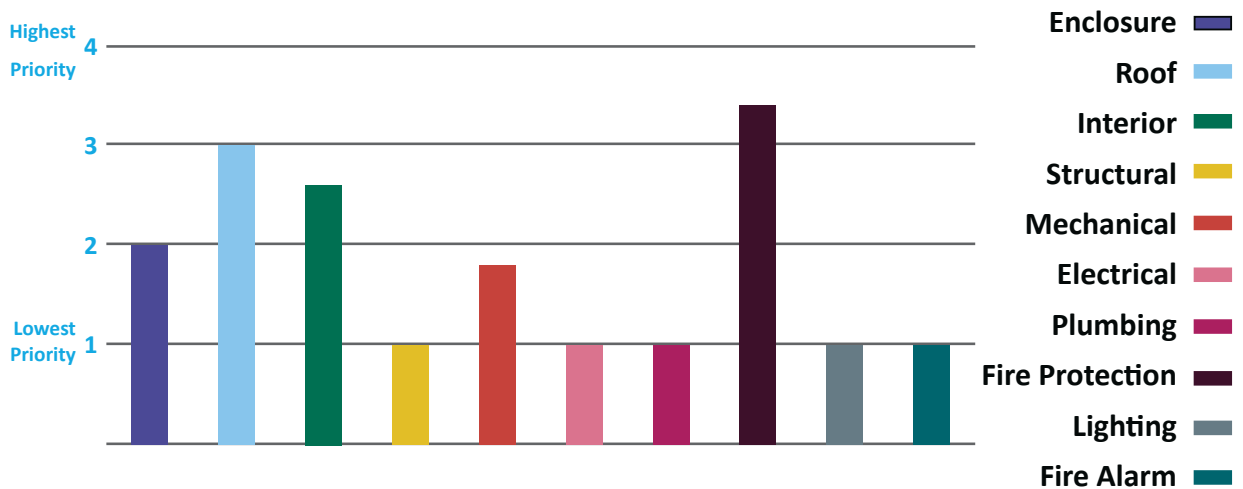
### Prioritization of Required Work

Each of the elements that were reviewed under this assessment was ranked on a scale of 1-4, with a 4 rating equating to the highest priority. Components that received a ranking of 3 should be considered to be moderate priorities, while rankings of 2 and 1 are considered to be low priorities. The following chart graphically presents the survey results (reference Section 4 for a detailed description for each category).

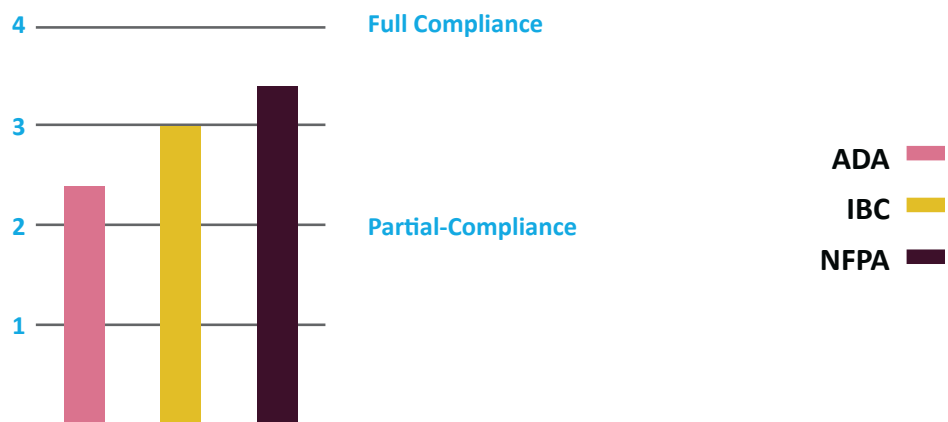
### Code Compliance Evaluation

The graph below represents the building's overall conformity with IBC, NFPA and ADA requirements. Compliance was rated on a scale of 1-4, with a 4 rating equating to full compliance. A rating of 2 or under indicates that the building requires moderate to substantial code compliance updates in order to protect the safety of the building's occupants.

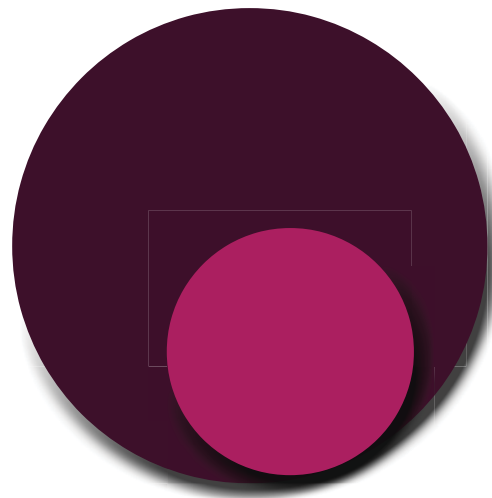
### Executive Summary Chart

The chart below indicates the estimated value of the required work addressed by the building survey alongside the potential replacement cost. The replacement cost is provided as a guideline for comparative purposes and is based on replacing the building as is, i.e. size and use. Information considered includes the type of structure, year built and existing area for the building.

**Survey Estimate** ■ \$10,151,701  
**Renovate Like New Project** ■ \$36,318,180

The required Alteration work addressed in this survey equates to approximately 28% of the construction cost of a Renovate like New project.

Comparative Replacement costs for a new building would be \$43,502,760. Site acquisition costs were not factored into this comparison.
