**RE: Three Year AHERA Asbestos Re-inspection  
and Management Plan Update  
Sarah Noble Intermediate School  
25 Sunny Valley Road, New Milford, CT  
EnviroScience Project No. 04-542.10**

ASBESTOS HAZARD EMERGENCY RESPONSE ACT  
THREE-YEAR ASBESTOS REINSPECTION AND  
MANAGEMENT PLAN UPDATE

FOR  
SARAH NOBLE INTERMEDIATE SCHOOL

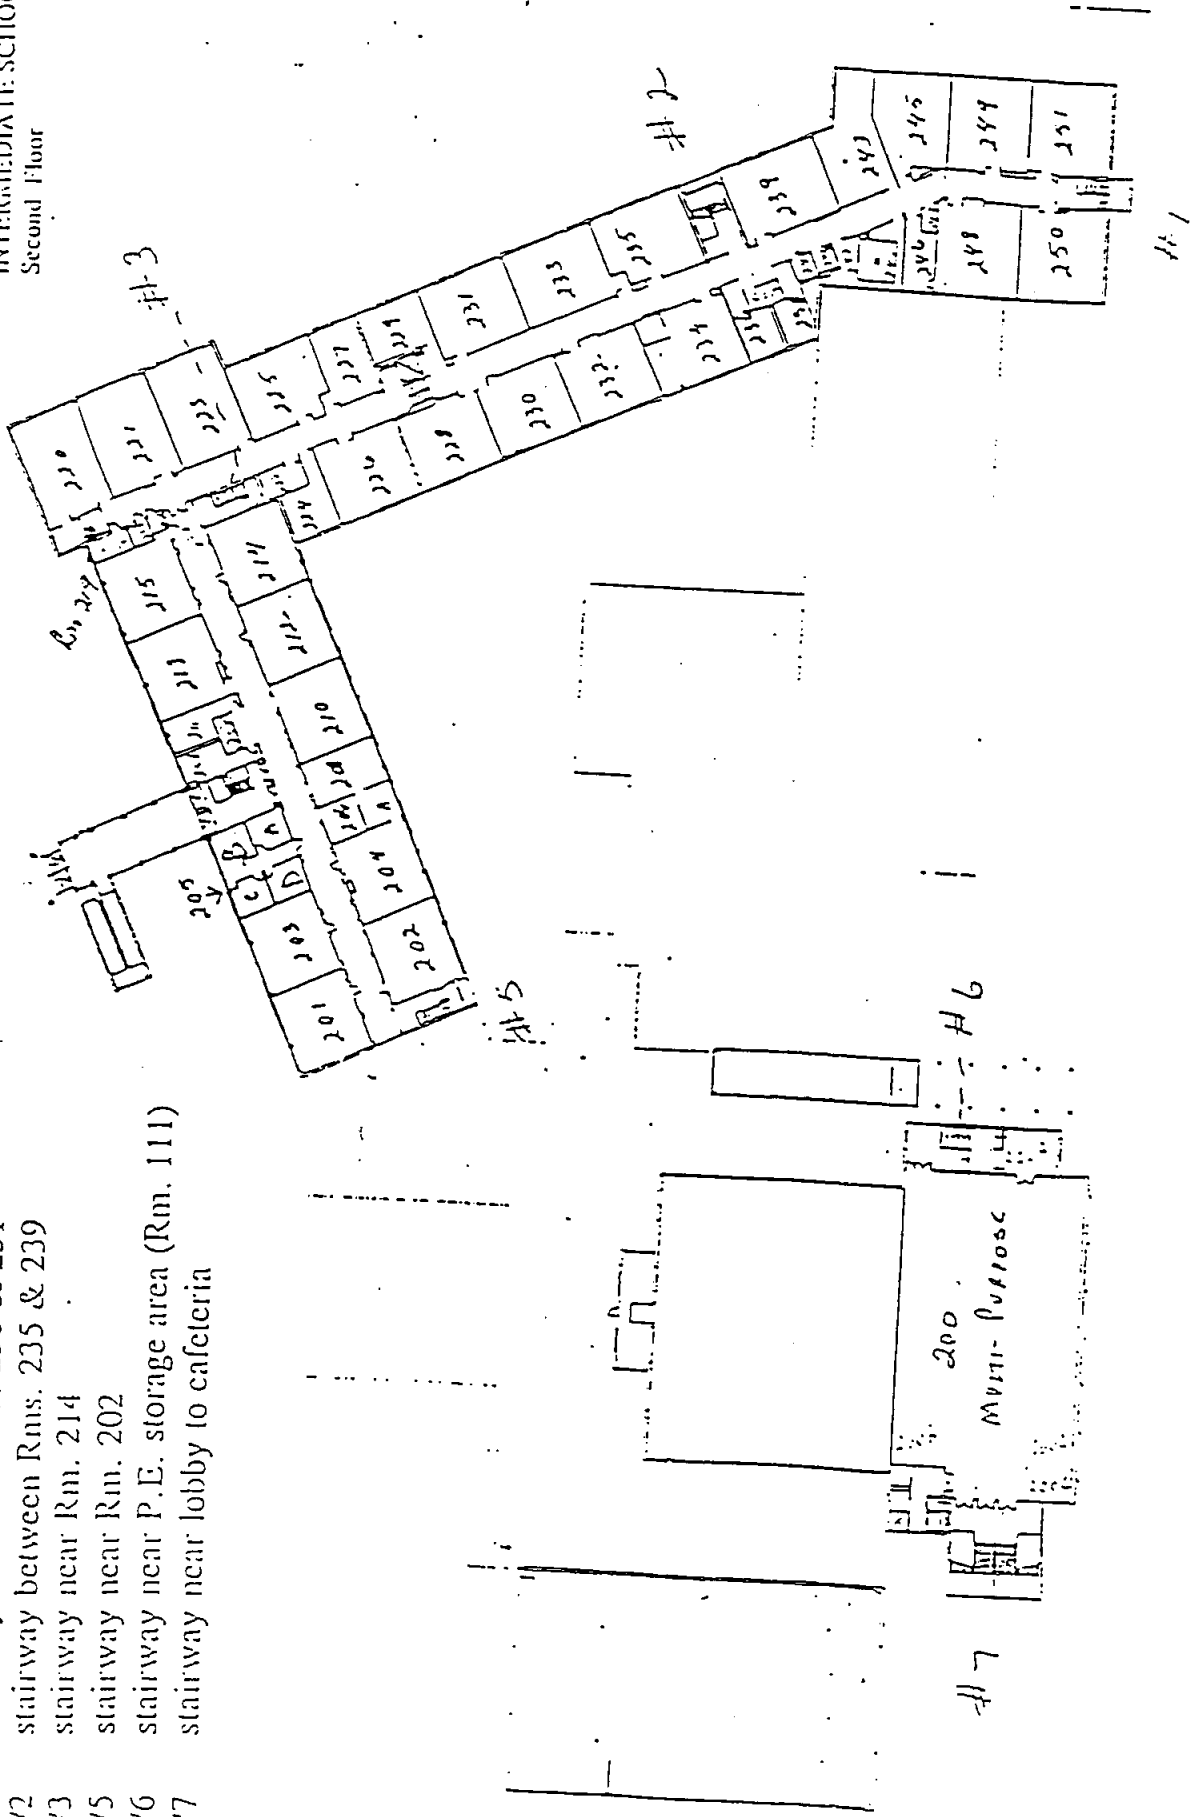
Revised 12/01  
 SARAH NOBLE  
 INTERMEDIATE SCHOOL  
 Second Floor

AREAS OF REFUGE:

- #1 stairway between Rms. 250 & 251
- #2 stairway between Rms. 235 & 239
- #3 stairway near Rm. 214
- #5 stairway near Rm. 202
- #6 stairway near P.E. storage area (Rm. 111)
- #7 stairway near lobby to cafeteria
