# Alcott Elementary School

### Alcott Elementary School

<b>Stories</b>	Two
<b>Area</b>	94,706 sf
<b>Address</b>	1490 Woodtick Road, Wolcott, CT
<b>Original Construction</b>	1947
<b>Addition(s)</b>	1967
<b>Grades</b>	Pre-K - Fifth Grade
<b>Description</b>	School

## 2 Executive Summary

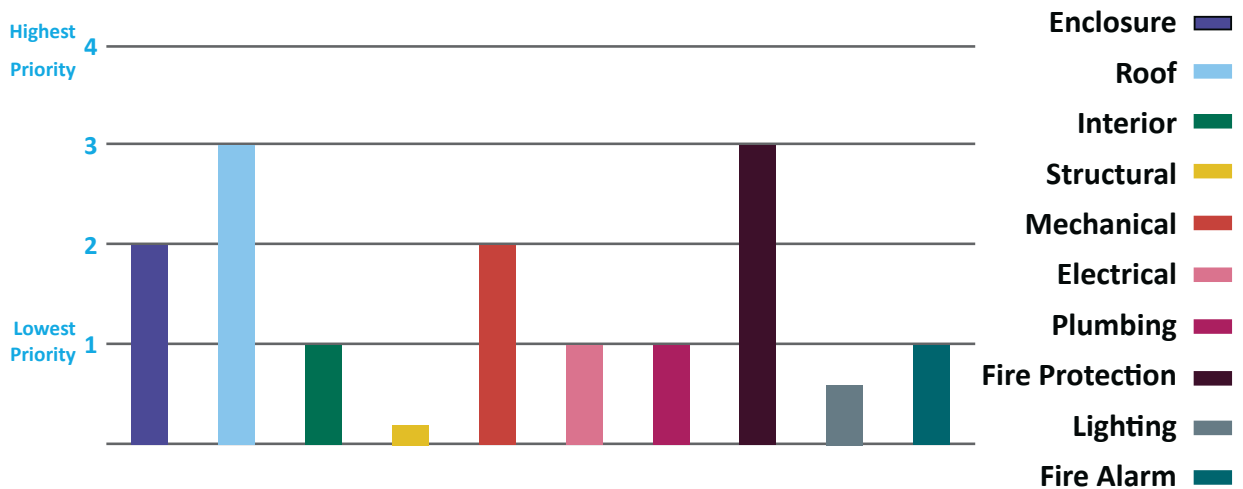
### Prioritization of Required Work

Each of the elements that were reviewed under this assessment was ranked on a scale of 1-4, with a 4 rating equating to the highest priority. Components that received a ranking of 3 should be considered to be moderate priorities, while rankings of 2 and 1 are considered to be low priorities. The following chart graphically presents the survey results (reference Section 4 for a detailed description for each category).

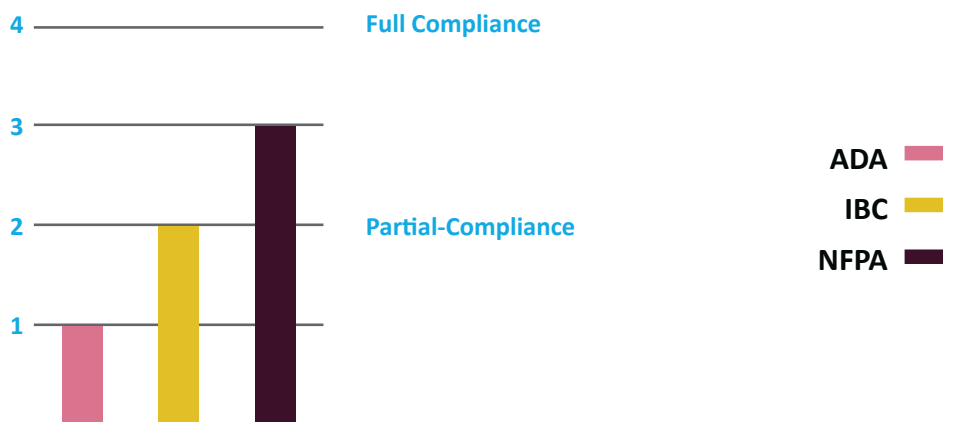
### Code Compliance Evaluation

The graph below represents the building’s overall conformity with IBC, NFPA and ADA requirements. Compliance was rated on a scale of 1-4, with a 4 rating equating to full compliance. A rating of 2 or under indicates that the building requires moderate to substantial code compliance updates in order to protect the safety of the building’s occupants.

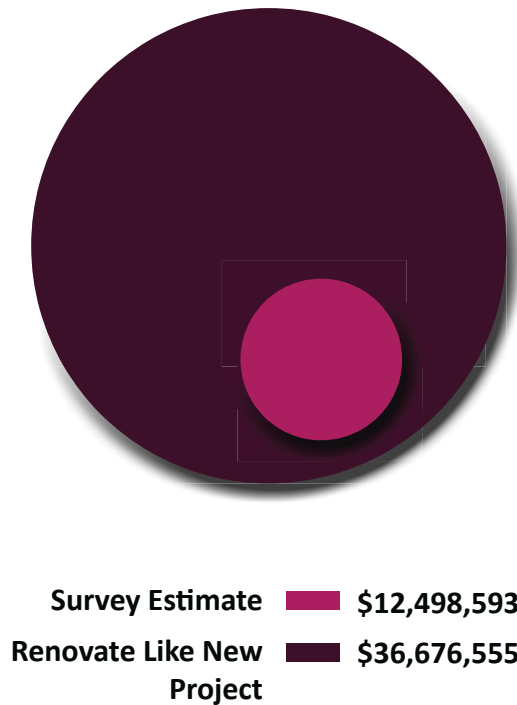
## Executive Summary Chart

The chart below indicates the estimated value of the required work addressed by the building survey alongside the potential replacement cost. The replacement cost is provided as a guideline for comparative purposes and is based on replacing the building as is, i.e. size and use. Information considered includes the type of structure, year built and existing area for the building.

The required Alteration work addressed in this survey equates to approximately 34% of the construction cost of a Renovate like New project. Comparative Replacement costs for a new building would be \$45,900,000. Site acquisition costs were not factored into this comparison.
