# Tyrrell Middle School

## 2 Executive Summary

### Tyrrell Middle School

<b>Stories</b>	Two
<b>Area</b>	154,174
<b>Address</b>	500 Todd Road, Wolcott
<b>Original Construction</b>	1965
<b>Addition(s)</b>	2000
<b>Grades</b>	6-8
<b>Description</b>	School

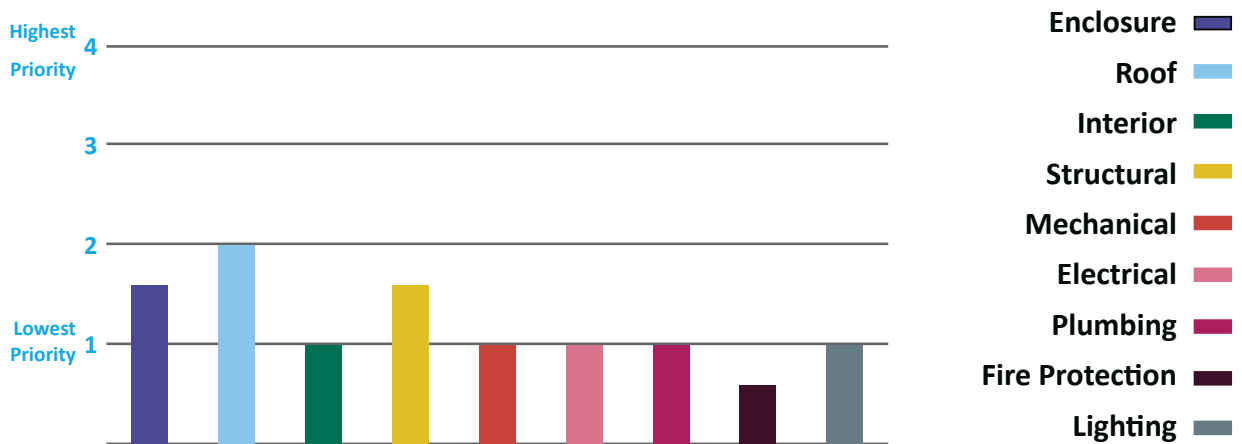
### Prioritization of Required Work

Each of the elements that were reviewed under this assessment was ranked on a scale of 1-4, with a 4 rating equating to the highest priority. Components that received a ranking of 3 should be considered to be moderate priorities, while rankings of 2 and 1 are considered to be low priorities. The following chart graphically presents the survey results (reference Section 4 for a detailed description for each category).

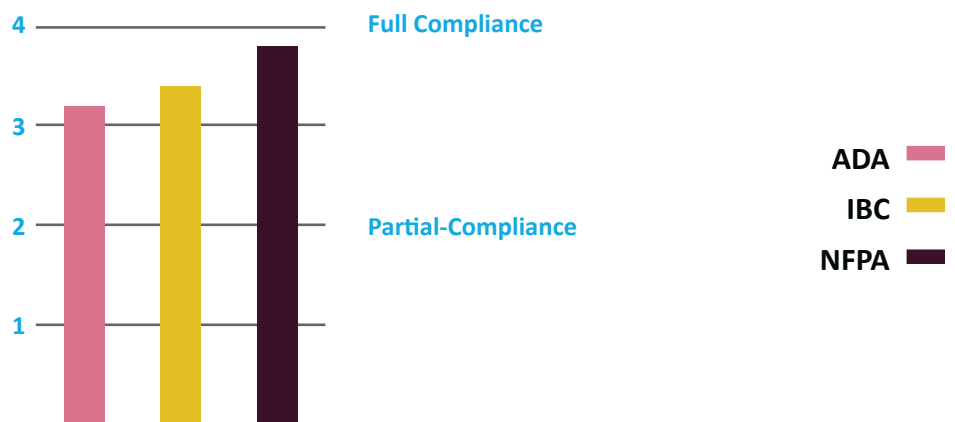
### Code Compliance Evaluation

The graph below represents the building's overall conformity with IBC, NFPA and ADA requirements. Compliance was rated on a scale of 1-4, with a 4 rating equating to full compliance. A rating of 2 or under indicates that the building requires moderate to substantial code compliance updates in order to protect the safety of the building's occupants.

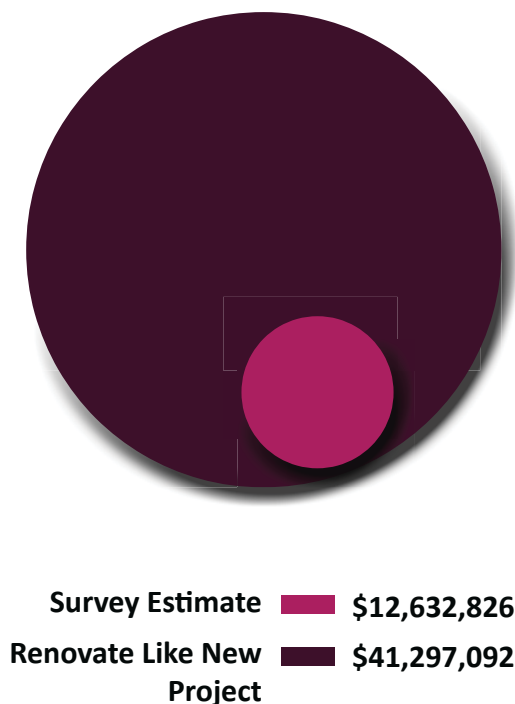
### Executive Summary Chart

The chart below indicates the estimated value of the required work addressed by the building survey alongside the potential replacement cost. The replacement cost is provided as a guideline for comparative purposes and is based on replacing the building as is, i.e. size and use. Information considered includes the type of structure, year built and existing area for the building.

The required Alteration work addressed in this survey equates to approximately 31% of the construction cost of a Renovate Like New project. Comparative Replacement costs for a new building would be \$72,100,000. Site acquisition costs were not factored into this comparison.
