Frisbie Elementary School

18 Executive Summary

Stories	One
Area	63,730
Address	24 Todd Road, Wolcott
Original Construction	1953
Addition(s)	1953 and 2000
Grades	Kindergarten - 5th Grade
Description	School

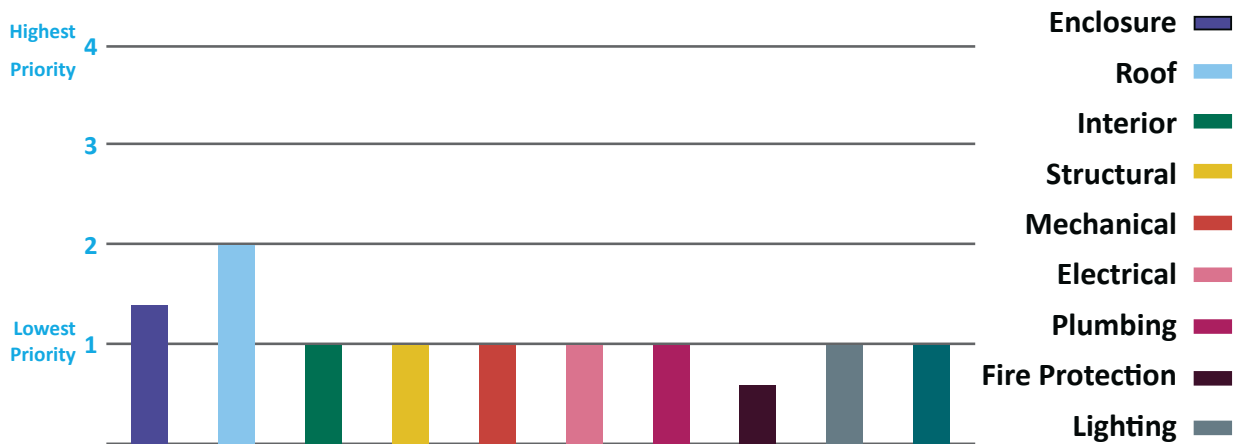
Prioritization of Required Work

Each of the elements that were reviewed under this assessment was ranked on a scale of 1-4, with a 4 rating equating to the highest priority. Components that received a ranking of 3 should be considered to be moderate priorities, while rankings of 2 and 1 are considered to be low priorities. The following chart graphically presents the survey results (reference Section 4 for a detailed description for each category).

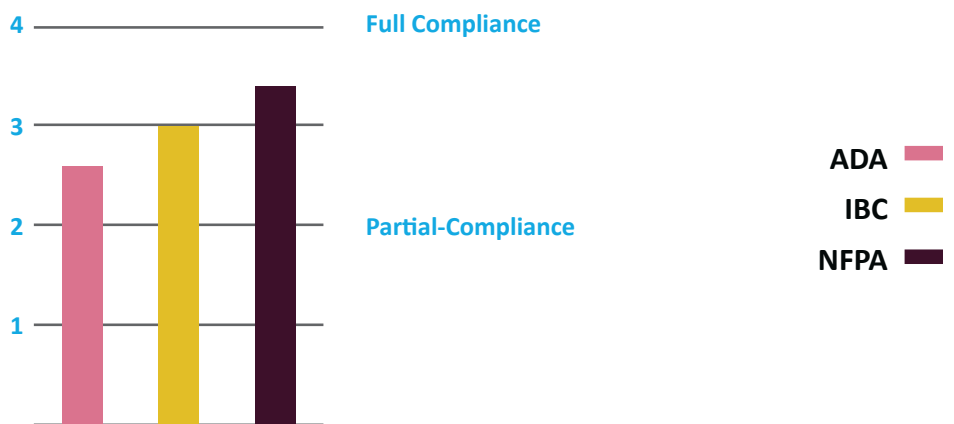
Code Compliance Evaluation

The graph below represents the building’s overall conformity with IBC, NFPA and ADA requirements. Compliance was rated on a scale of 1-4, with a 4 rating equating to full compliance. A rating of 2 or under indicates that the building requires moderate to substantial code compliance updates in order to protect the safety of the building’s occupants.

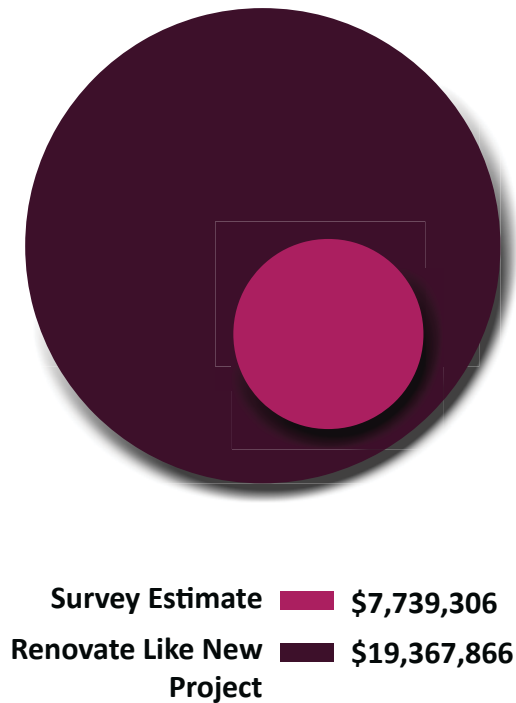
Executive Summary Chart

The chart below indicates the estimated value of the required work addressed by the building survey alongside the potential replacement cost. The replacement cost is provided as a guideline for comparative purposes and is based on replacing the building as is, i.e. size and use. Information considered includes the type of structure, year built and existing area for the building.

The required Alteration work addressed in this survey equates to approximately 40% of the construction cost of a Renovate like New project. Comparative Replacement costs for a new building would be \$32,448,500. Site acquisition costs were not factored into this comparison.
