JACKSON COUNTY CENTRAL SCHOOL DISTRICT

2018 Facilities Assessment

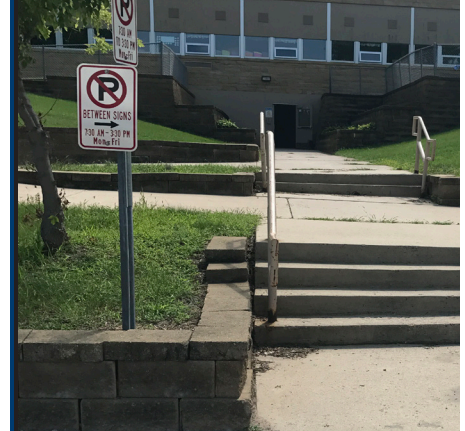
No Parking sign west of the stairway

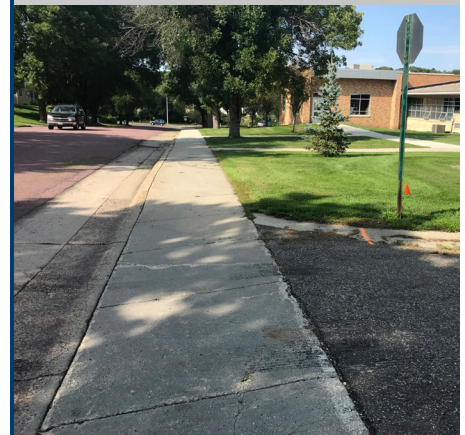
Unmarked bus loading zone

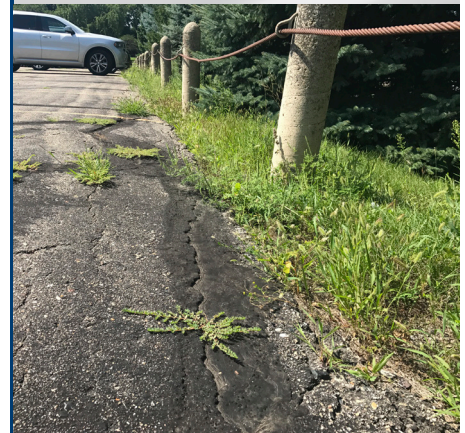
Concrete bollards and steel safety cable on northern face of north parking lot

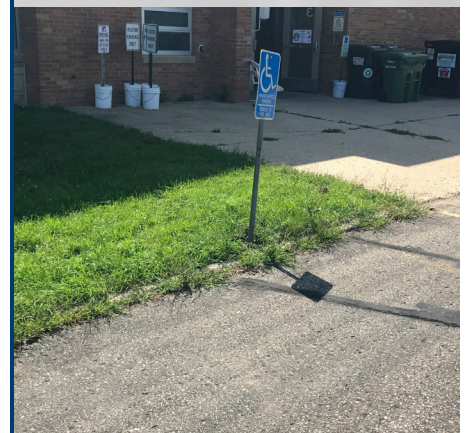
Handicap parking sign below the ADA 60 inch height requirement

During the site visit, it was noted that the handicap signage is not placed the required 60-inches from the ground. The lot is striped to function in a one-way orientation although no signage is present. The striping is fading, but still visible throughout the lot.

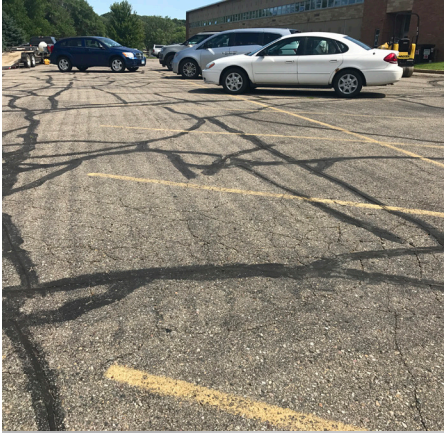
Fading striping in north parking lot

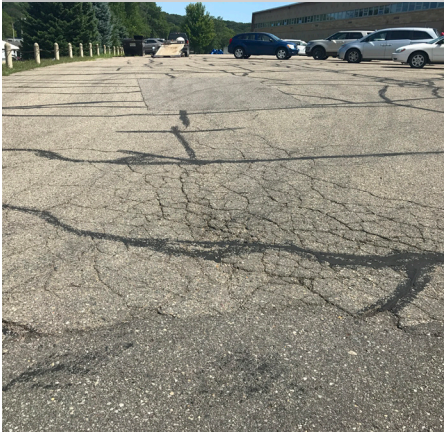
Alligator block cracking in north parking lot

The north parking lot received a PCI score of 42 out of 100 which falls in the fair category. The value can primarily be attributed to the large areas of alligator block cracking which indicate base failure. Additional longitudinal and transverse cracking with a series of patches also impacted the overall pavement rating. The pavement has been maintained with crack filling, seal coating and patching, however due to the large areas of base failure, the pavement is expected to need reconstruction within the next five years.

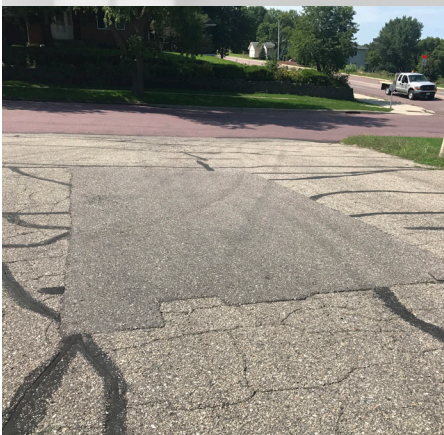
Crack filling, seal coating and patching

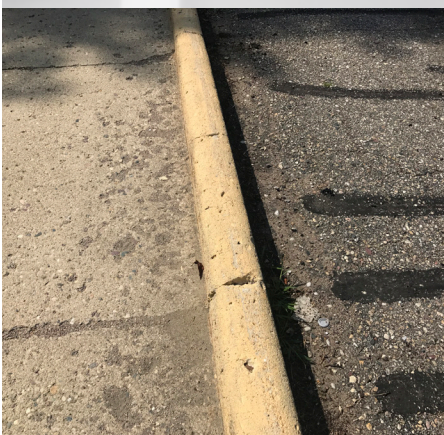
Minor cracking and faded paint on curb

There is curbing located along the southwest edge of the parking lot, which provides a barrier between the parking lot and sidewalk. The curbing is in fair condition, with minor cracking and faded paint noted. The curb is elevated above both the sidewalk and parking lot which could create a tripping hazard.

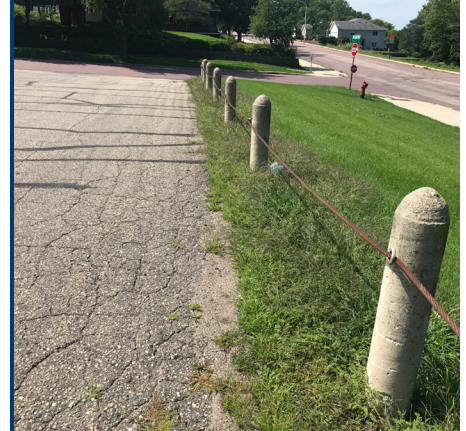
Stormwater from the parking lot sheet flows to the north into a grassed area which then drains into the city storm collection system in Springfield Parkway. The drainage within the lot appears to be adequate with only minor sediment buildup noted along the north pavement/grass edge.

Minor sediment buildup along the north pavement/grass edge

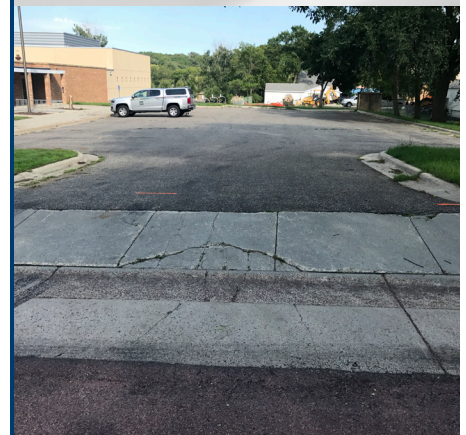
Cracking in concrete pavement of the southern parking lot driveway apron

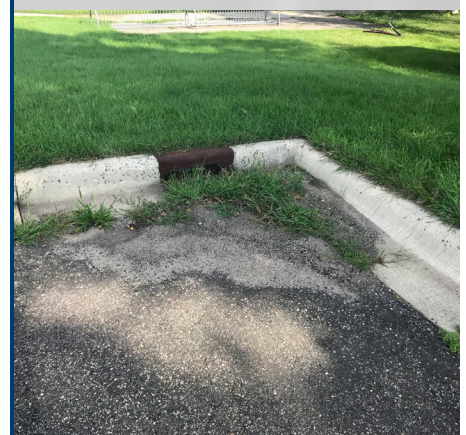
Sediment and vegetation buildup in front of south parking lot catch basin

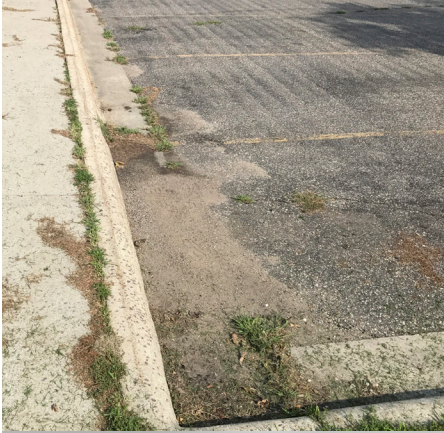
Sediment buildup in northwest edge of southern parking lot

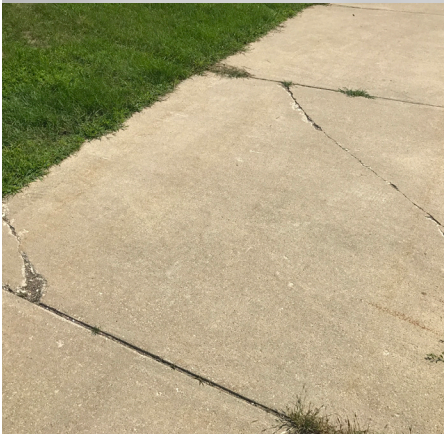
Corner breaking on five of the north walkway panels

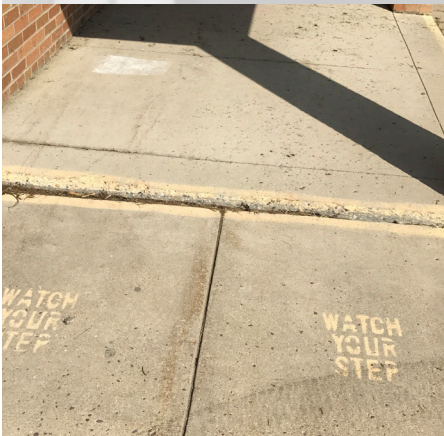
Concrete pavement raised approximately 2-3 inches from adjacent sidewalk

System Recommendations: ADA accessible routes should be created throughout the site and areas with a difference in pavement height greater than 1/4" should be corrected.

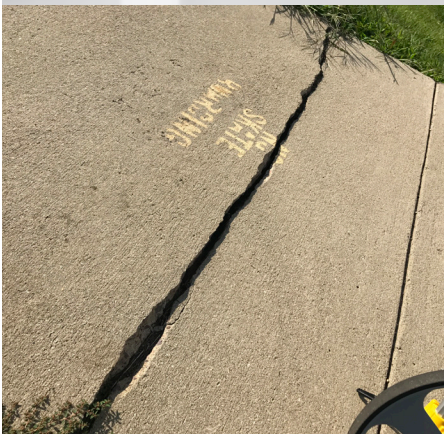
Cracking on the landings of stairs connecting the southern parking lot to the bituminous play area

The stairs connecting the southern parking lot to the bituminous play area was observed having large cracking on the landings that have caused deflections of up to an inch and the edges of the stairs are not flush with the ground. The railings and paint are fading and there is no ADA accessible route following the stairs.

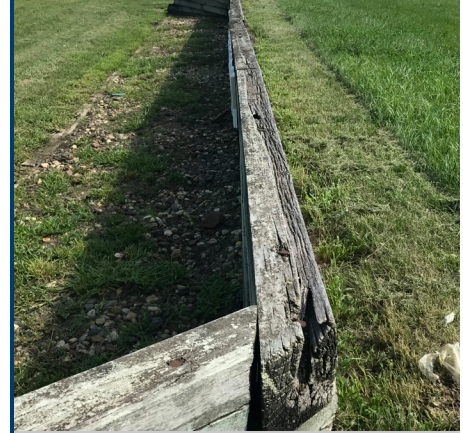
System Observation: The wooden retaining wall shows signs of rot and is bowing outward. Additionally, the retaining wall is not fenced off and allows direct access to the intersection of Springfield Parkway, 4th Street, and 3rd Street from the baseball field.

Rotting in wood retaining wall

System Recommendations: Replace dislodged or broken modular blocks within the various concrete block retaining walls. Reconstruct the wooden retaining wall/school sign and install chain-link fencing to connect the existing fence.

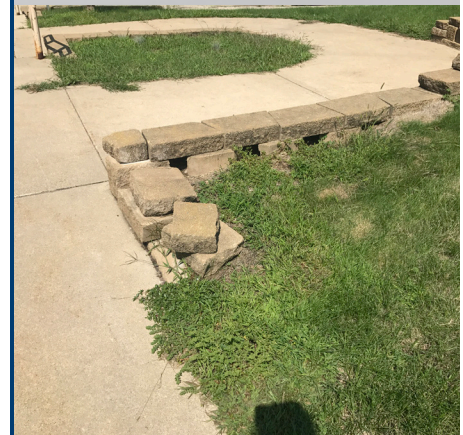
Retaining walls surrounding the concrete sidewalk on the north side of the site provide access to door 7 of the school facility. Some of the retaining wall bricks were observed to be loose, missing, or cracked. Stepped retaining walls are also located near door 7 and it was noted that some of the bricks were also loose.

Loose bricks on northern retaining wall

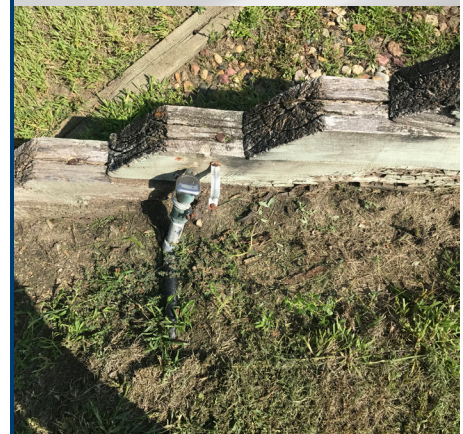
System Observation: Utility lines at the eastern perimeter of the site were observed to be exposed and damaged.

Exposed and damaged utility line

System Recommendations: Replace and properly cover exposed / damaged utilities located at northeast corner of property. The construction at the time of the site walk-through should be assessed to have been properly finished and covered to improve site safety.

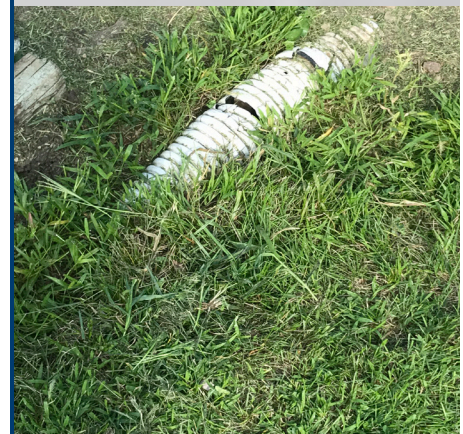
Exposed and damaged utility lines

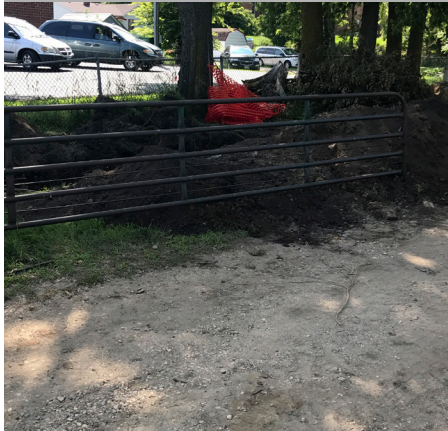
Exposed electrical utilities along southern perimeter of site

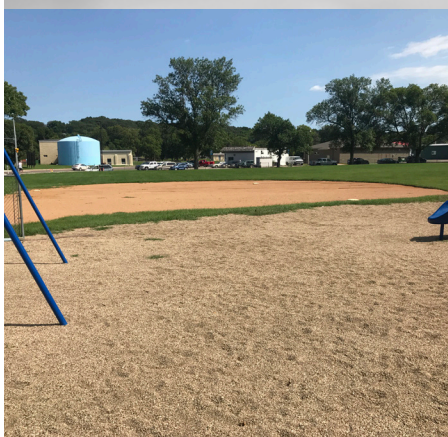
The baseball fields have a shared outfield with no outfield fencing, only backstops, first and third base fencing. The backstop and first/third base fencing on the north field is in fair condition, but the south field's fencing is in poor condition with posts leaning, warped top rails and mesh. Both fields have dugouts with wood edging that is deteriorating. The uneven wood edging creates a tripping hazard at the dugout gates. The dugout benches are faded and leaning.

Baseball field with no outfield fencing

System Recommendations: Replace deficient chain-link fencing mesh, ties, posts and railings. Remove the wooded posts creating a step between the dugout fence line and the infield. Construction additional fencing to protect players and extend to be parallel with the playground bounce structure, while leaving an access for players.

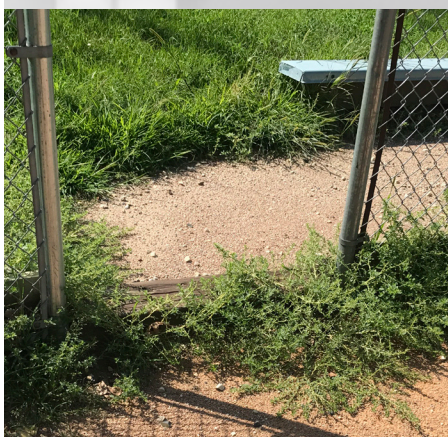
Deteriorating wood edging in dugout

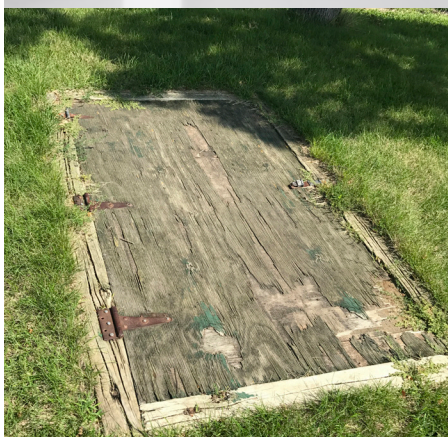
Along the eastern fence line, a deteriorating wooden door, flush with the ground was noted. The door is located near an old electrical panel.

Deteriorating wooden door near old electrical panel

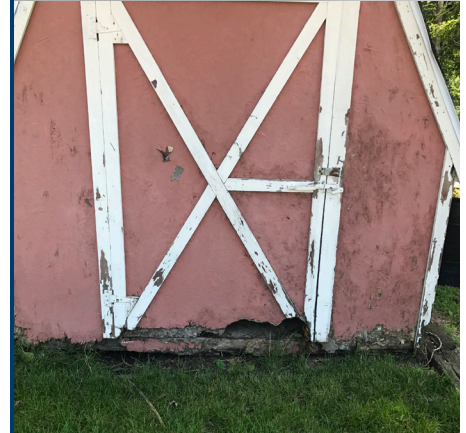
There are two storage sheds on the south side of the south baseball field. One is constructed of wood and is poor condition. The wood is rotten creating holes and many roof shingles are missing. The second shed is good condition and is raised on cement blocks and wood.

Rotten wood with missing shingles in storage shed on south side of the south baseball field

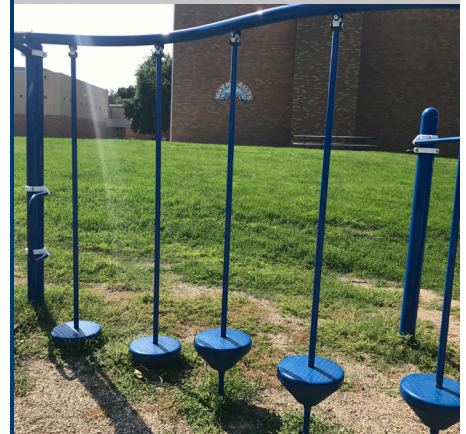
Vegetation in southern play structure platforms

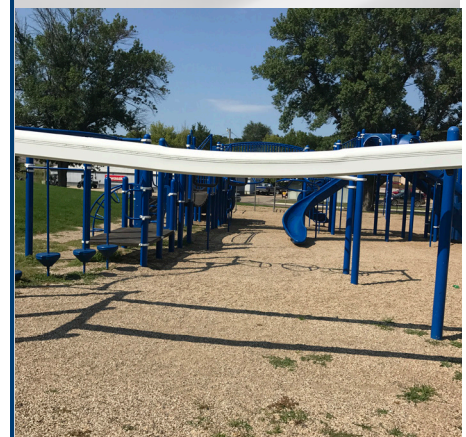
The large play structure appears to be in fair condition, but is located notably close to the surrounding grass, possibly encroaching on the approximate use and safety zones of the equipment. There are visible signs of use on the structure, notably on the slides. The southern play structure platforms are beginning to be buried with the surrounding safety surface / vegetation, reducing their intended functionality. The platforms provide access to a piece of track equipment and passage to the balancing platforms. The track equipment is visibly bowing at the center of the track and cannot be used for its intended purpose.

Bowing in center of track equipment

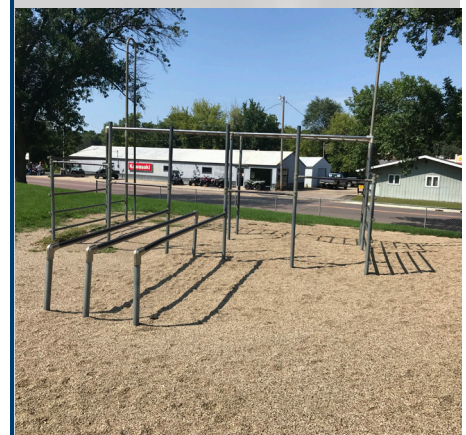
Additionally, the playground has a series of older, metal equipment that has visible signs of rusting, discoloring, scraping, and missing pieces. The bare metal of the equipment can reach high temperatures, creating a burn risk.

Rusting, discoloring, scraping, and missing pieces on metal playground

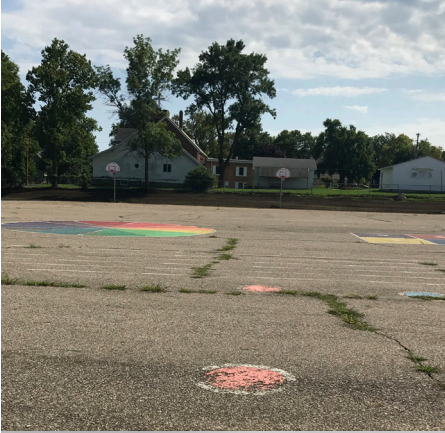
System Observation: It received a PCI rating of 76 out of 100 which is classified as “Very Good”. The primary defects in the pavement are a series of longitudinal / transverse cracks and localized depressions throughout the pavement. The playground has been maintained by sealing cracks, however since the last maintenance period, new cracks have formed.

Cracks and localized depressions throughout bituminous play area pavement

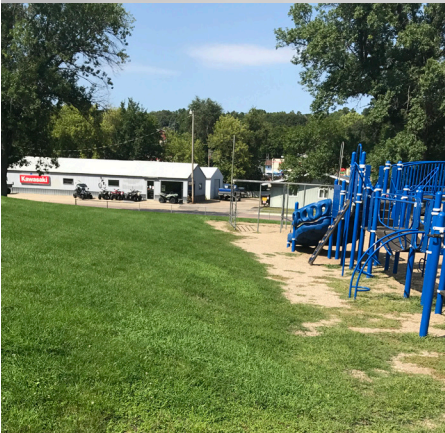
System Observation: The playground does not have a defined container edge, spreading the pea gravel safety surface throughout the surrounding grass. Debris and vegetation was observed within the safety surfacing and there are no ADA access routes to or throughout the playground. The existing safety surface for the playground is pea gravel and per the National Recreation and Park Association’s requirements, a loose-fill depth of nine inches is required to protect fall heights of 5 feet.

No defined container edge of play area and impending on use zone

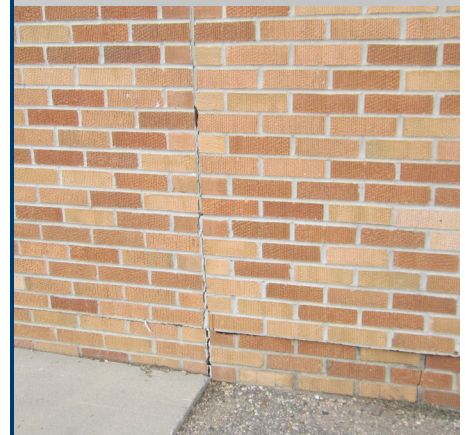
Cracking and joint failure, and discoloration on brick wall

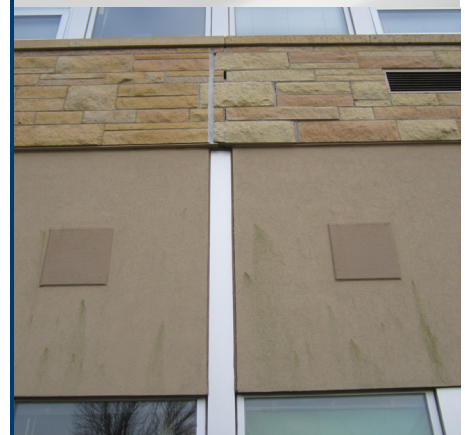
Discoloration and peeling at corners on stucco panels

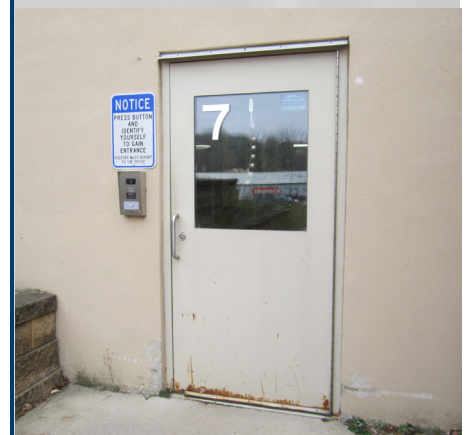
Rusting, peeling paint and damage on metal door

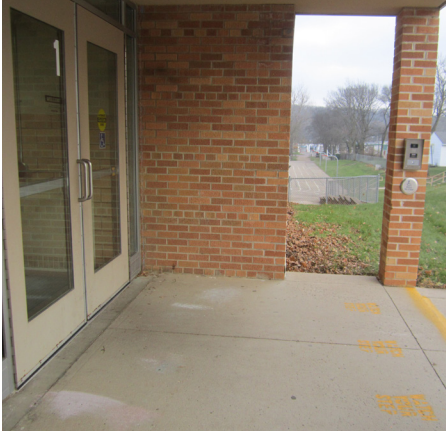
Elevation difference in stoops and sidewalks

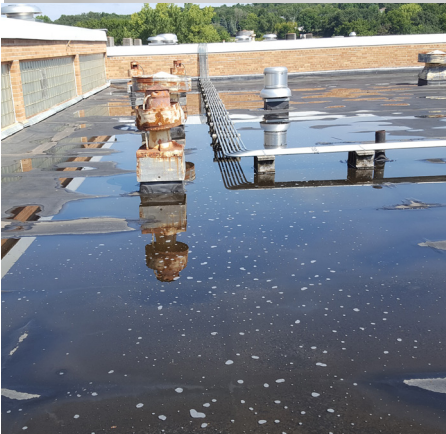
System Observation: TPO in excellent condition; adhered rubber roof has large amount of standing water, damaged metal flashing and discolored stone cap; most

Large amount of standing water on rubber roof

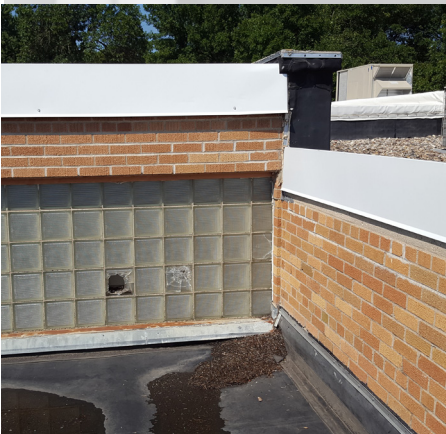
Damaged metal flashing and glass block at rubber roof

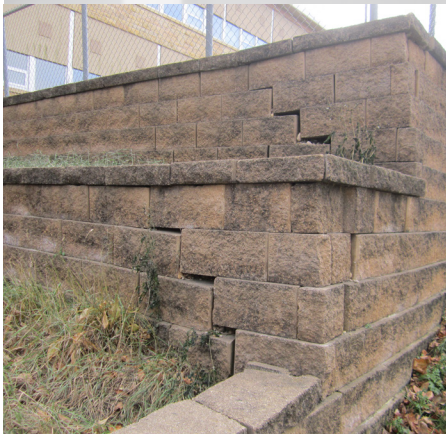
Shifting at corners of stone retaining walls

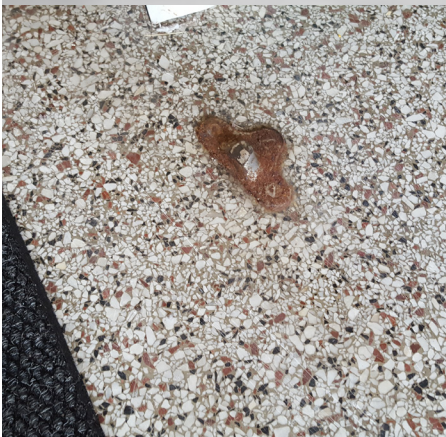
Damaged locations in terrazzo floor

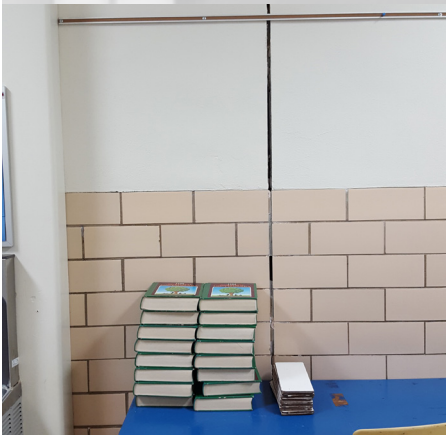
Damage in glazed concrete block walls, cracking in plaster above

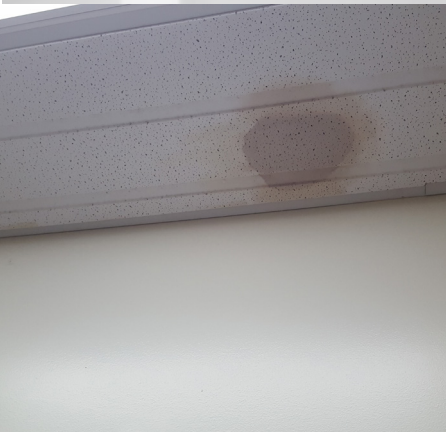
Stained ceiling tiles

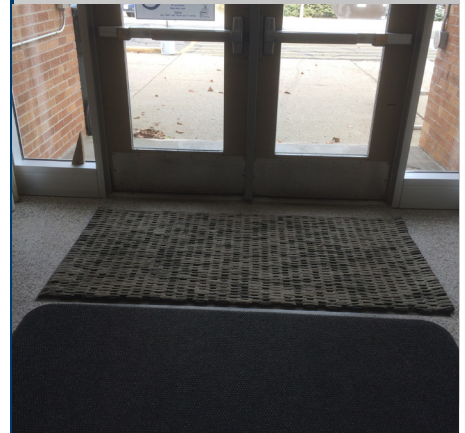
Non fitting walk-off mats in recessed terrazzo areas

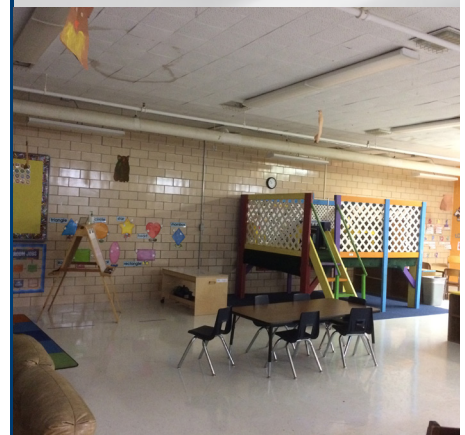
Stained ceiling tiles

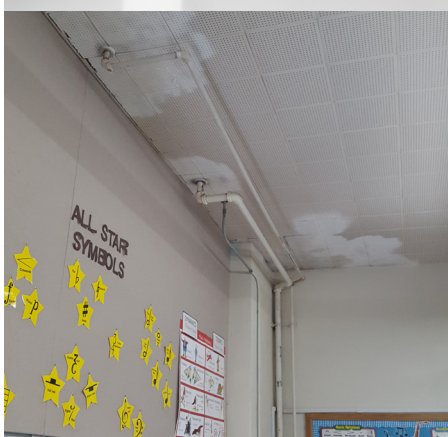
Damaged ceiling tiles

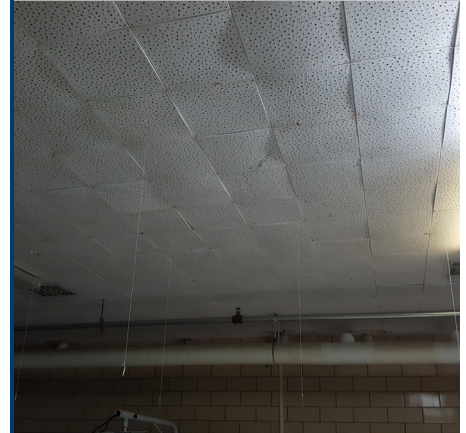
Stained, punctured, cracking and uneven ceiling tiles

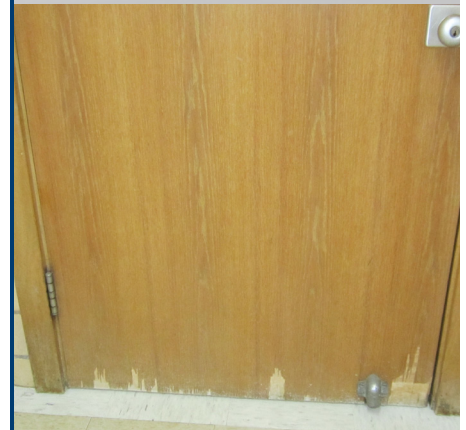
System Observations: Wood doors and frames have significant damage; some doors have noncompliant knob hardware.

Damage and noncompliant knob hardware in wood doors

System Recommendations: Replace damaged wood doors and frames.

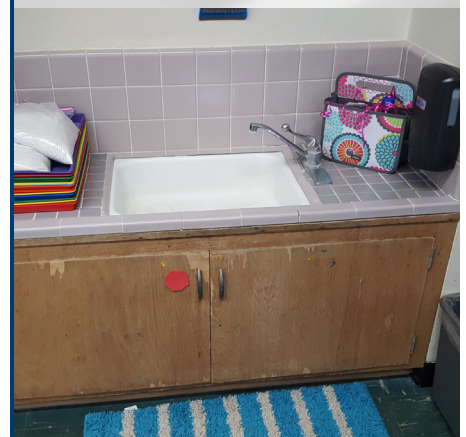
System Observations: The wood casework is in fair condition, while the cabinets with sinks have extensive damage.

Damage in cabinet and sink casework

System Recommendations: replace damaged cabinets

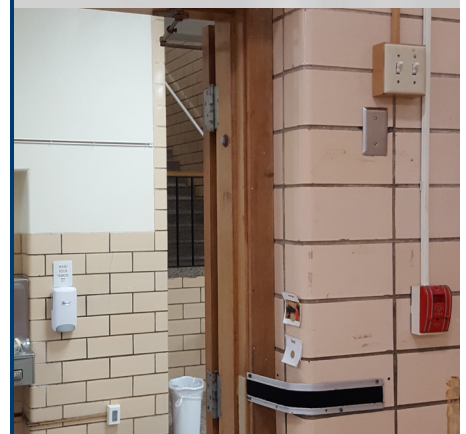
System Observations: The glazed concrete block walls are in fair condition, with joint staining and damage where items were previously attached; concrete masonry unit walls are in very good condition.

Damage and joint stain in glazed concrete block walls

System Recommendations: Repair damaged glazed concrete block walls.

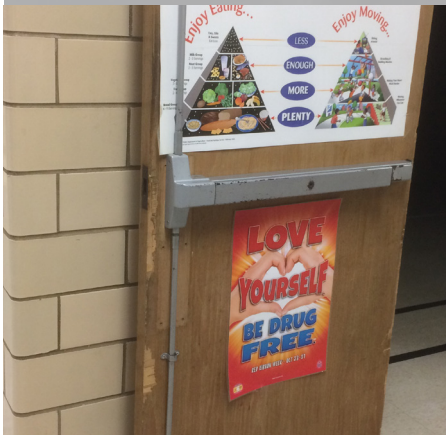
Damage in wood door

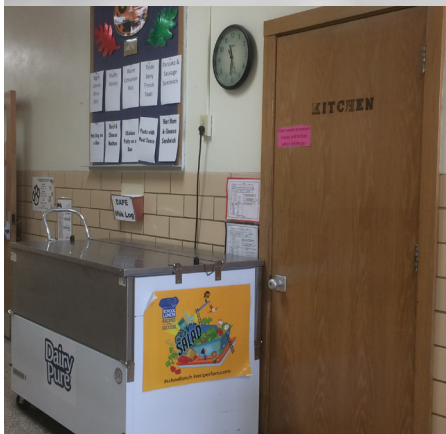
Damage and noncompliant knob hardware on cafeteria doors

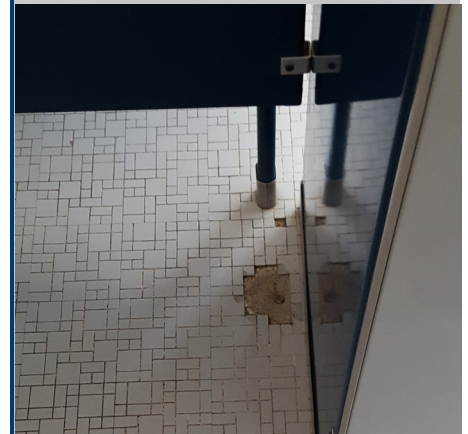
System Observations: The older ceramic mosaic tile is stained with some missing tile; the newer ceramic tile is in very good condition; and the vinyl composition tile is well maintained.

Stained, missing tile in restroom floor

System Recommendations: Replace older ceramic mosaic tile floor.

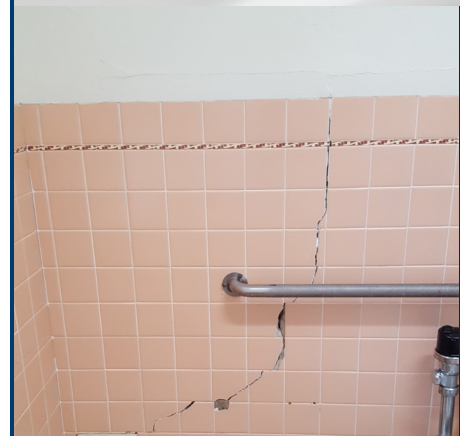
System Observations: The older ceramic tile has severe cracking in some areas, with damage to plaster walls above; the newer ceramic tile in very good condition; the glazed concrete block is in fair condition with joint staining and damage where items were previously attached.

Cracking in ceramic tile with damage above in plaster wall

System Recommendations: Replace cracked ceramic tile and plaster walls above; repair damaged glazed concrete block walls.

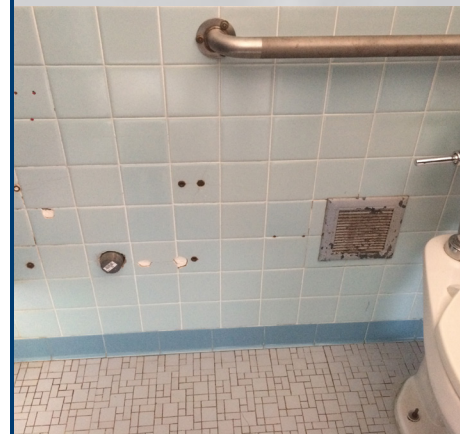
Joint stain, damage where items previously attached in glazed concrete block wall

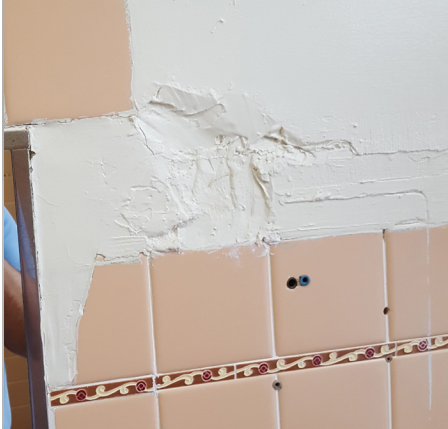
Damage to plaster restroom walls

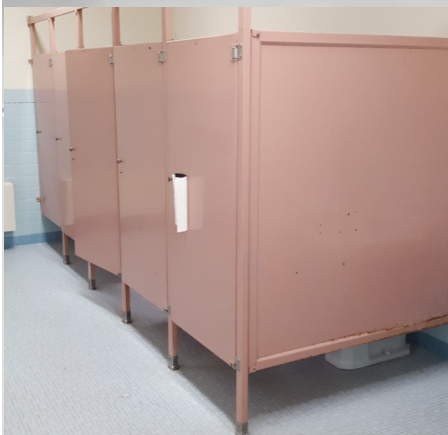
System Observations: Metal partitions are chipped and rusting at seams; plastic laminate and solid surface partitions are in good condition; and there are no urinal partitions in older restrooms.

Chipped and rusting at seams in metal partitions

System Recommendations: Replace damaged metal partitions and install urinal partitions.

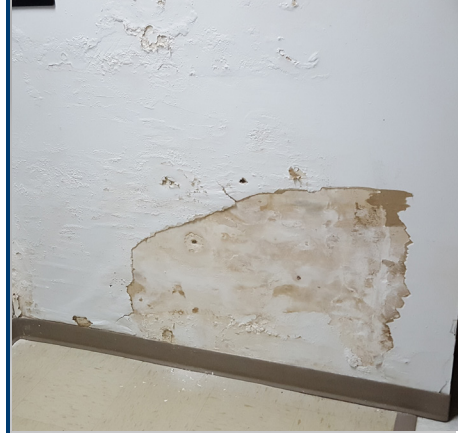
System Observations: Painted plaster has localized damage; glazed concrete block walls have minor visible damage and some joint staining.

Localized damage in plaster wall

System Recommendations: Repair cracked plaster and damaged block.

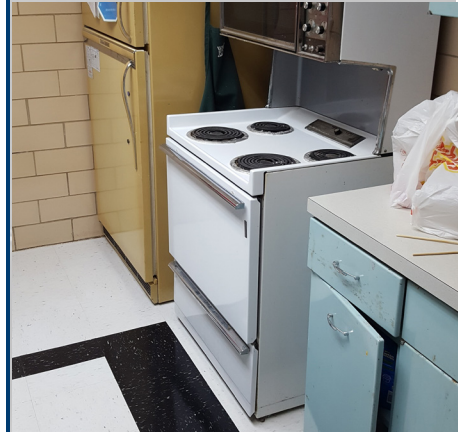
System Condition: Poor

Poor conditions in kitchen cabinetry and appliances

System Recommendations: Replace damaged cabinetry and appliances.

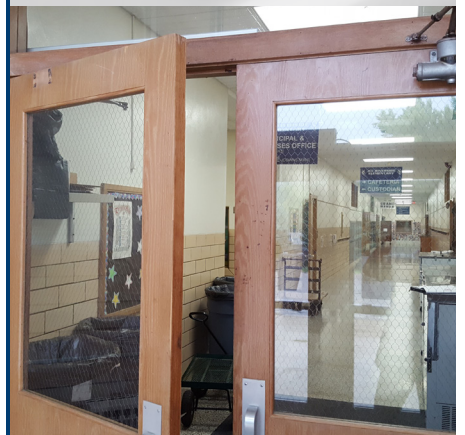
Noncompliant wired glass in doors and sidelights

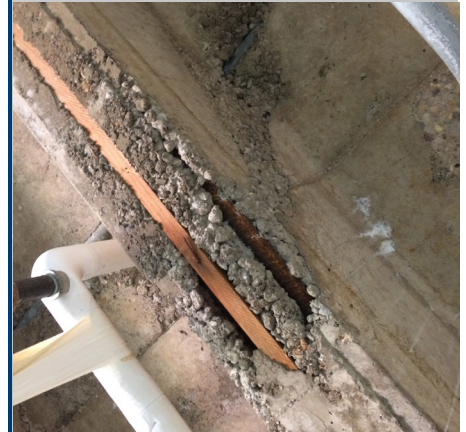
Exposed Rebar in Joint

System Observations: The structural steel columns and concrete load-bearing walls supporting the façade, roof framing, and floor framing appear to be performing adequately as evidenced by the lack of excessive cracks and bowed walls. However, some damage is visible at the north wall where a planned expansion joint exists between the original building and the first addition. The damage includes missing mortar between the stone and brick façade, primarily near the top of this wall. The roof eave also appears slightly disjointed above the missing mortar. The combination of these issues has apparently allowed for excessive moisture to collect inside the wall at this location, as evidenced by the water stains visible from the classrooms on the top floor at this location. It does not appear the existing water damage to the wall is cause for short-term structural concern, but damage will worsen and could cause long-term structural issues if the façade and eave are not repaired and moisture continues to collect within the wall.

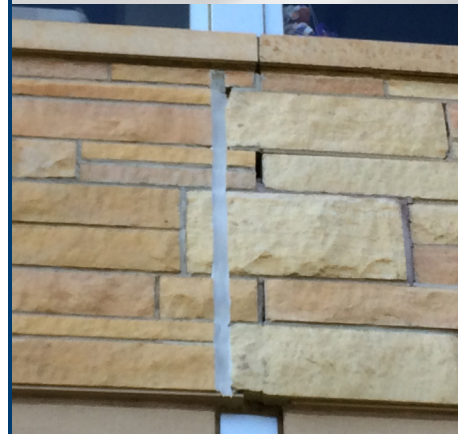
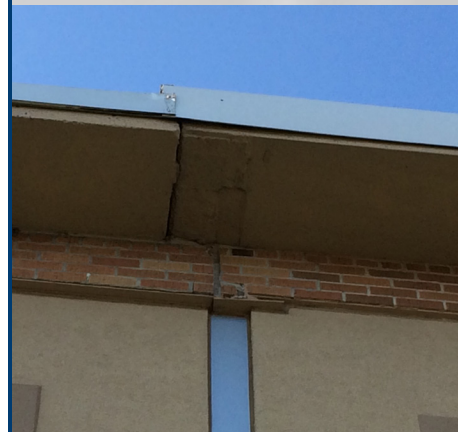
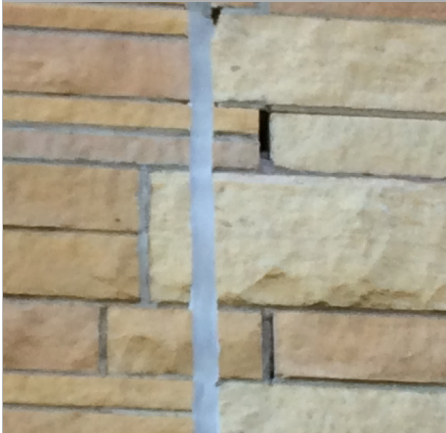
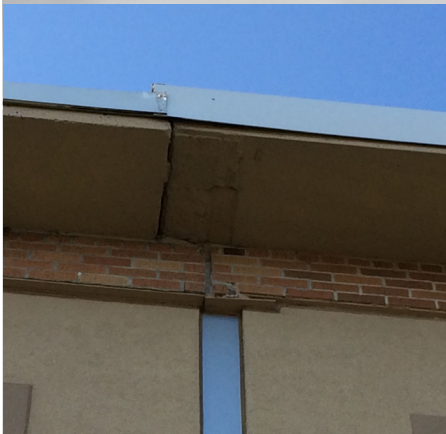
Missing Mortar in Stone at Joint

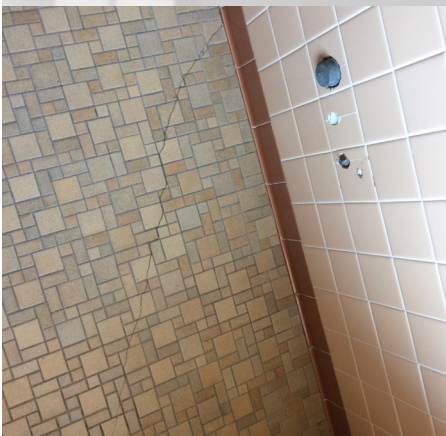
Crack in floor of boys' restroom

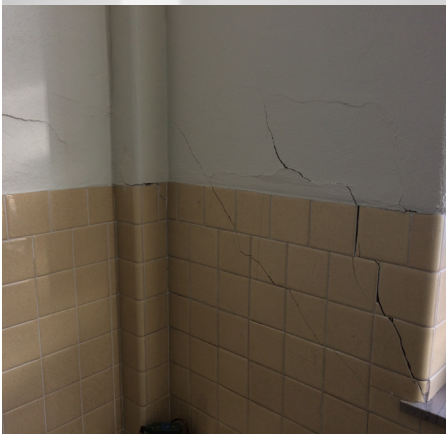
Cracks in wall of upper level

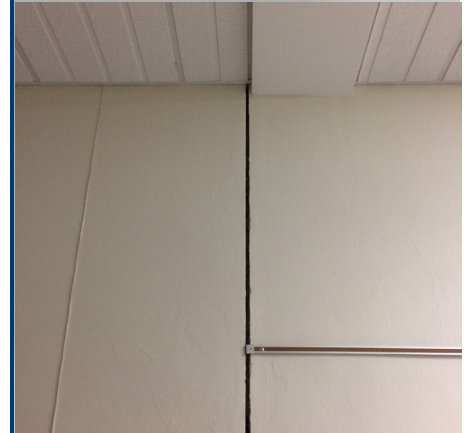
Missing sealant in joint

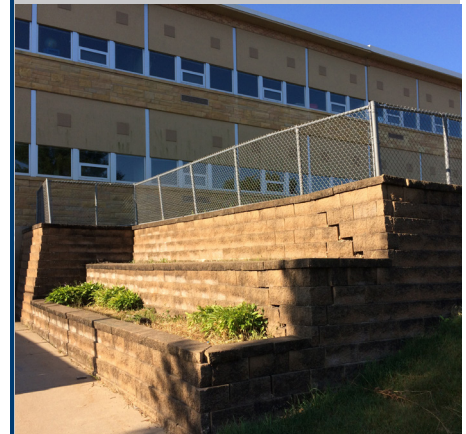
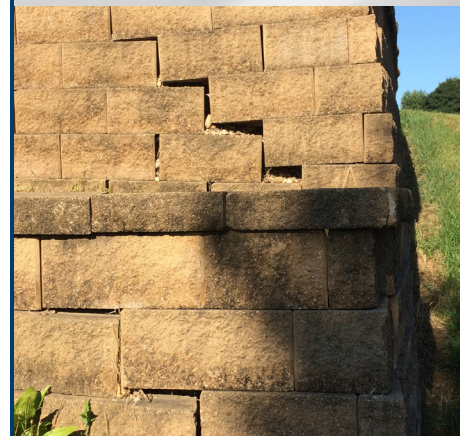
Damaged retaining wall

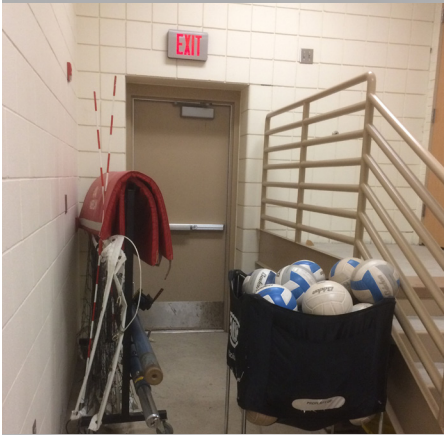
Partially blocked path to exterior exit door

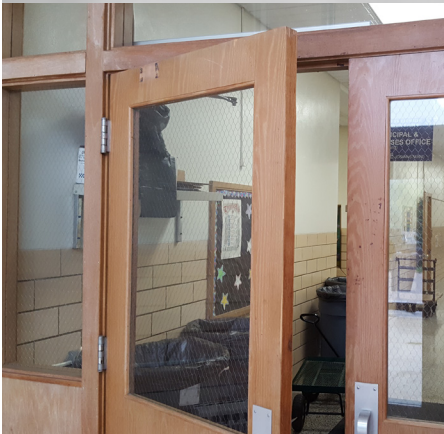
Wired glass in corridor door systems and sidelights

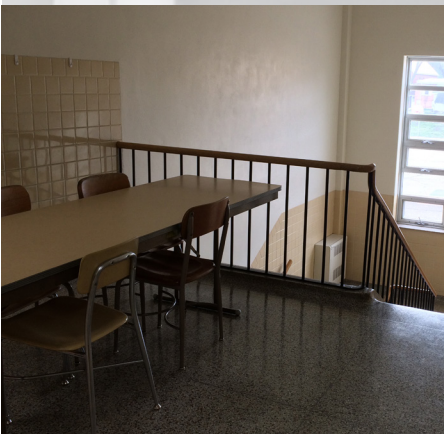
Noncompliant handrails and guards on stairways

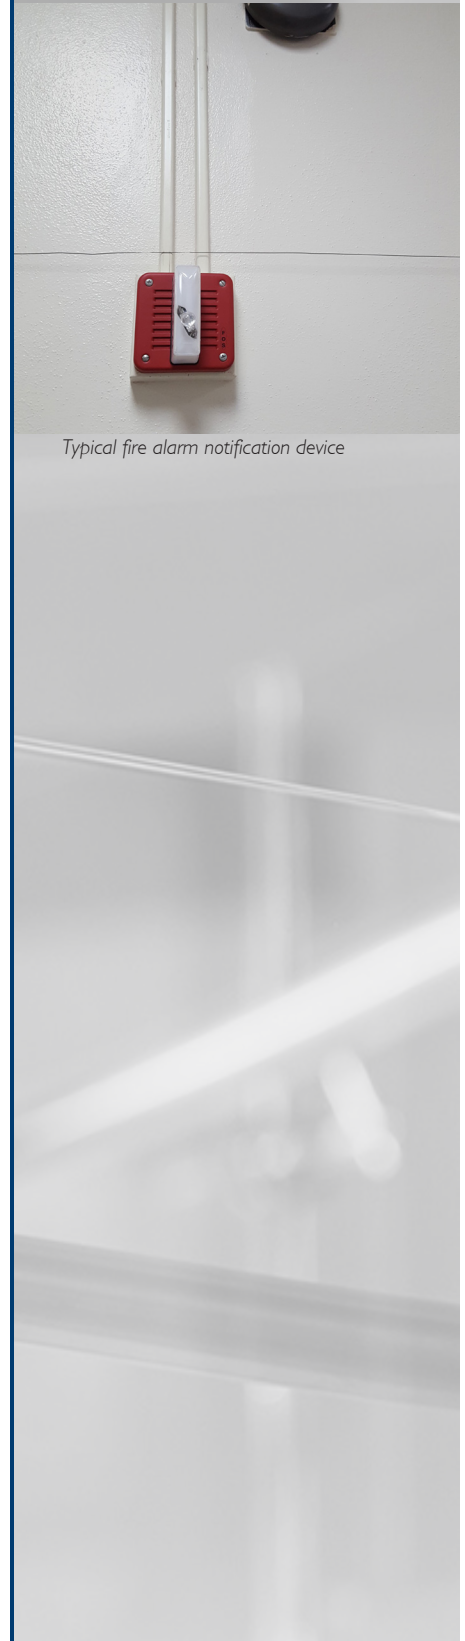
The systems were in good working order but having two separate fire alarms systems can cause issues. The entire building should be notified in the event of a fire and this may not be possible with the two systems. It is recommended that the two fire alarm systems be replaced by a single fire alarm system.

Typical fire alarm notification device

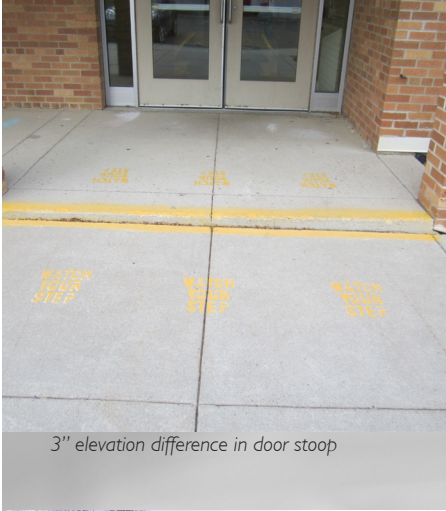
3" elevation difference in door stoop

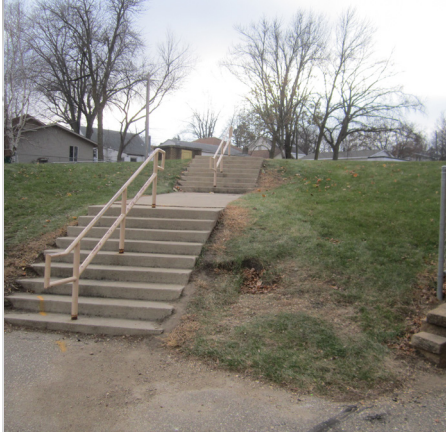
Cracking and a handrail in the center rather than on the sides on concrete stairway

The concrete stairway leading from the bituminous play area to the visitor parking lot has severe cracking and a handrail in the center rather than on the sides.

Replace the concrete stairway on the south side.

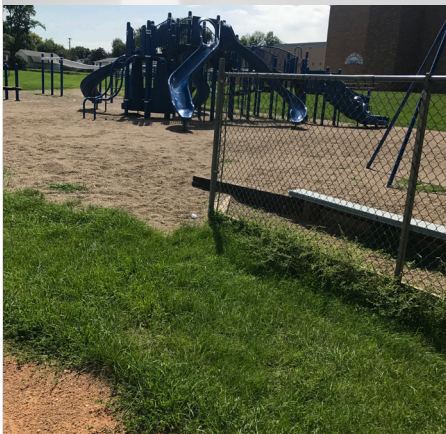
Non accessible play area

Currently the existing play areas on site are not fully accessible. If alterations are made in the future, ADA guidelines for accessible play areas would apply. Depending on the scope of the modifications, the altered areas may need to meet requirements for ground surface conditions, accessible routes to and within play areas, accessible ground level and elevated play components, and accessible routes connecting play components. Normal maintenance activities are not considered alterations.

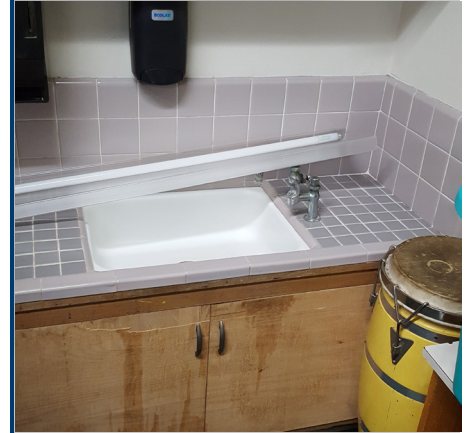
Non accessible classroom sink

Replace sinks and casework in classrooms as required to provide clear floor space and knee and toe clearance under the sinks. Install insulation on exposed pipes.

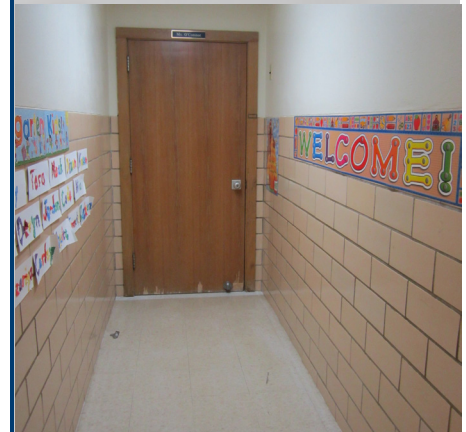
Limited maneuvering clearance on the pull side on the south side classroom doors

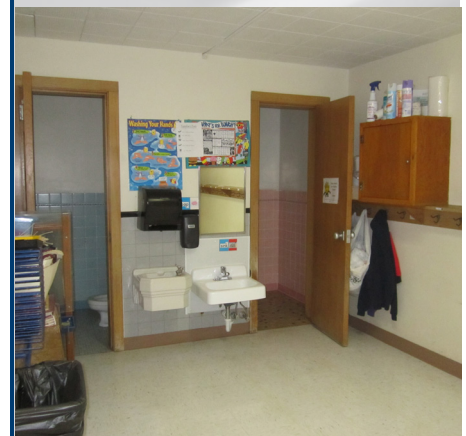
Limited maneuvering clearance on the pull side on the restroom doors

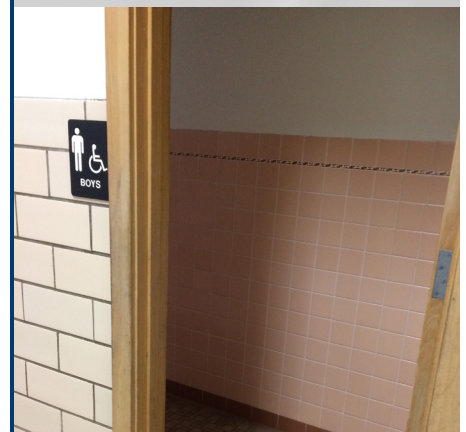
Limited maneuvering clearance in restroom entrance vestibules

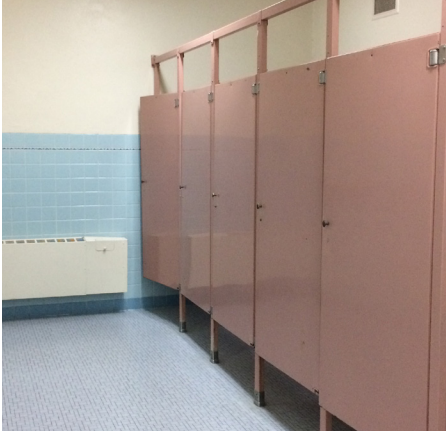
No wheelchair or ambulatory accessible compartments in restroom

Reconfigure the older multiuse restrooms to include one wheelchair accessible toilet compartment and one ambulatory accessible toilet compartment in each restroom.

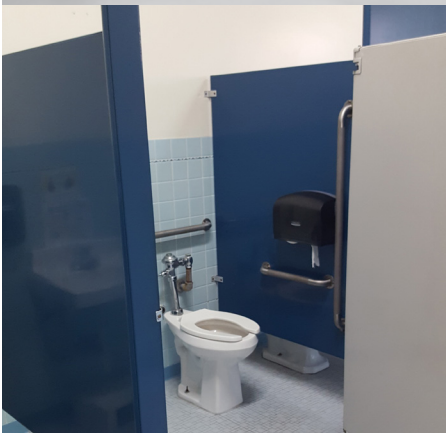
Noncompliant accessories, mounting heights and locations

Verify mounting heights and locations of all restroom accessories and make adjustments as required to meet accessibility standards.

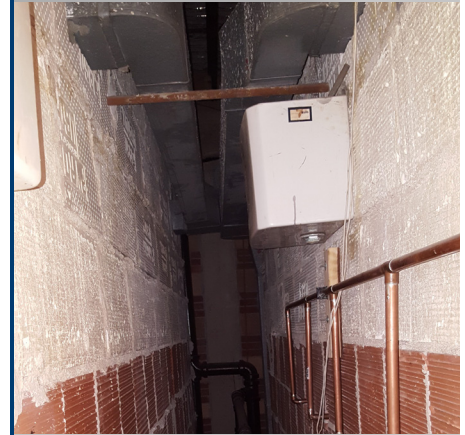
Domestic cold water, domestic hot water, and domestic hot water recirculation lines have fiber glass insulation on the pipe. Typically closed cell insulation is recommended on the cold water lines.

Uninsulated domestic water lines

Replace missing/damaged domestic water piping insulation.

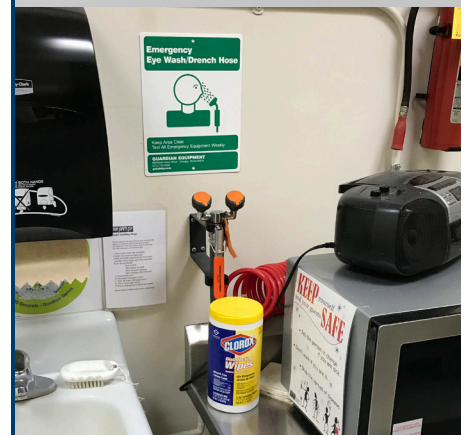
Eyewash station with no thermostatic mixing valve

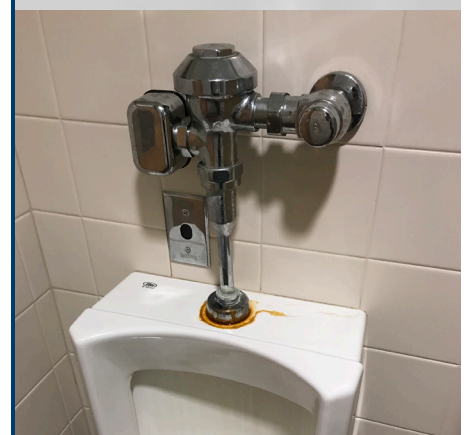
Area A, B, and C: The fixtures in the restrooms were in poor condition. The fixtures have stains and some are even cracked. The chrome finish on the flush valves were wore off. Various urinals and lavatories weren't secure to the wall. One flush valve was broken and a different type of flush valve was installed in its place. Exposed wire for the flush valve runs down the wall behind the fixture. Replacing the fixtures with high efficiency low water flush valves in the restrooms and verifying they are secure to the wall is recommended.

Stained fixture due to leaking flush valve

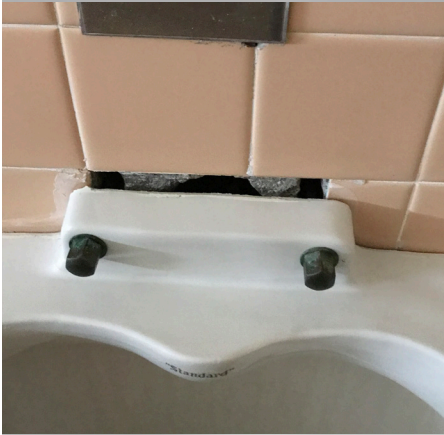
Fixtures Loose from Wall

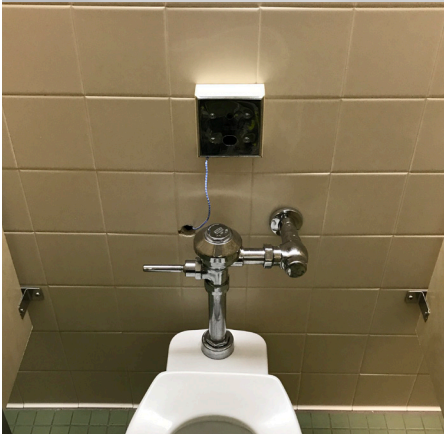
Replaced flush valve with exposed wire

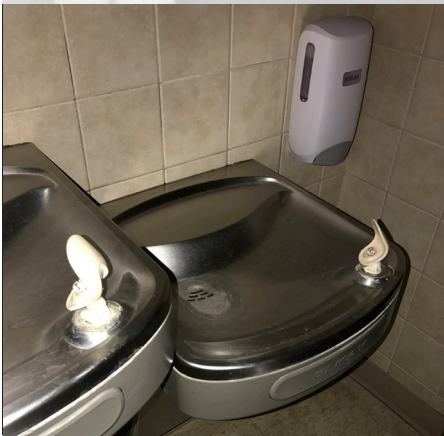
The electric water coolers should be fixed and secured to the wall. They are currently loose from the wall and move when lifted. It is recommended to make sure the screws are tightened and the water cooler is secured to the wall. Also fix the broken handles to make sure the electric water cooler operates as design intended.

Broken electric water cooler

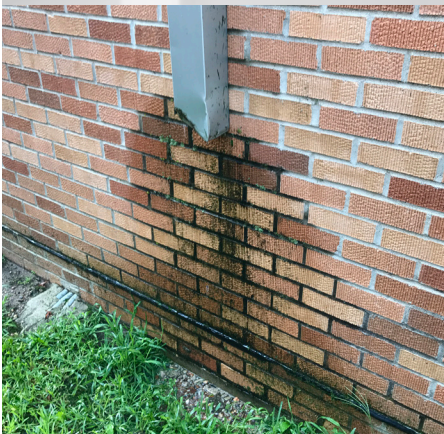
Area C and D: The 2016 addition has an overflow scupper for roof drainage as well as the overflow scupper location off of the vestibule in the 2003 addition is missing a splash block. The location on the ground where this water comes off the roof has begun to erode. It is recommended to place a splash block below where the water would hit to help eliminate the soil erosion.

Splash block missing on roof drainage

Add downspouts and splash blocks to overflow scuppers that are missing.

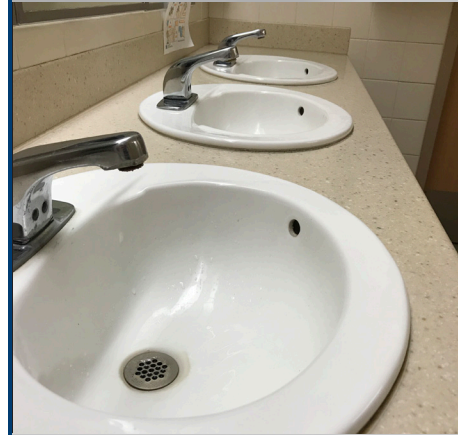
General: The faucets are missing aerators. Reinstalling the aerators on the faucets help ensure a proper flow of water coming out of the faucet while reduces the water usage.

Missing aerators on faucets

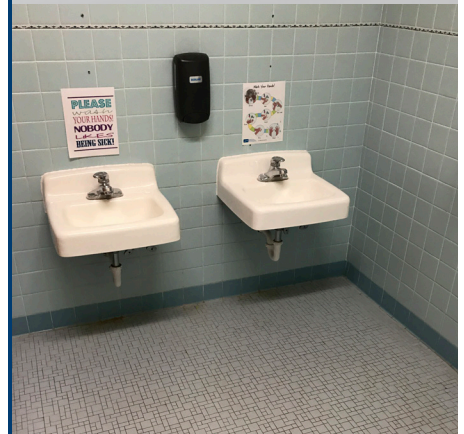
The lavatories in the building are missing pipe wrap. Pipe wrap should be used below the lavatories to meet ADA needs.

Pipe wrap missing below lavatories

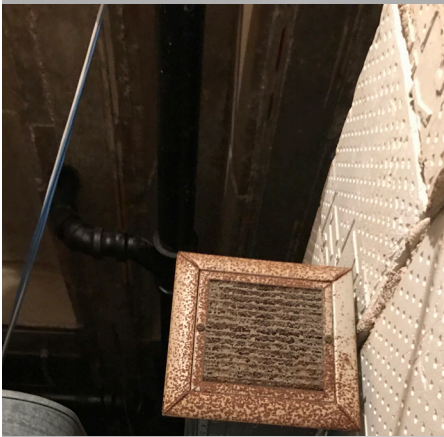
Dirty and rusted exhaust grilles

A general note for return/exhaust grilles is that they are dirty and rusted. They should be cleaned if dirty and replaced if rusted to ensure that proper airflow is going through the diffuser.
