JACKSON COUNTY CENTRAL SCHOOL DISTRICT

2018 Facilities Assessment

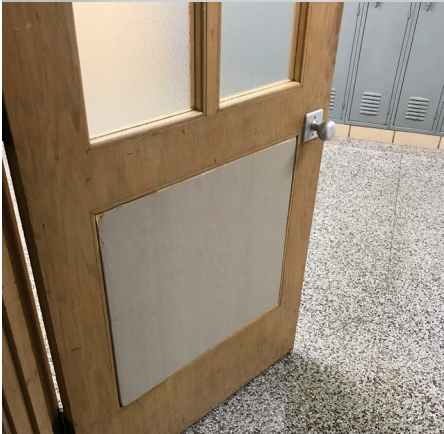
Transfer grille in door is covered

The classrooms that have an original unit ventilator that doesn't have cooling capabilities lack any form of relief air. A large majority of the classrooms have the transfer grille that is located in the doors removed which traps the air in the classroom. The unit ventilator will bring a certain amount of outside air into the space. The air already in the space has to go somewhere when more air is added. The rooms that don't have the louver to relieve the air to the hallway become pressurized which can pose problems. ISG recommends that all classrooms have louvers or transfer grilles to allow for the air to leave the classrooms. Once in the hallway a relief damper should be installed to allow for the air to leave the building. This air flow issue has been resolved in the classrooms with the newer unit ventilator as the relief dampers were placed directly in each classroom.

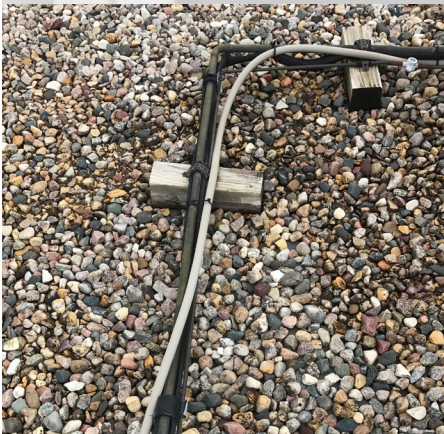
Refrigerant piping insulation is missing

The insulation on the exterior refrigerant piping from the unit ventilator to the condenser is in poor condition. There are rips and the insulation is sagging or completely deteriorated from the pipe. It is recommended to replace the insulation with new insulation to help with efficiencies of the system.

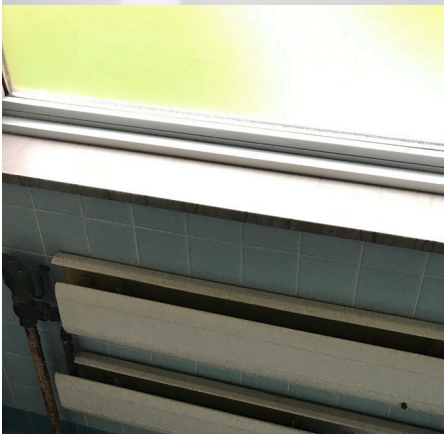
Fin tube cover is missing

Girl's restroom B109 is missing the fin tube radiation cover on the wall. This cover should be fixed and installed to make sure no exposed coils are on the wall as these can get warm when operating.

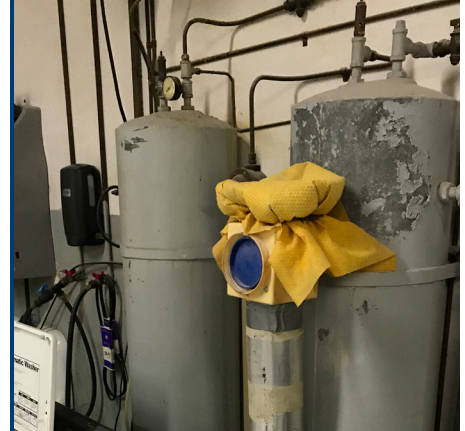
Dryer vent should be ducted to exterior

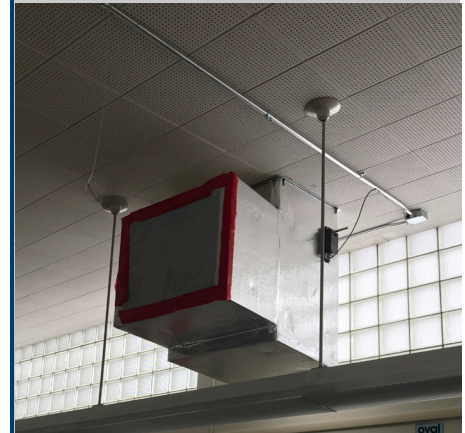
Covered relief dampers

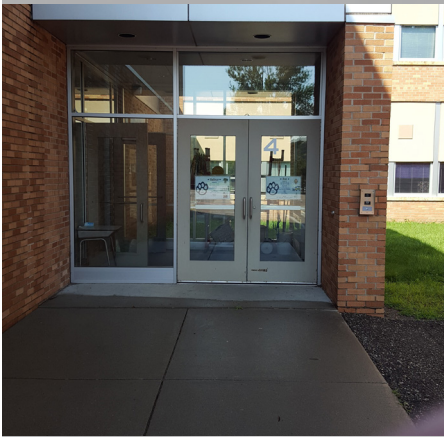
Typical entrance with video door station

Incorporate the remaining entrance into the access control system.

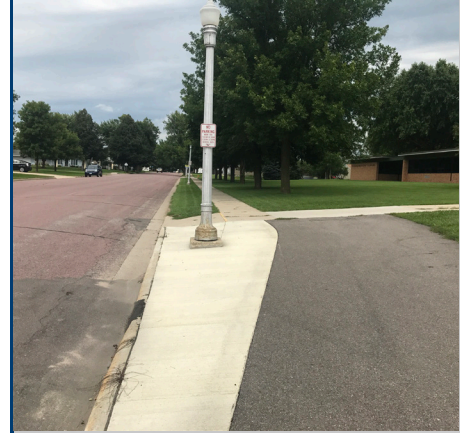
Bus loading zones indicated by "No Parking" signs along Milwaukee Street

System Recommendations: The bus loading zone appears to adequately serve the facility's needs. Milwaukee Street is within City Right of Way and this consideration should be kept in mind for future construction.

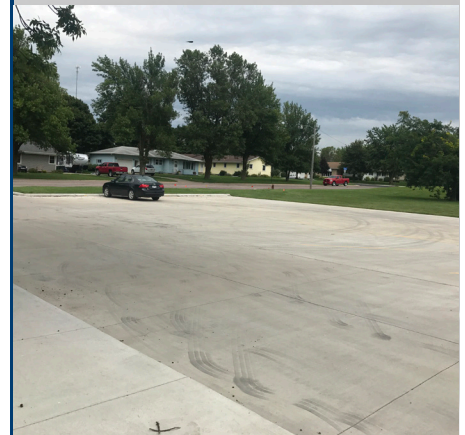
System Observation: The lot appears to have been recently reconstructed with minimal defects noted. A total of 23 parking stalls are striped, 2 of which are designated as handicap accessible along with 1 "Principal Only", one "15 Minute", and 1 "Cooks

Concrete staff parking lot north of school

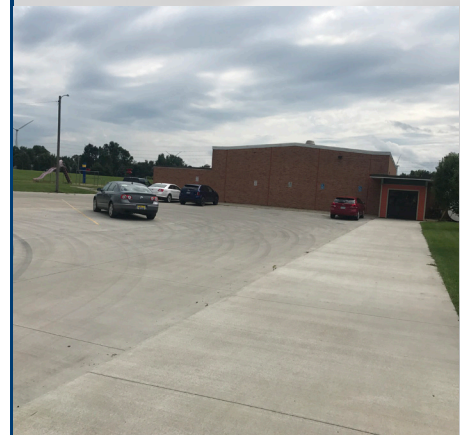
Concrete sidewalk providing access to two school doorways

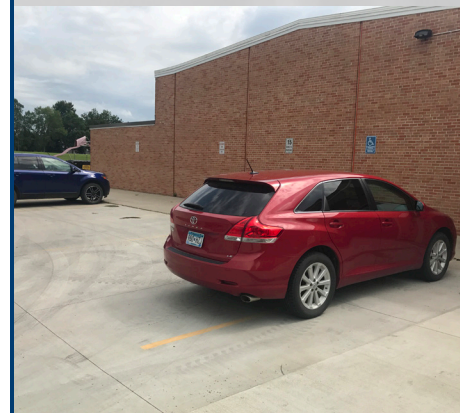
Handicap spaces not striped with an access aisle or pavement symbol

Only" stall. A minimum of 1 parking space per classroom is required by the City of Lakefield City Code, with 16 classrooms for student use, the school is meeting the minimum City parking standards. The handicap stall signage appears to meet height requirements, however the spaces are not striped with an access aisle or pavement symbol. The 2010 Americans with Disabilities Act (ADA) Standards for Accessible Design require 1 accessible space, 1 of which must be van-accessible, for lots containing 1-25 stalls.

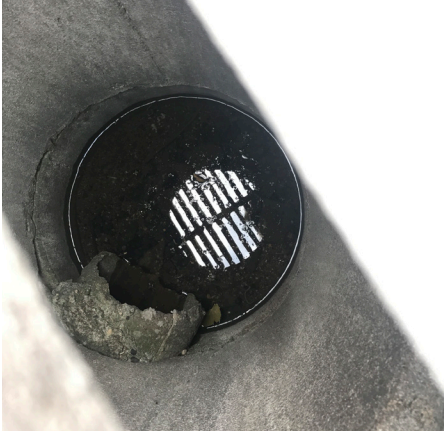
Cracking on chamber of reinforced concrete

Stormwater drainage in the staff parking lot sheet flows into the two area inlet structures on the west of the parking lot which is then directed to the north into the city's stormwater collection system. The northwestern structure is constructed of reinforced concrete and bricks. The mortar and grout appeared to not fill the voids of the brick properly and the concrete casting was in fair condition. The southwestern area inlets is constructed on reinforced concrete and has a visible edge cracking on one of the chambers, originating at the inlet of the pipe. Sediment appeared to naturally collect around the eastern gutter line of the parking lot and may indicate that the stormwater collection system does not adequately handle runoff from the parking lot.

System Recommendations: If one does not exist, a maintenance schedule should be implemented to experience the full life of the pavement. It is recommended that concrete patching of areas experiencing wear occur every 10 years or as necessary from the initial installation. Prior to the installation of the new pavement, existing utilities in the vicinity should be inspected for integrity so that replacement of deficient utilities may occur without impacting new pavement.

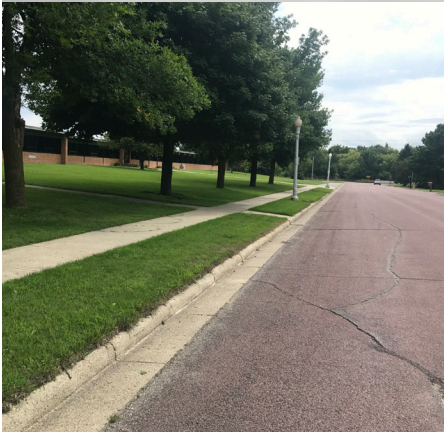
Concrete pathway leading to school doors along Milwaukee Street

There are two concrete pathways that lead to two sets of school doors. The southernmost walkway leads to the main entrance to the school, while the northern walkway leads to an auxiliary entrance. The concrete pavement leading to the northernmost walkway on the west building face appears to be older with discoloring, slight deflection of panels, cracking, and signs of weathering. Both of the concrete stoops in front of the doorways are raised above 1/4" to the adjacent walkways and does not meet ADA accessibility requirements.

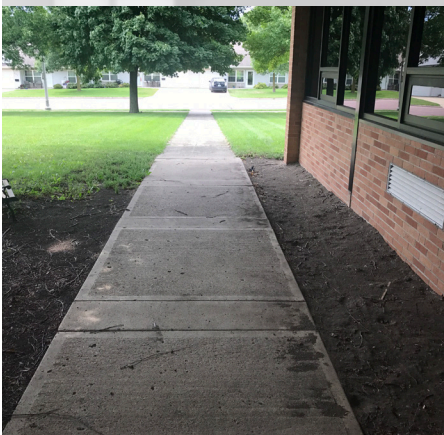
Discoloring, deflection of panels, cracking, and signs of weathering on concrete pavement

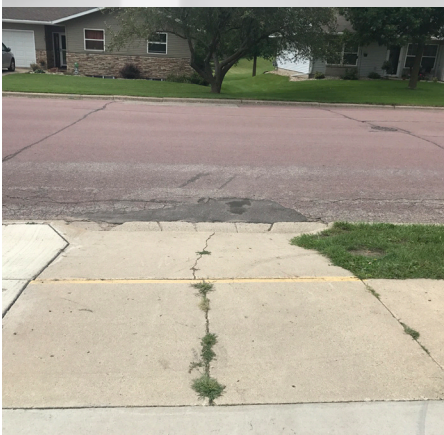
Cracks in the gutter line pavement in accessible ramp leading to main school doors

The sidewalk that runs parallel with Milwaukee Street has one accessible access point of the five paved indicated accesses. The accessible ramp leads to the main school doors has linear cracks and severe cracks in the gutter line pavement. The southernmost concrete pathway leading from Milwaukee Street to the main school doors is in fair condition. A series of linear cracking has formed in four of the panels. The paneling leads to a concrete stoop that is not flush with the pathway, having a half inch height difference. The stoop then provides access to the school doors, making the pathway not accessible.

System Recommendations: Repair cracked concrete sidewalk, as indicated in the repair map. The accessible ramp leading to the main school entrance should be replaced and brought up to ADA standards. Surrounding city pavement was observed exhibiting similar distresses and may need to be repaired to extend the life of the bituminous roadway pavement and the concrete ramp.

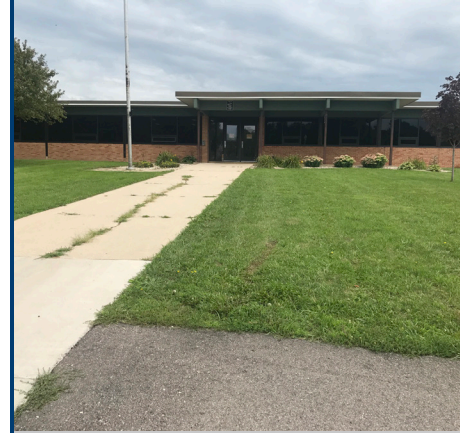
Cracking in concrete pathway to main school doors

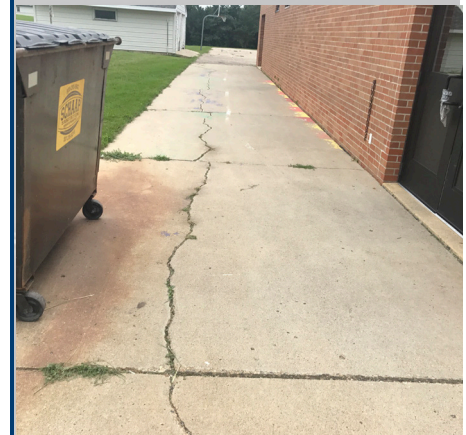
Cracking and discoloring in eastern sidewalk

The concrete sidewalk running parallel with Broadway Avenue had a series of linear cracking through the paneling and was discolored.

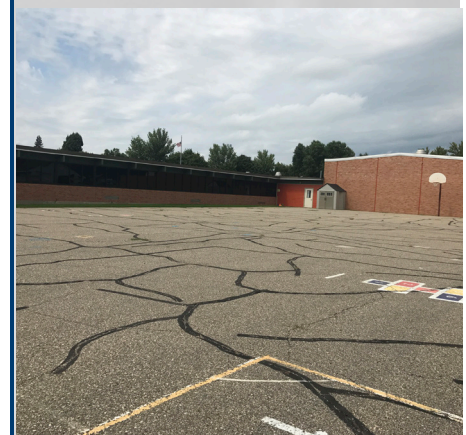
Crack filling and sealing of southern bituminous playground

System Observation: The pavement received a PCI value of 53 out of 100 which is classified as “Fair to Good” condition. The primary defects of the pavement were longitudinal and transverse cracking. Crack filling and sealing has been performed previously, however new cracking has occurred and previous joints are beginning to lose their seal.

System Recommendations: Routine inspection and maintenance is recommended for the entire playground to ensure proper drainage. Crack fill and seal coat maintenance every 5-7 years is typical of bituminous pavement with mill and overlay or reconstruction of the parking lot in 10-20 years. Consider resetting the leaning basketball hoops when scheduling the next mill and overlay or reconstruction.

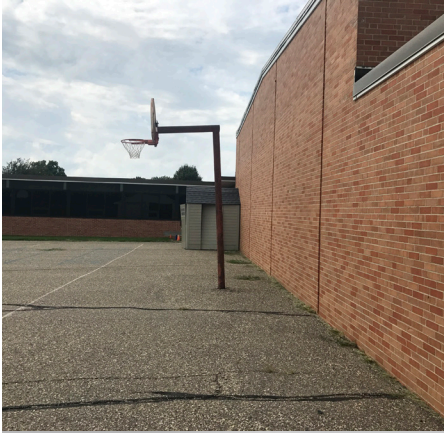
Rusted and leaning northern basketball hoop

The basketball hoop backboards are plastic and do not show signs of cracking. The north hoop has begun to lean and the rim is beginning to rust. The east and south hoop appear to still be vertical.

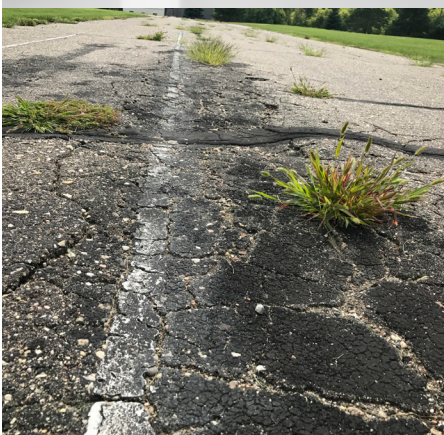
Severe cracking and vegetative growth within the bituminous surfacing

System Observation: There is no ADA accessible route to and from the track or playground areas. The track surfacing is in very poor condition with a PCI rating of 21 out of 100. The pavement had been crack sealed previously, however a significant amount of new cracks have formed with substantial vegetation growth within the pavement. The poor condition of the track is not conducive to use for track meets. The interior field appears to have adequate drainage. The field generally drains outward towards the track edges, however a field tile inlet is located near the center of the field to provide additional drainage capacity. The field tile inlet is not covered and allows debris to enter the drainage system.

System Recommendations: Because of the high cost for a new track which is rarely used, it is recommended to remove the current track as there are many tripping hazards throughout the running surface. The chain-link backstop should be removed immediately as it is a safety hazard. ADA accessible routes should be installed leading to the playground areas.

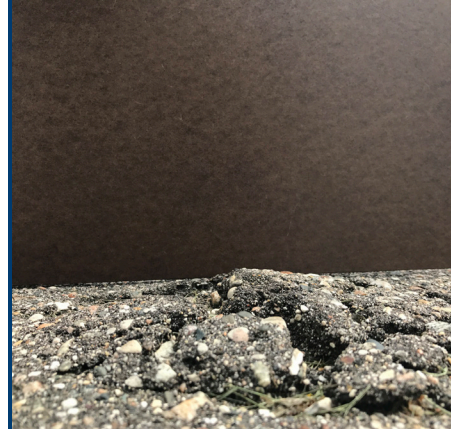
Unusable track condition

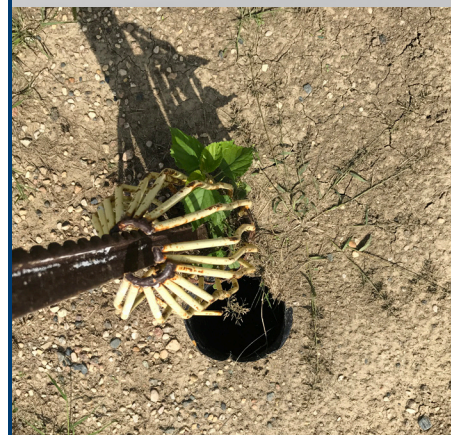
Uncovered field tile inlet

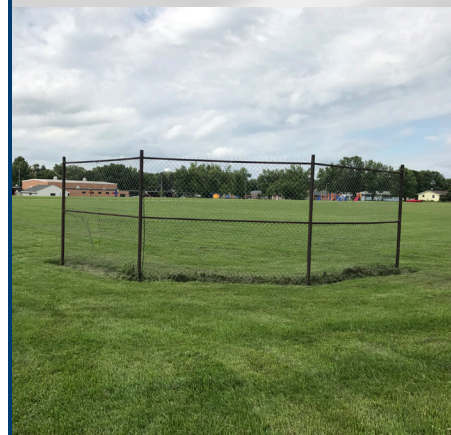
The posts of the chain-link baseball backstop are severely rusted and there is a large hole in the chain-link mesh.

Rust and hole in chain-link baseball backstop fence

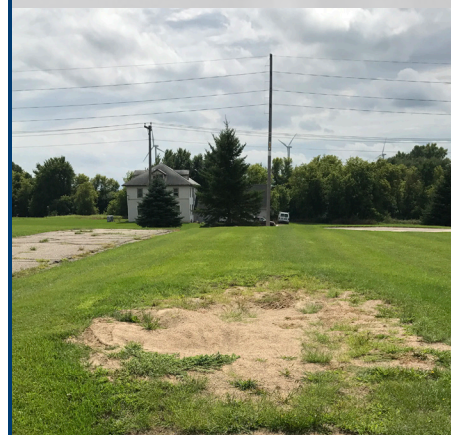
The concrete pavement runways leading to the long jump and pole vault are in fair condition, although the landing areas need to be maintained/replaced to bring back to a usable condition.

Unusable landing area of long jump and pole vault runways pavement

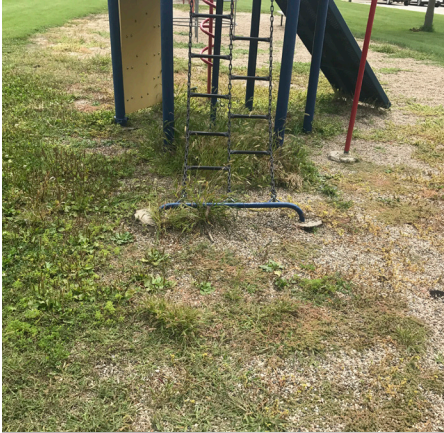
System Observation: The playground equipment appears weathered and intended for use by older students. The composite play structure has exposed concrete footings which poses a tripping hazard.

Exposed concrete footings of northwestern playground composite structure

System Recommendations: Construction of safety surfacing edging to help reduce the amount of surface loss and ensure the safety surfacing extends to all equipment use zones. Remove and replace the metal climbing and composite structure.

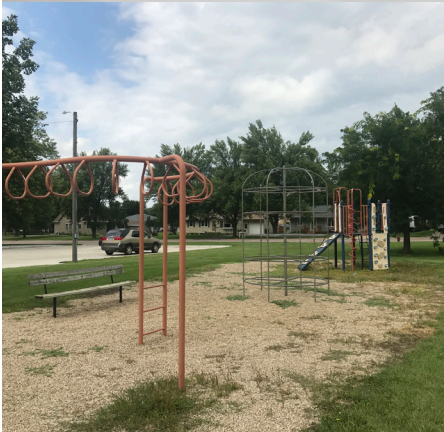
The northwest play area has a metal climbing structure which is not painted and rusting. The exposed metal creates a burn hazard during the summer months.

The playground also has an overhead loop ladder. The ladder shows signs of age with faded and chipped paint. The equipment is also located near the edge of the safety surface and may not fully protect children from falls.

Rusted metal climbing structure in northwest play area and faded paint on overhead loop ladder

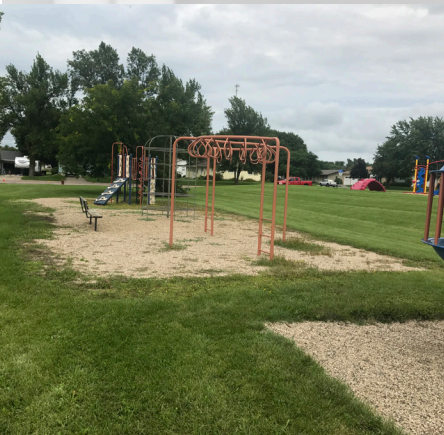
Dangerous short distance of play equipment from edge of safety surface

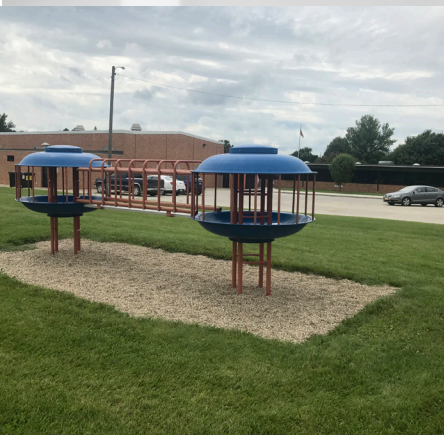
Hazards in piece of playground equipment presenting areas of entrapment and short safety zone

System Observation: The playground is equipped with one piece of equipment, which allows for children to climb up and across the structure. Certain openings of the playground equipment could present an entrapment hazard if the distance between any interior opposing surfaces is greater than 3.5 inches and less than 9 inches. There are also open metal railings that are not capped, exposing children to sharp edges and rust. The safety zone around the equipment appears limited and may pose a fall risk to children.

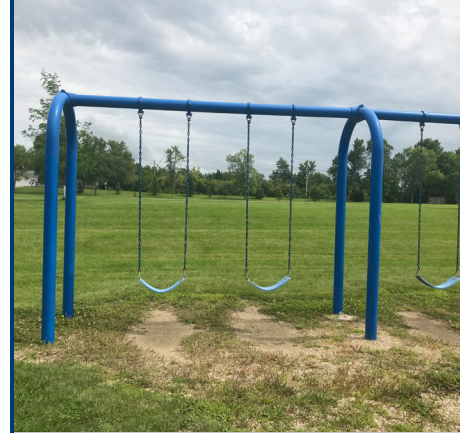
Exposed footing of swings

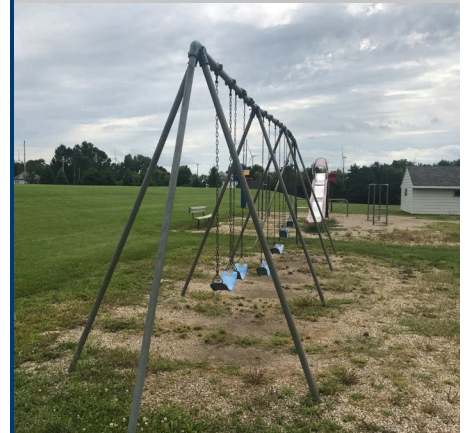
No rubber chain, mounted on discolored scraped metal frame

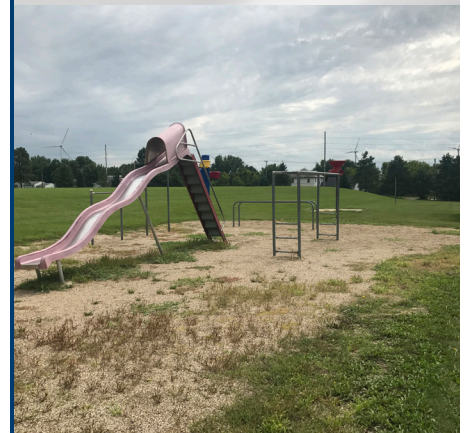
Rusting, discoloring, faded paint, scraping, missing pieces on playground equipment

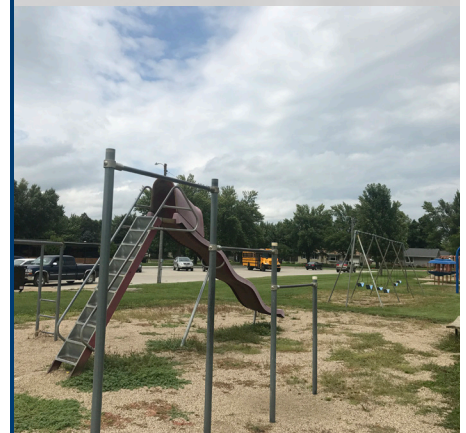
Burn hazards on exposed metal playground equipment

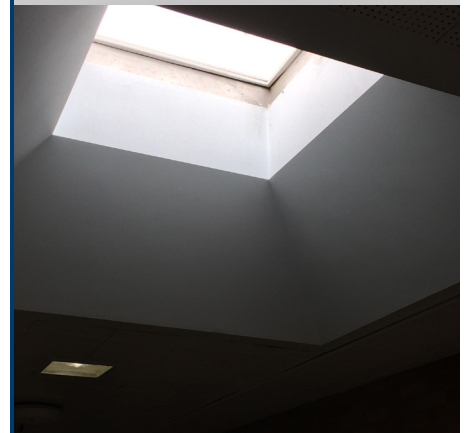
Damaged skylights

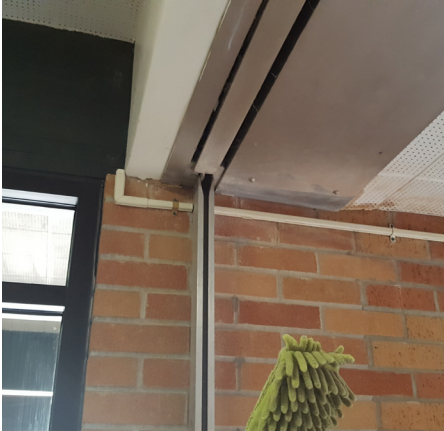
Recessed ceiling security grille

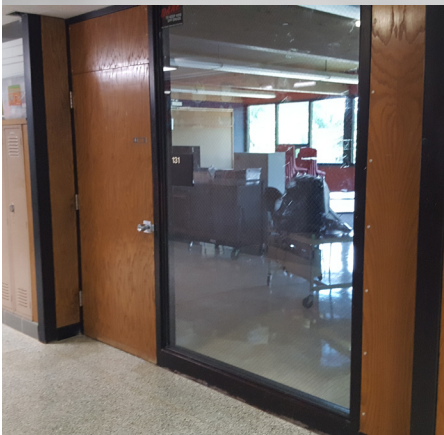
Wired glass sidelights

System Recommendations: Replace damaged wood doors and panels; replace noncompliant knob hardware with handle locksets; and replace wired glass with safety glass.

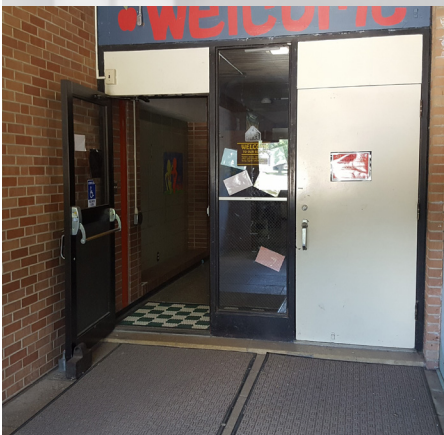
Vestibule floor at entrance is lower than corridor floor

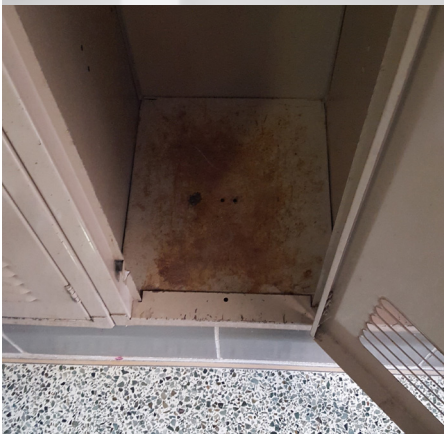
Damage and rusting in metal locker

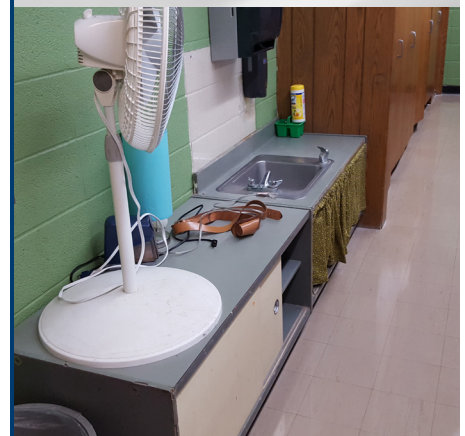
System Observations: Vinyl composition tile floor is well maintained, with some cracking and missing tile at the doors.

Cracking and missing tile floor at door

System Recommendations: Replace cracked and missing vinyl composition tiles.

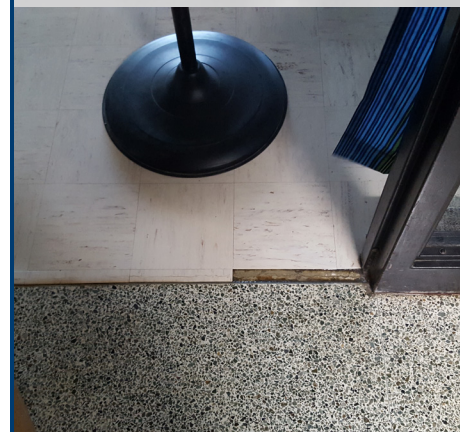
System Observations: Some wood doors and panels have significant damage; most classroom doors have noncompliant knob hardware; and sidelights have wired glass.

Damaged door

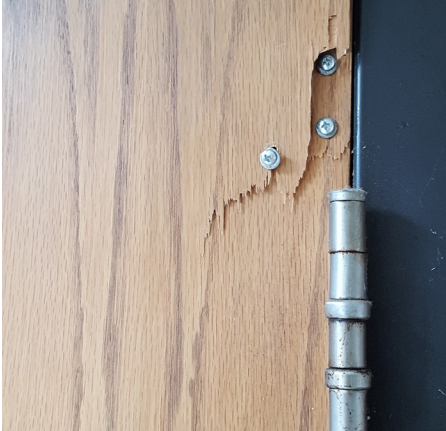
System Observations: Plastic laminate cabinets have extensive damage, including cracking, peeling and stained sinks; wood closet doors and trim have extensive damage.

System Condition: Poor

Damage in plastic laminate cabinets

System Recommendations: Replace damaged cabinets, wood closet doors, and trim.

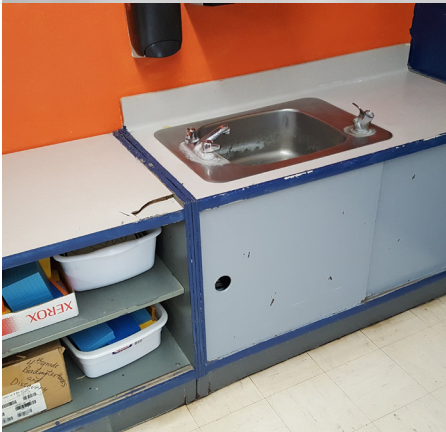
Damage in wood closet doors and trim

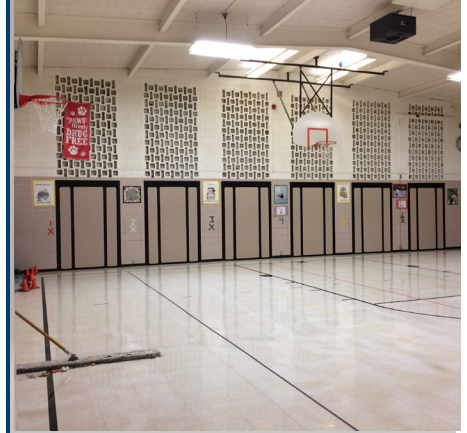
System Observations: Vinyl composition tile floor is discolored but well maintained, and has cracking across the width of the gymnasium at each mainframe column line.

System Condition: Fair

Cracking and discolored vinyl tile floor

System Recommendations: Replace cracked vinyl composition tile floor if cracked tiles are problematic for gymnasium activities; expansion joints will prevent cracking of new floor material.

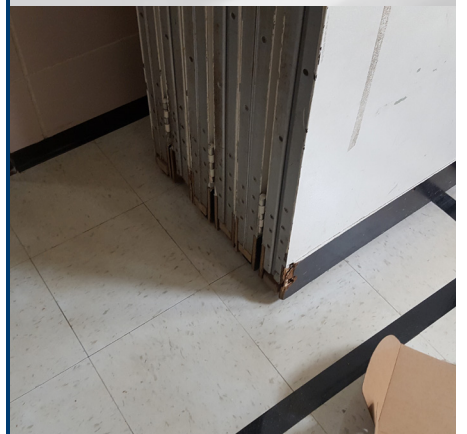
System Observations: Wood doors and hardware generally in good condition, with most doors showing signs of water damage to bottom edges.

Water damage to kitchen door

System Recommendations: Replace doors with water damage.

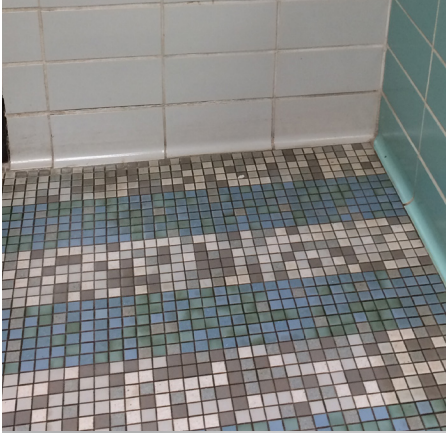
Cracked pieces in ceramic tile wall

System Observations: Brick walls are in good condition but vinyl base has peeled off; glazed concrete block walls have joint staining and punctures where items were previously attached; and ceramic tile has a few cracked pieces.

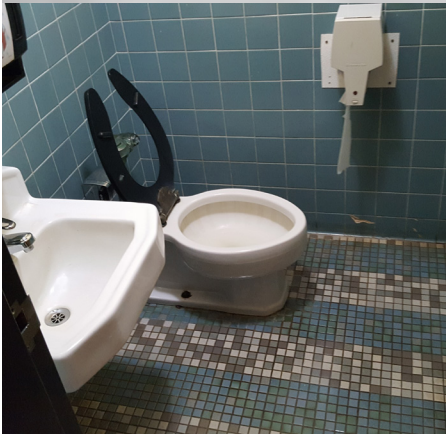
Chipped and rusting at seams in toilet partitions

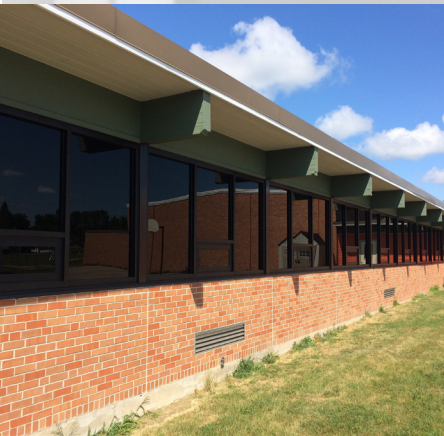
Moisture damaged glue-laminated beams

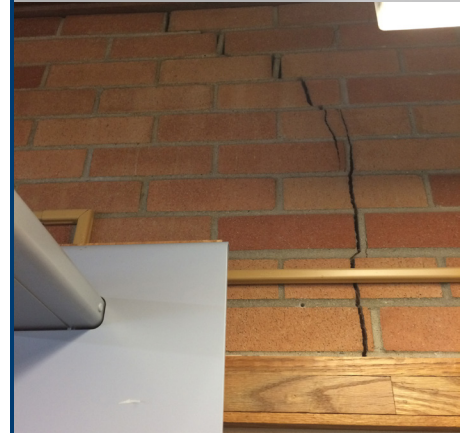
Crack in brick

Patch crack in brick wall in room 106; maintenance staff shall monitor on a monthly basis after completion of repair.

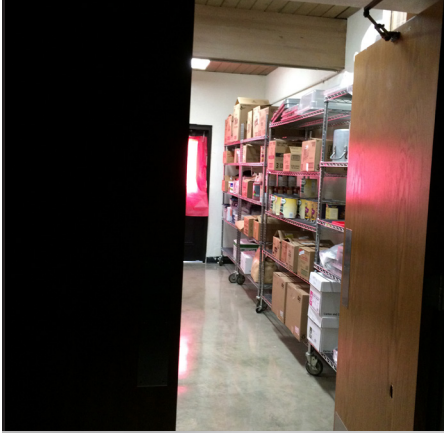
Egress from gymnasium through kitchen storage rooms

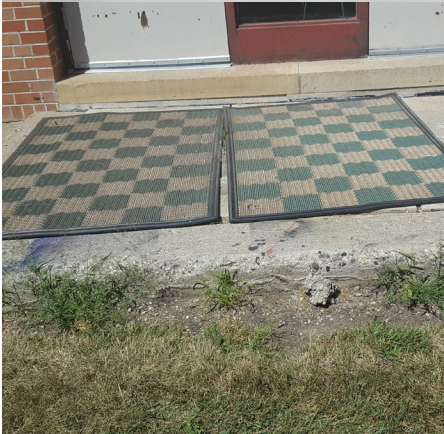
Door stoop height difference at exit doors

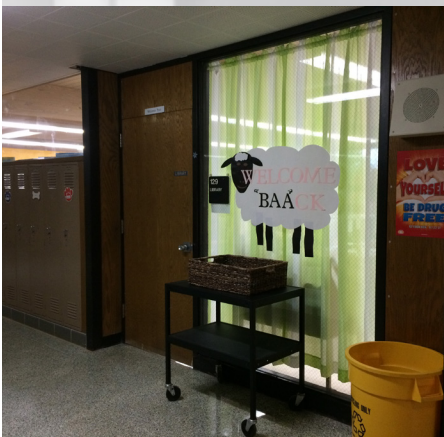
Noncompliant wired glass in classroom sidelights

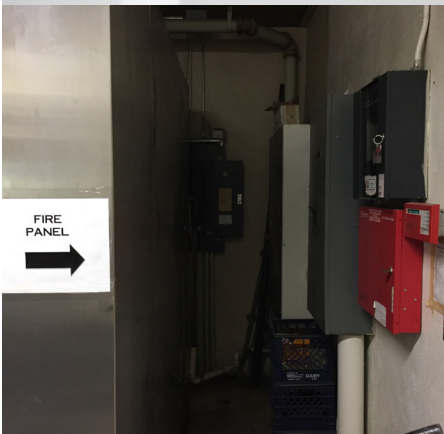
Fire alarm control panel with limited clearance

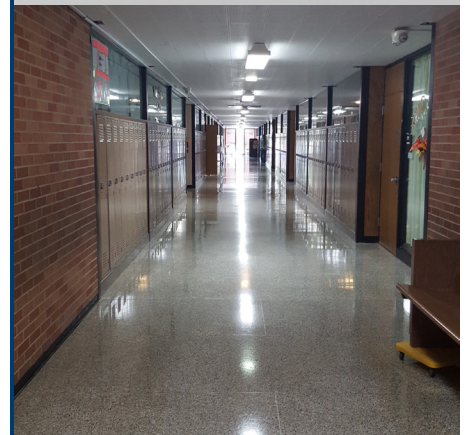
Typical emergency light in corridor

The current emergency lighting layout should be further evaluated to ensure that proper light levels are achieved in all paths of egress. Additional units should be added if required for proper egress.

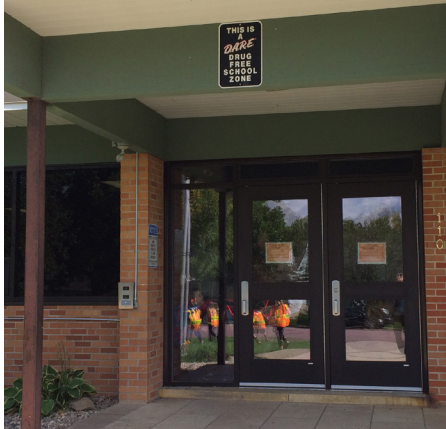
Door stoop height difference at main school entrance

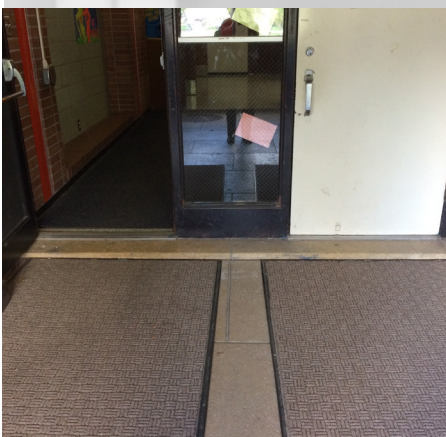
Noncompliant accessible route and entrance to the building

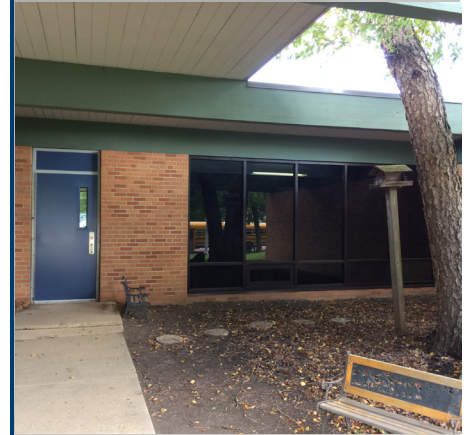
Height difference in stoop and door sill in courtyard entrance

Replace the concrete stoop and sidewalk in the courtyard as required to meet accessibility standards.

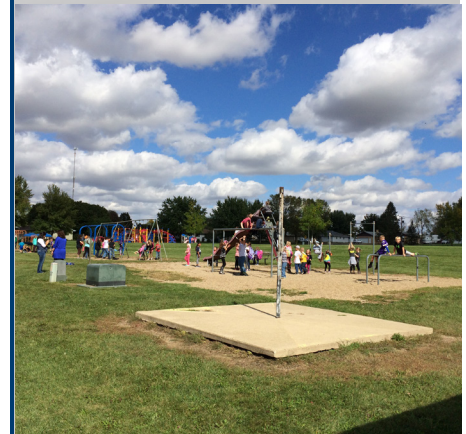
Currently the existing play areas on site are not fully accessible. If alterations are made in the future, ADA guidelines for accessible play areas would apply. Depending on the scope of the modifications, the altered areas may need to meet requirements for ground surface conditions, accessible routes to and within play areas, accessible ground level and elevated play components, and accessible routes connecting play components. Normal maintenance activities are not considered alterations.

Noncompliant play area site

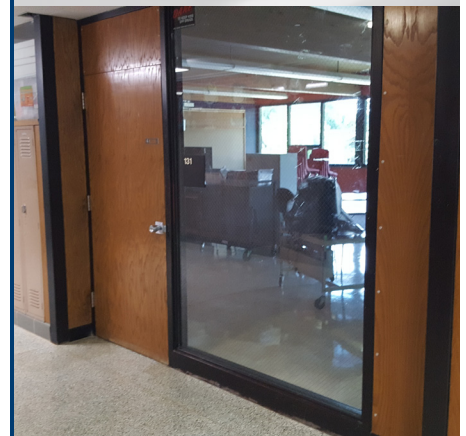
Noncompliant locksets with knob hardware in classroom doors

Replace noncompliant knob hardware with handle locksets on classroom doors.

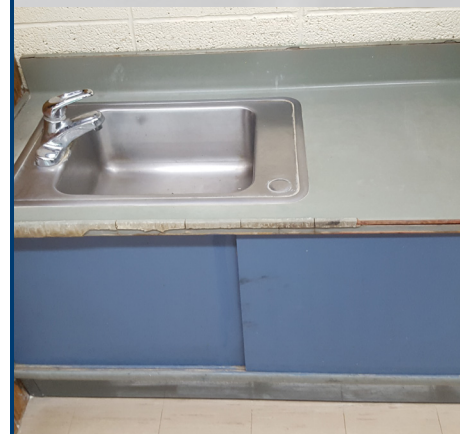
Noncompliant classroom sinks

Replace sinks and casework in classrooms as required to provide clear floor space and knee and toe space under the sinks. Install insulation on exposed pipes.

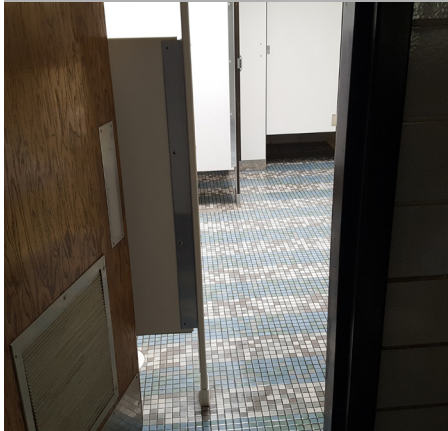
Limited maneuvering clearances at restroom vestibule

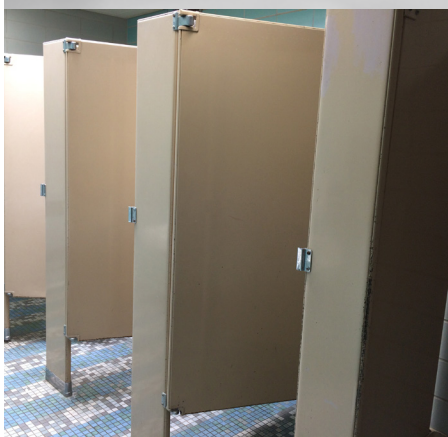
Noncompliant girls toilet compartments

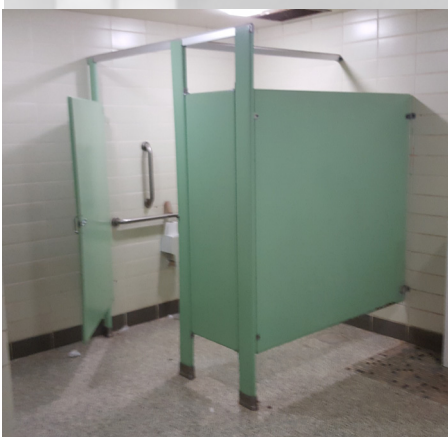
Noncompliant boys toilet compartments

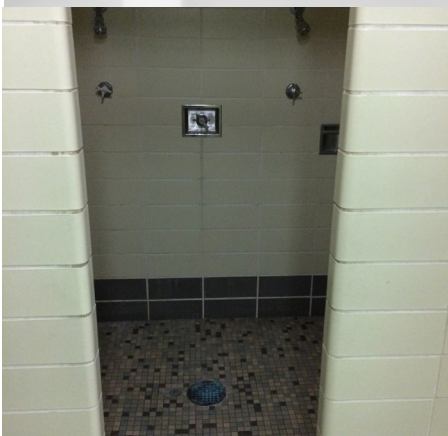
Noncompliant shower compartment

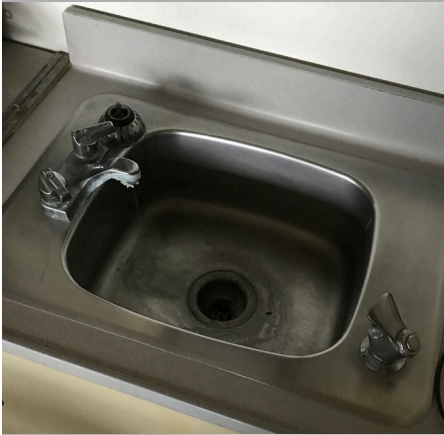
Sinks in classrooms not working properly

Classroom sinks are in poor condition. All are experiencing hard water stains, rust in the bowls and rust on the fixtures. Furthermore, faucets either leak, do not work, or have very low flow due to blockage within the supply pipe.

Replace sinks in restrooms and classrooms.

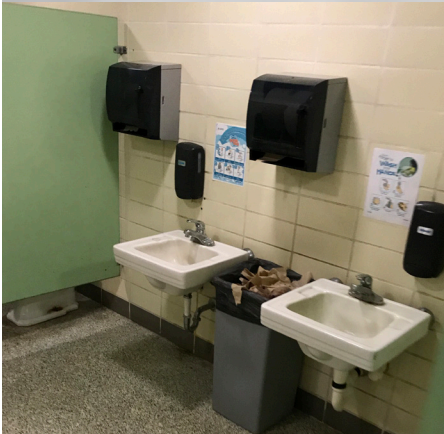
Pipe wrap missing below lavatories

Lavatories within the building are missing pipe wrap to meet ADA needs.

Replace missing/damaged domestic water piping insulation.

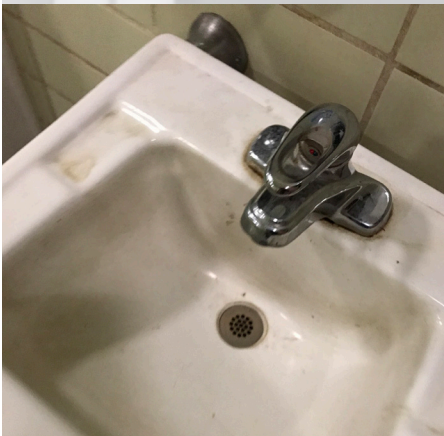
Lavatories stained

1958 Building: Fixtures in the restrooms are in rough condition. Fixtures are stained and some are cracked. In addition the chrome finish on the flush valves is wore off.

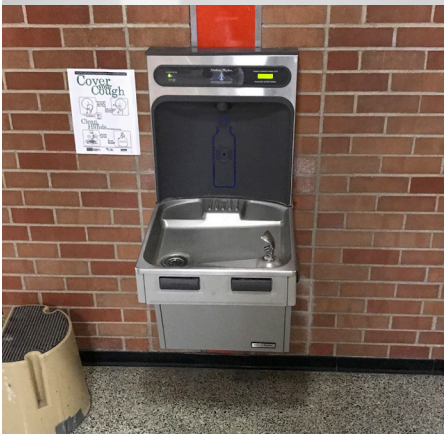
Broken electric water cooler

1962 Addition: The electric water cooler is loose and not mounted securely. In addition, the unit has broken handles.

Repair broken electric water coolers and secure to wall.

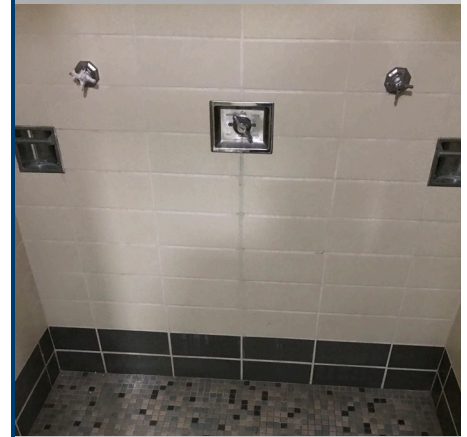
Shower fixtures are leaking and leaving water stains behind.

Leaking shower valve

Replace leaking valve in showers.

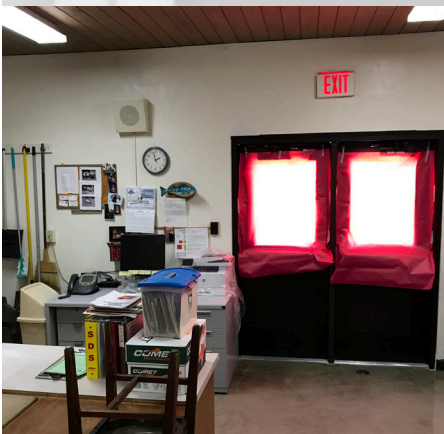
Office off of Kitchen with no air movement

Adding air to the kitchen office space, as well as some fin tube or unit heater is recommended.

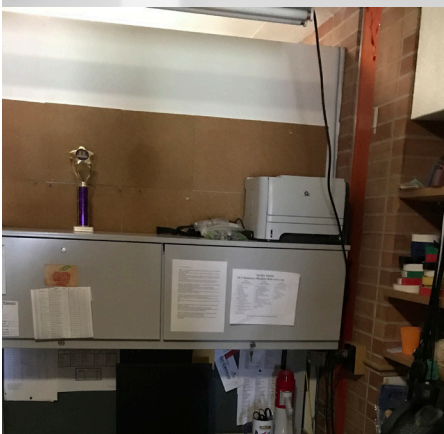
Office in hallway with no air movement

There was an office placed in the hallway which doesn't meet code. There is no form of outside air dedicated to the office space. Code requires a certain amount of outside air dedicated to an occupied space.

Add outside air to the office of the hallway space as well as some fin tube or unit heater is recommended.

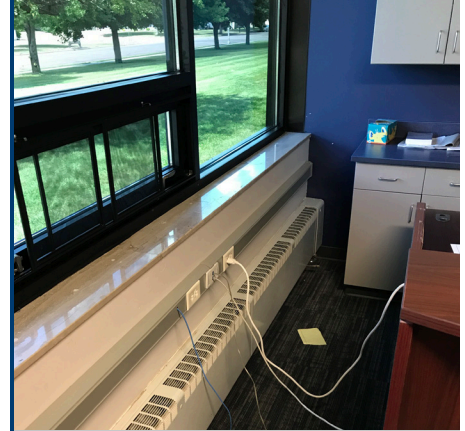
No air movement in offices

The front offices lack any form of fresh air. The exterior rooms in this area have fin tube radiation to handle the envelope loss but no source of outside air. The internal rooms in this area don't have fin tube radiation or fresh air movement. Code require a certain amount of outside air dedicated to an occupied space. Adding air to the space as well as some fin tube or unit heater is recommended to allow the space to be used as an office.

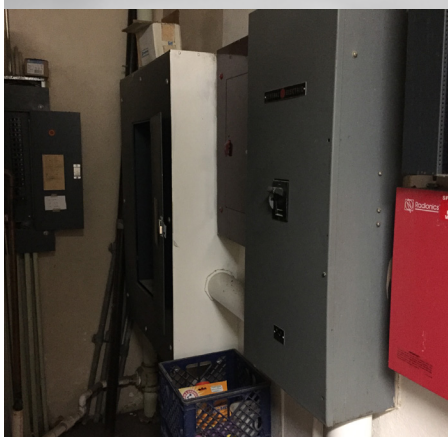
Main switchboard without proper working clearance

System Observations: The main electrical gear was manufactured by General Electric, and appears to be original to the building. It is likely past or approaching the end of its estimated useful life of 30 years. The main issue with the electrical gear is that a walk-in cooler was installed directly in front of the main switchboard and is only providing 2 feet of clearance in front of the equipment, while the National Electric Safety Code requires a minimum clearance of 3 feet in front of all electrical gear.

The walk-in cooler currently located in front of the main switchboard should be relocated to provide the necessary 3 feet of clearance in front of the electrical panels. It should be verified that all receptacles near sinks are provided with GFCI protection. The sagging branch panel cover, located in the kitchen, should be replaced if it is damaged and will no longer provide the necessary coverage.

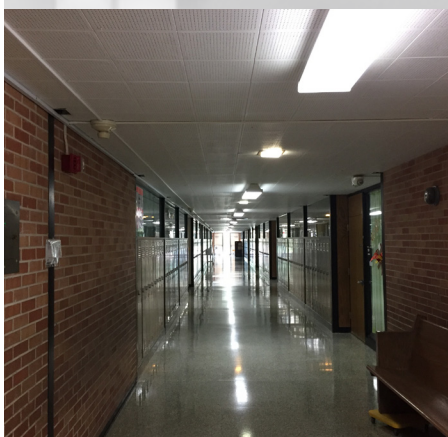
Corridor with a combination of fluorescent and incandescent lighting

The existing fluorescent light fixtures are in good condition and should continue to serve the building well, as linear fluorescent T8 lamps are efficient and still widely used and available. The remaining incandescent fixtures should be replaced, as these fixtures are not nearly as efficient, and bulbs for them are becoming more difficult to acquire. The

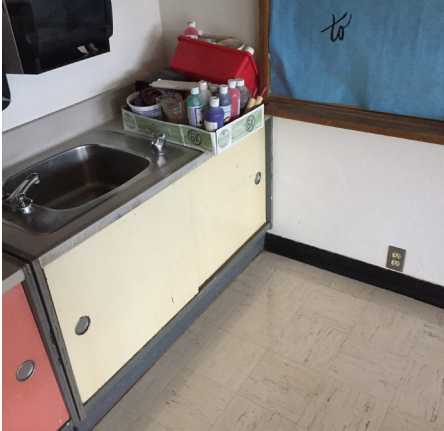
Receptacle near sink without GFCI protection

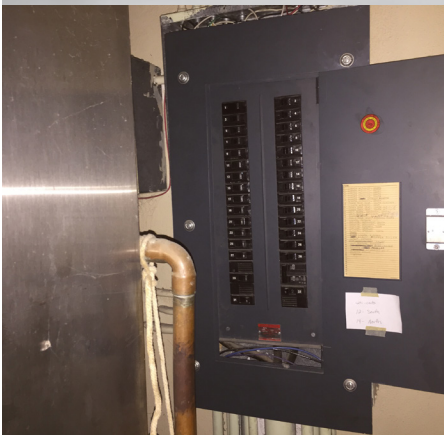
Branch panel with sagging cover

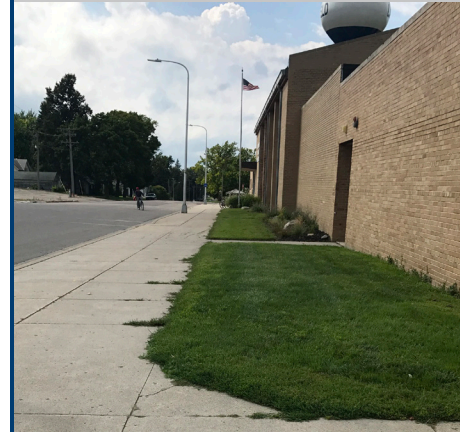
No designated signing or striping on 4th Avenue North

System Recommendations: The surrounding roadways are within the city ROW and any adjustments would require coordination with the city. Stripe parking spaces along adjacent streets to maximize parking stalls. Because no parking can be constructed onsite, the school is reliant on the city-owned lot at the southwest corner of 4th Avenue and Main Street.

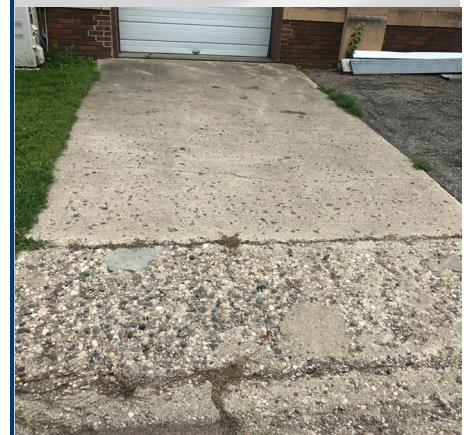
Cracking, exposed aggregate, vegetation, and signs of weathering on driveway

The bituminous pavement was evaluated and given a Pavement Condition Rating (PCI) of 7/100. The deficiencies observed included significant alligator, transverse, and longitudinal cracks and needs to be reconstructed.

System Recommendations: Reconstruct the bituminous and concrete driveways. Routine inspection and maintenance is recommended for the pavement to ensure the full design life is achieved.

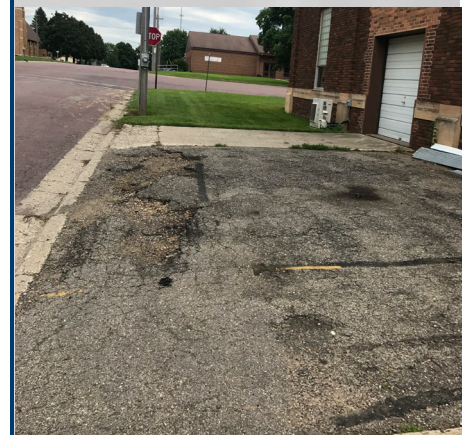
Damaged bituminous pavement separating concrete accesses

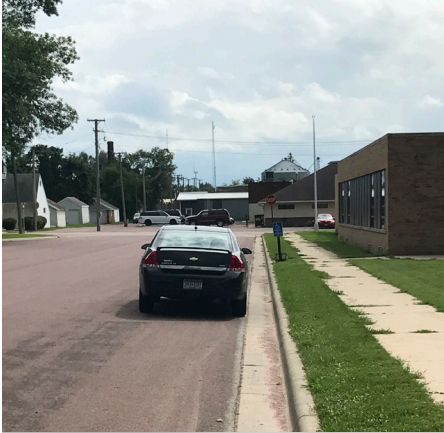
Lack of pavement markings/stripping and designating parking spaces.

System Observation: At the time of inspection, no pavement markings/stripping designating parking spaces. The available space allows for approximately 10 vehicles to park on either side of the street. The lack of signage and available parking spots may lead to congestion during pick-up / drop-off periods. The city-owned parking lot is in very poor condition and will require full reconstruction.

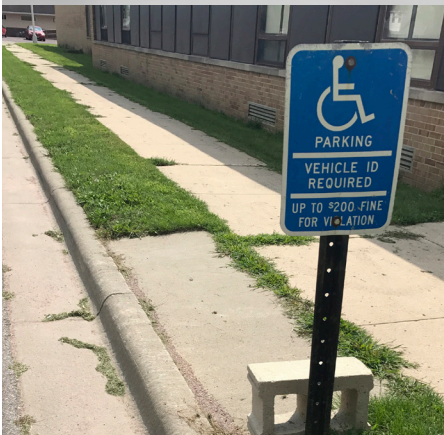
Unmounted handicap sign

System Recommendations: The surrounding roadways are within the city ROW and any alterations would require coordination with the City. The handicap accessible signage on Cherry Street should be replaced and remounted to meet ADA standards, and accompanied by an ADA accessible ramp. The ADA accessible ramp on Griffin needs to be reconstructed and be ADA compliant.

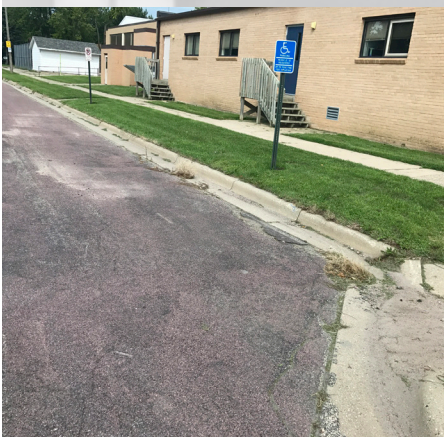
Sediment collection at the junction of the sidewalk panels and curb line

The second ADA accessible sign is mounted along North Griffin Street, near an accessible ramp located at the intersection with 4th Avenue North. The ramp has visible sediment collecting at the junction of the sidewalk panels and the curb line, indicating inadequate stormwater drainage.

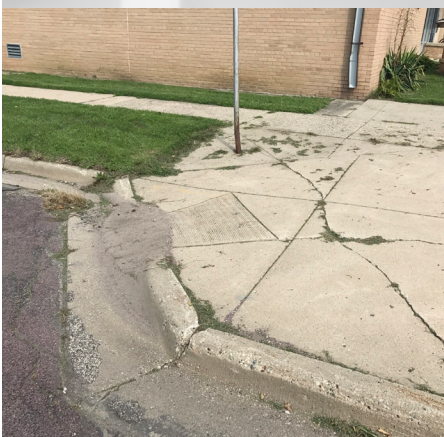
Cracking in concrete walkways

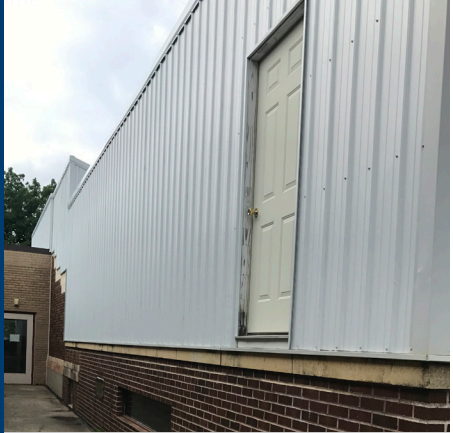
Door with lack of ground access

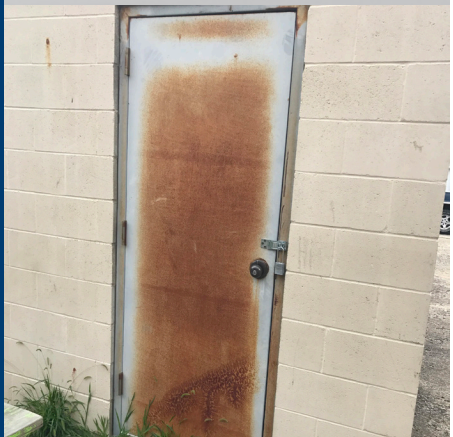
Discolored padlocked ground level door

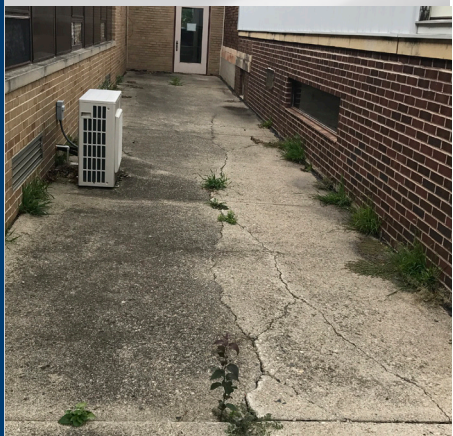
Cracking and discoloration of panels

System Observation: Overall the concrete is in fair condition. Large linear cracking and discoloration of panels was observed along the interior green space walkway between the east and west buildings. The interior green space sidewalk also has a gutter line on the north side and exhibited sediment collection.

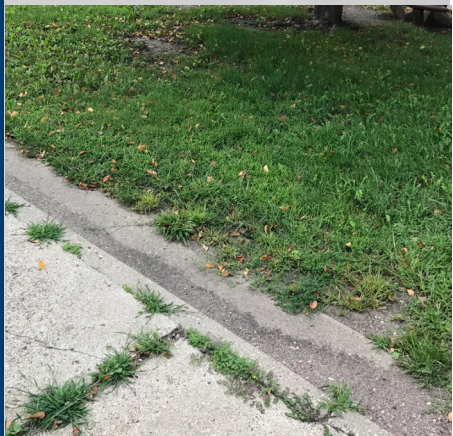
Sediment collection along gutter line on the north side of the pavement

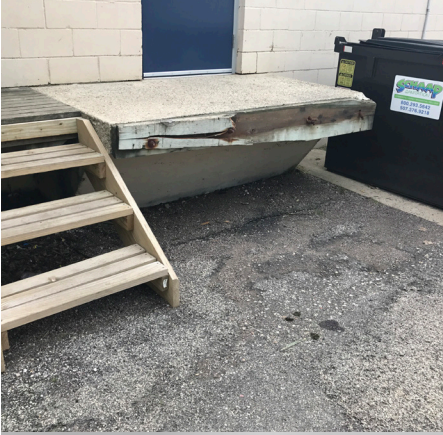
Exposed and rusted rotting wood on bolts and dowel bar

South of the basketball court, there is a set of wooden stairs that connect to a floating concrete slab for an unmarked blue door. The concrete slab shows signs of aging and weathering. There is a piece of wood on the front face of the concrete slab that is bolted into the concrete. The bolts and dowel bar was exposed and rusted, with the wood rotting.
