JACKSON COUNTY CENTRAL SCHOOL DISTRICT

2018 Facilities Assessment

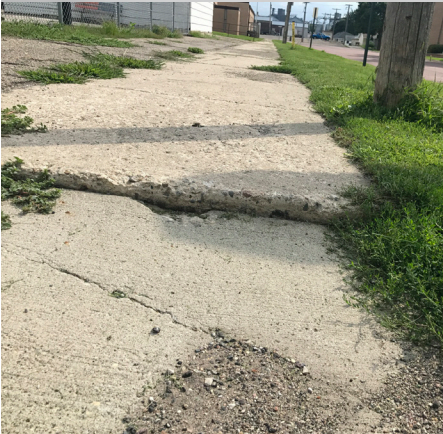
Cracked concrete sidewalk along north Griffin Street

The concrete sidewalk along North Griffin Street has “D” and linear cracks, and some of these panels have deflected which has led to tripping hazards. There was also significant cracking observed at the ADA access points of the north and south intersection ramps of North Griffin Street and are no longer ADA compliant. 2. Sediment was observed collecting primarily near western edge of the basketball courts and onto the abutting western sidewalk along North Griffin Street.

System Recommendations: Areas with a difference in panel height greater than 1/4” or severe cracking need to be corrected. Install ADA compliant detectable warning tiles at each accessible ramp on the site. The surrounding roadways and perimeter sidewalks are within the city Right of Way (ROW) and would require coordination with the City.

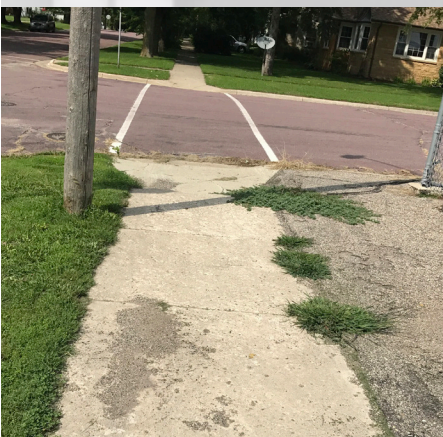
No advance detectable warning tiles on walkway accessible ramps and sediment collection

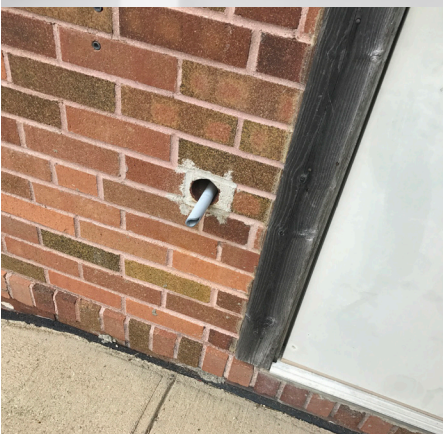
Exposed conduit piping around eastern building and by basketball courts

System Observation: Utilities lines and conduit piping was observed to be exposed around the eastern building and by the basketball courts. Two electrical pedestals have covers that are worn out and no longer lying flat. One of the pedestals is located at the northeast corner of the basketball court, while the secondary pedestal is facing east against a wooden electrical post within the basketball court. There are cables,

System Recommendations: Replace any broken and exposed utilities. Install barriers to all readily accessible utilities near the basketball court, interior grassy area, and on the west face of the building.

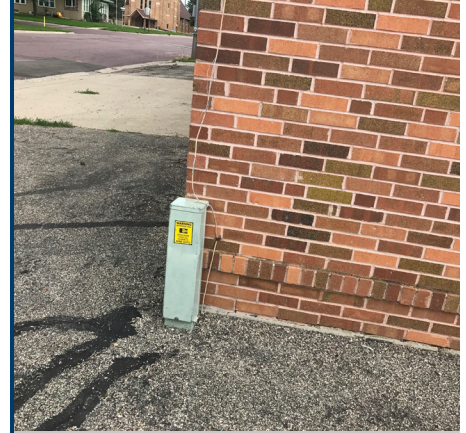
Worn and warped electrical pedestals covers

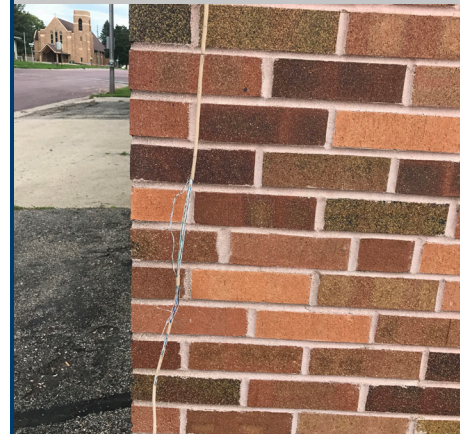
Lack of protective coating and fraying on cables

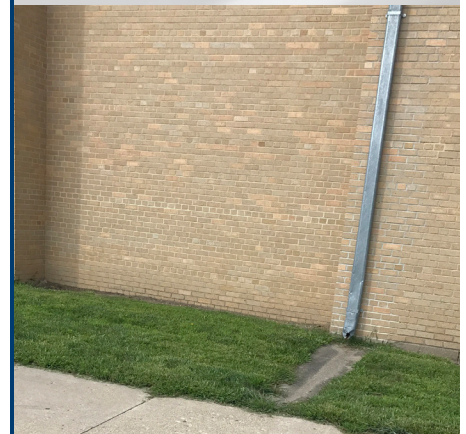
The building's roof drains are directed through concrete or rubber channels which flow into the surrounding grass, across the sidewalk and into the street collection system. One of the roof drains on the south face of the building has been damaged, reducing the water flow from the pipe.

Damaged roof drains on the south face of the building

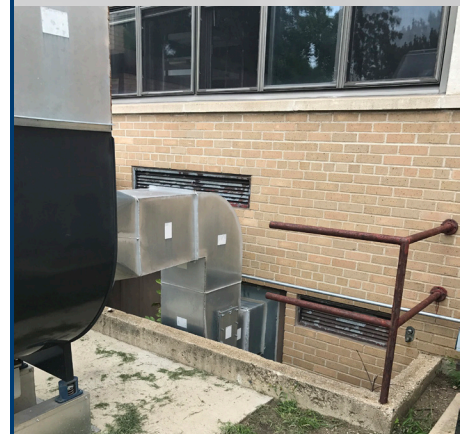
On the west building face there are railings that have been previously cut to make room for the duct and ventilation structures. The railings are old, rusted, and have exposed sharp edges. The structures no longer have a proper barrier and are accessible.

Cut rails to make room for duct and ventilation structures

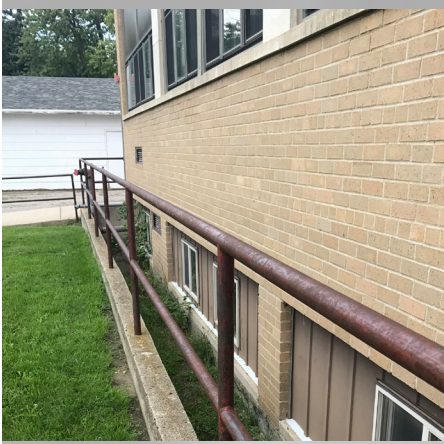
Rusted and sharp edges on railings

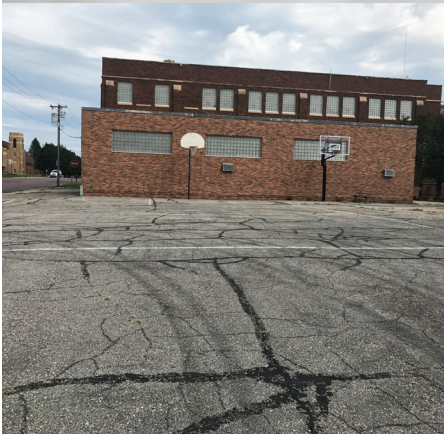
System Observation: The bituminous pavement in the play area has major signs of weathering, alligator, block, and transverse / longitudinal cracks. Distresses such as alligator and block cracking typically indicate that the base beneath the pavement has failed. The pavement was evaluated and received a PCI rating of 21 out of 100 which is classified as "poor" to "very poor".

Bituminous basketball court/playground at northwest corner of site

System Recommendations: It is recommended to fully reconstruct the bituminous basketball court and the adjacent concrete slab. Regrading would remove the elevation change between the bituminous and concrete pavement.

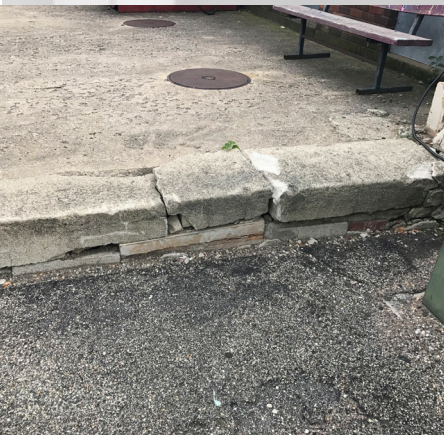
Adjacent to the basketball court, a concrete slab is located north of the previously constructed boiler/coal room. The slab is in poor condition due to the cracking and pitting observed. The pavement is not flush with the surrounding ground with a two-foot drop along the western side of the pavement. It appears that a series of construction work has been completed and is visible along the western edge of the slab, with noticeable layers of brick work and concrete pours. There is additional utility cables that were cemented into the concrete edge. The concrete adjacent to the bituminous basketball court is in poor condition and presents safety hazards. The concrete is an integral roof for a former coal room.

Cracking, pitting and two-foot drop along the western side of the pavement

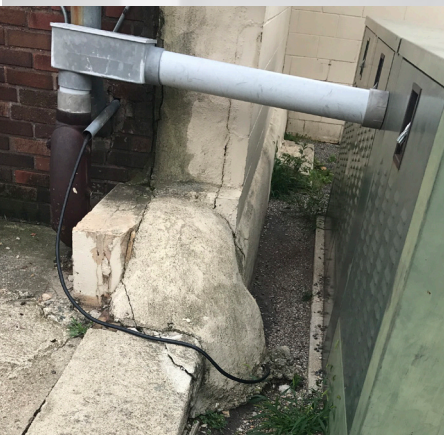
Utility cables cemented into the concrete edge.

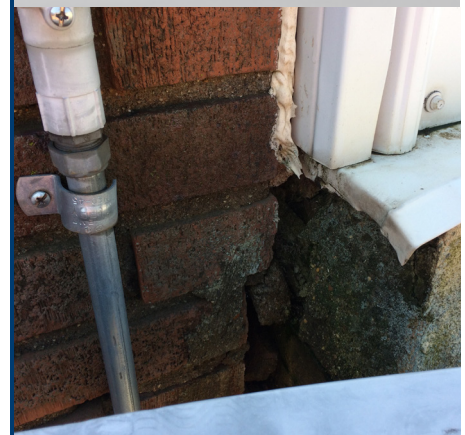
Brick damage

System Recommendations: Repairs are needed for damaged brick and failed joints, lintels and foundation; replace concrete cap with metal coping and fascia system; repair damaged stone panels; repair failing concrete masonry units and joints; and replace metal louvers.

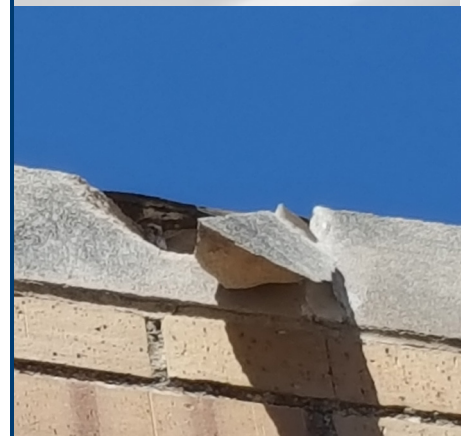
Concrete cap breakage

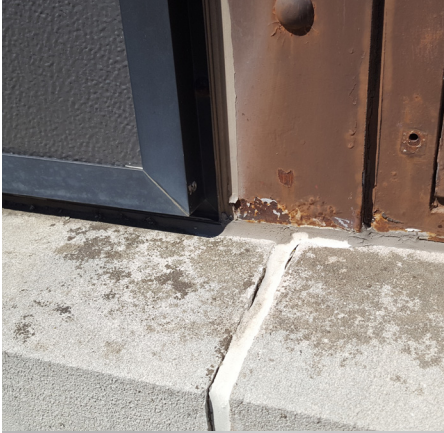
Rust and joint failure on metal framed window systems

System Recommendations: Replace metal framed window system with new aluminum framed window system with insulated glazing; replace glass block units with new glass block units or translucent wall system; replace window sills; and repair or replace soffits and trim.

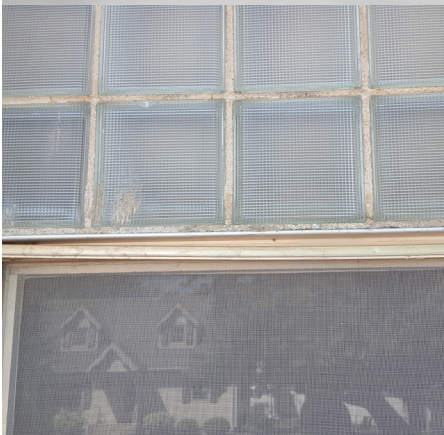
Bent frames on window system

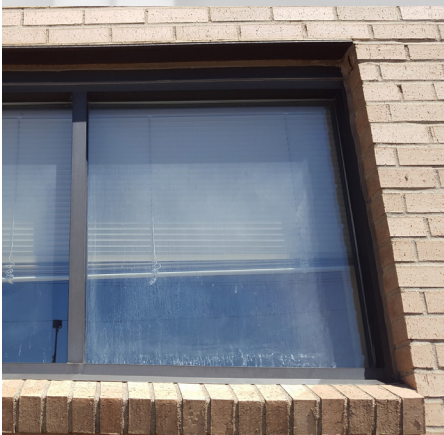
Damaged window system

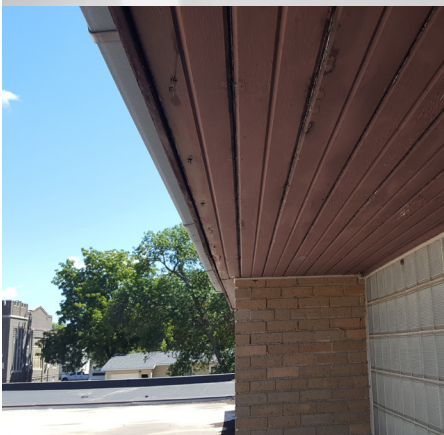
Rusting and peeling on soffits and trim

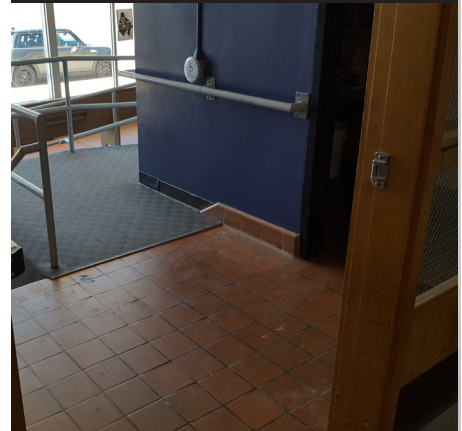
Uneven and noncompliant guards at entrance

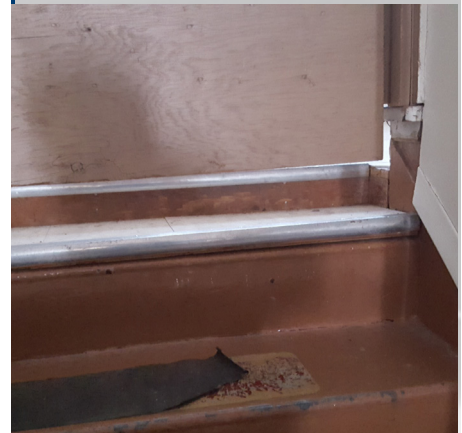
Damaged slip resistance materials; no stairway landing

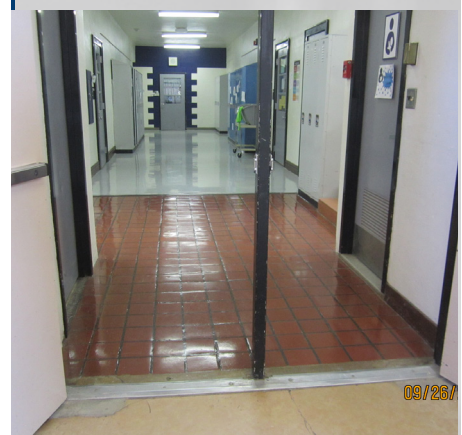
Astragals in held-open door conditions

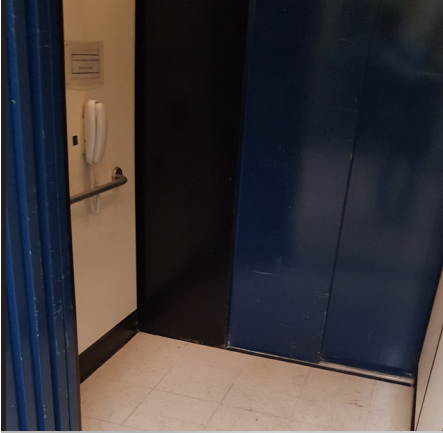
Limited maneuvering clearances in elevator cab

System Observation: Elevator cab does not appear to accommodate required maneuvering clearances for accessibility; walk-off mats and adjacent flooring damaged.

System Recommendations: Install a larger elevator.

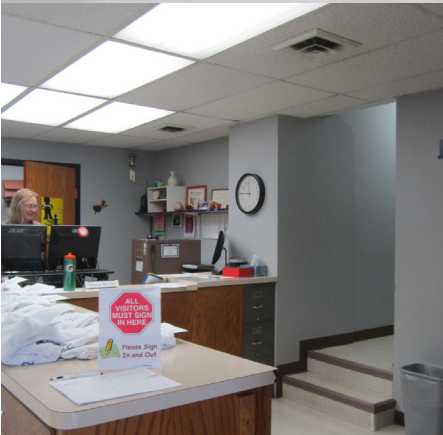
Service counter and stairway in school office

System Observation: Newer vinyl composition tile and carpet in good condition; older carpet in fair condition; level change of approximately two inches in middle of office area; two risers with no handrails near reception counter.

System Observation: Generally casework is in fair condition; although there is no accessible reception counter.

System Recommendations: Replace older carpet; install ramp at level change location; install handrails on both sides of stairways.

System Recommendations: Install an accessible reception counter.

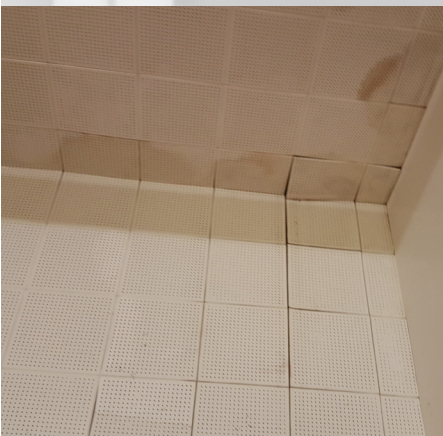
Stained, punctured, and cracked ceiling tiles

System Observation: Perforated acoustical ceiling tile has staining, punctures, cracking, uneven tiles and missing tiles; 2'-0" x 2'-0" acoustical ceiling tile generally in good condition.

System Recommendations: Repair or replace damaged and missing perforated acoustical ceiling tile; replace perforated acoustical ceiling tile with a suspended acoustical ceiling tile system if lighting replacement is performed; replace damaged acoustical ceiling tiles

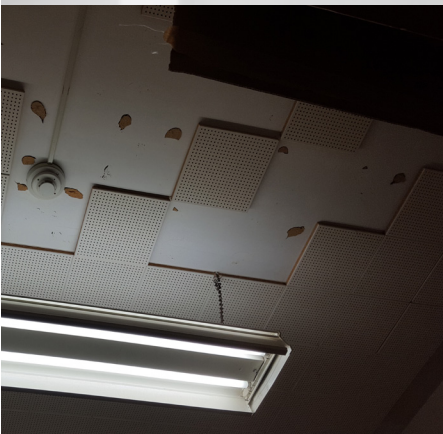
Uneven and missing ceiling tiles

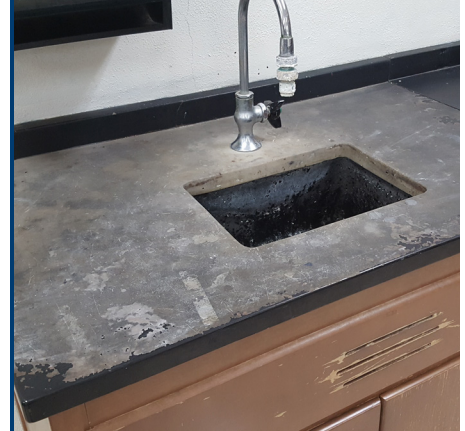
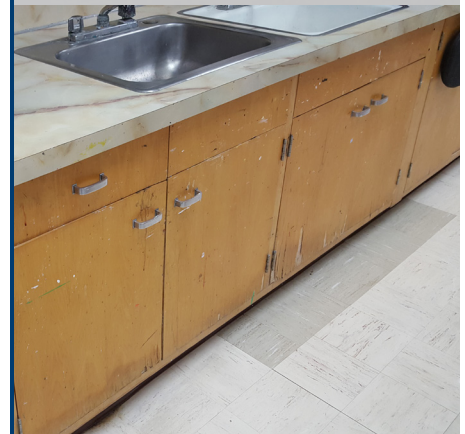
Damage and deterioration on casework

System Observation: Most wood, plastic laminate and metal casework has moderate to severe damage; some casework in science labs has severe damage and deterioration; media center does not appear to have an accessible service counter.

System Recommendations: Replace damaged casework and countertops and install an accessible service counter.

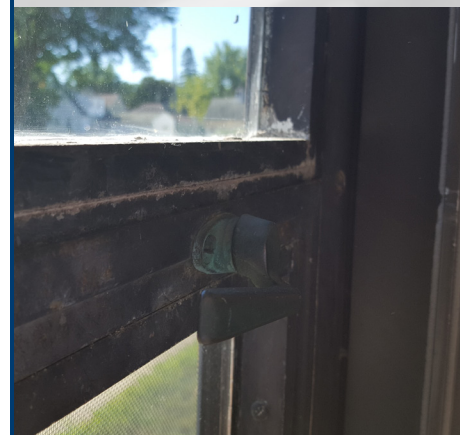
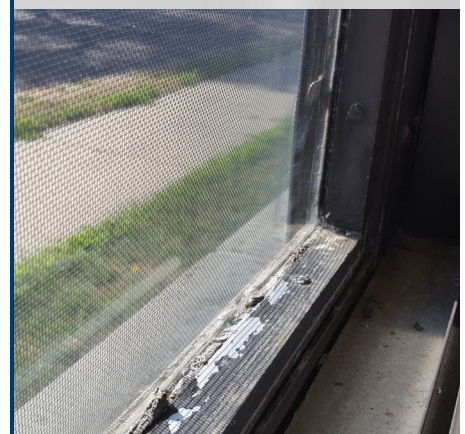
Rusting on metal framed window

System Observation: Whiteboards and smartboards are generally in good condition; old metal framed window system has severe rusting.

System Recommendations: Replace metal framed window system with new aluminum framed window system and insulated glazing.

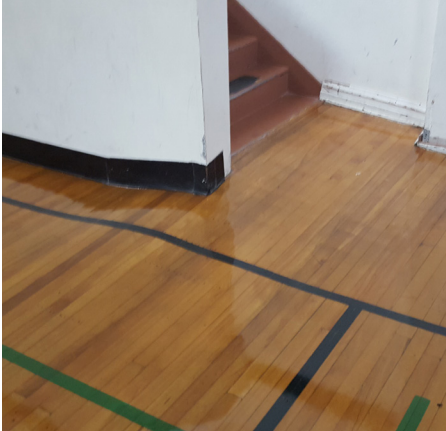
Wood floor with sloping at stairway

System Observation: Wood floors are well maintained but in fair condition due to age with sloping at stairways in older gym; vinyl composition tile in older gym storage room is severely damaged; vinyl composition tile in auditorium has nonslip striping and slopes in all directions; sealed concrete has cracking.

System Recommendations: Reconfigure wood floors to eliminate sloping or mark sloped areas; replace vinyl composition tile in older gym areas; reconfigure auditorium floor and seating to comply with accessibility requirements.

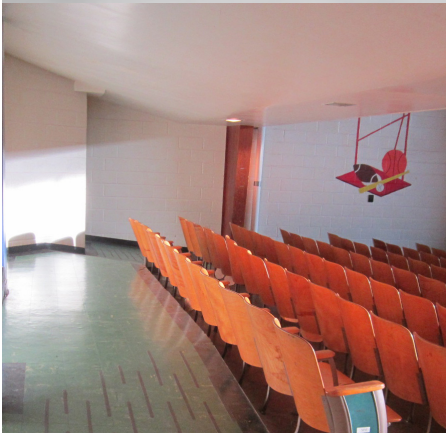
Nonslip striping and slopes in all directions on floor tile

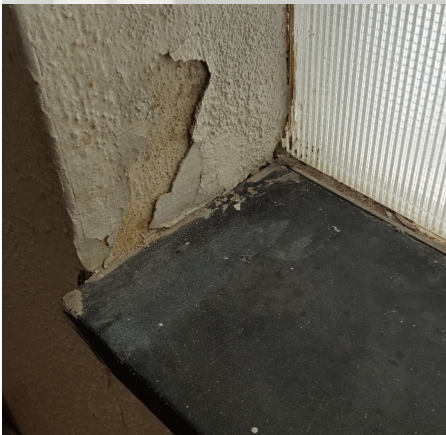
System Observation: Concrete masonry unit walls generally in good condition; plaster walls have cracking and peeling.

Damaged plaster wall

System Recommendations: Repair damaged plaster walls.

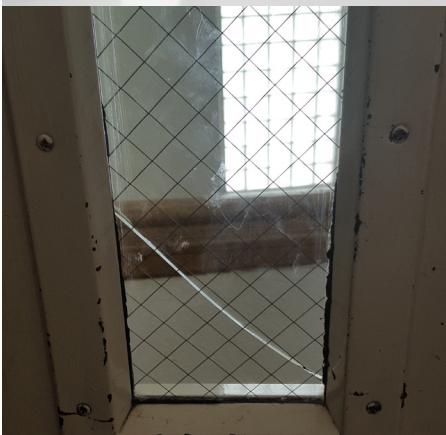
System Observation: Most doors have significant damage and noncompliant knob hardware; some doors have wired glass.

Damaged hollow metal door with wired glass

System Recommendations: Replace damaged doors; replace noncompliant knob hardware with handle locksets; and replace wired glass with safety glass.

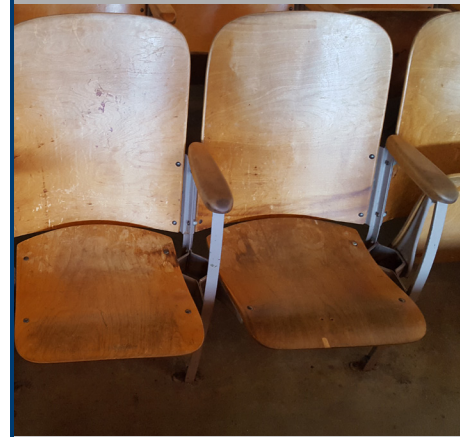
Damaged auditorium seats

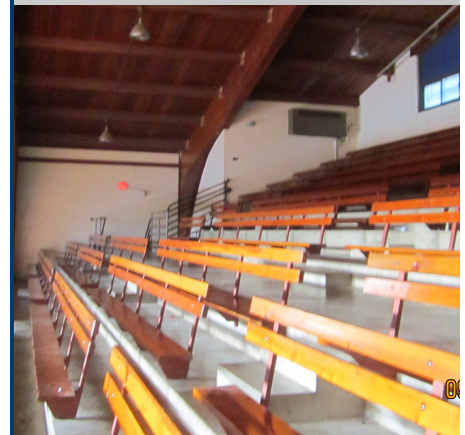
No accessible seating areas in balcony

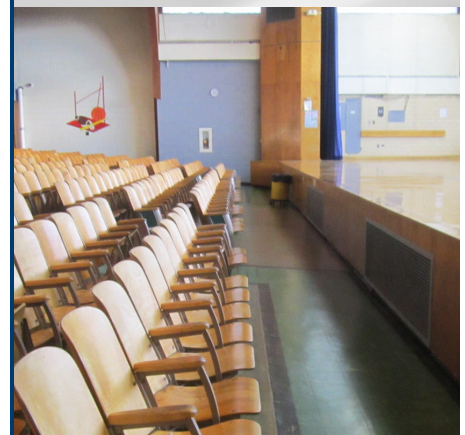
No guards at drop down to auditorium floor

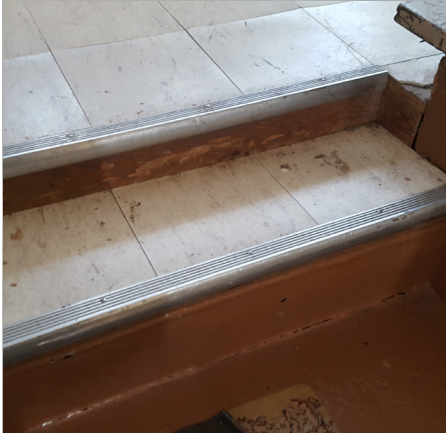
Noncompliant risers and treads on stairs

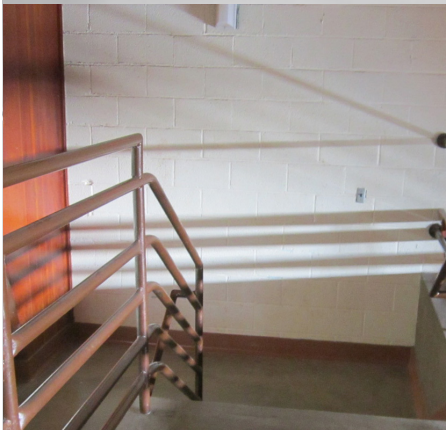
Noncompliant handrails and guards on stairs

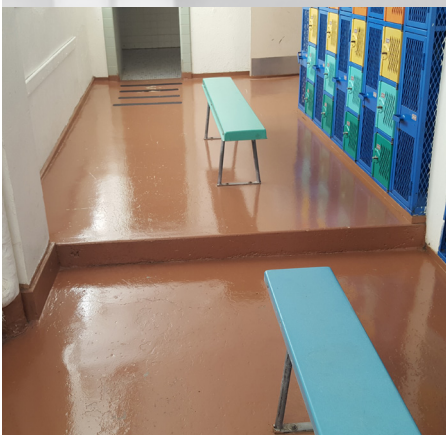
Unmarked elevation differences on concrete locker room floors

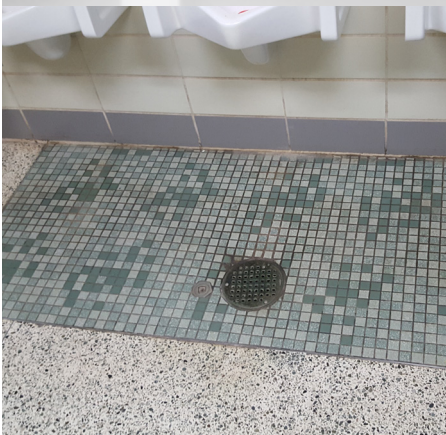
Staining on tiles under urinals.

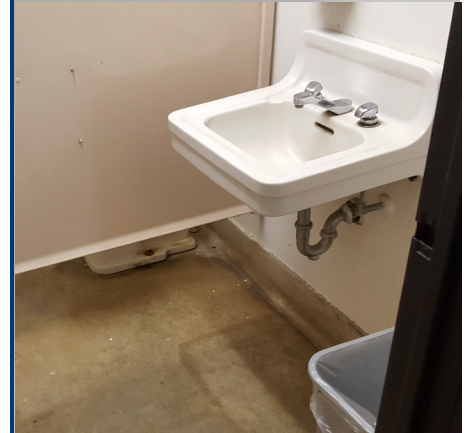
Stained sealed concrete floor around sink and toilet

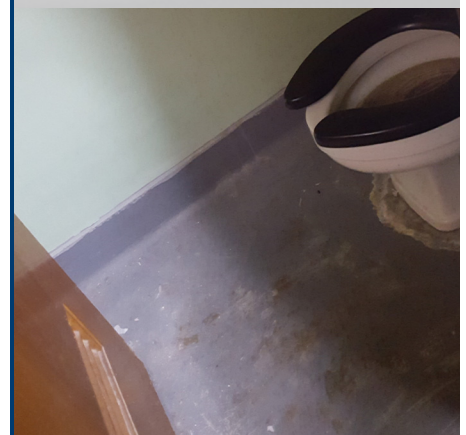
Stained sealed concrete floor around toilet

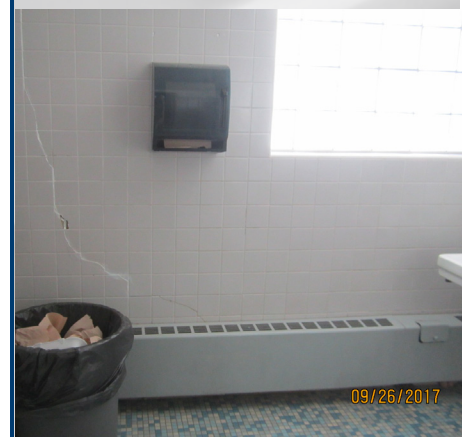
Cracking wall tiles

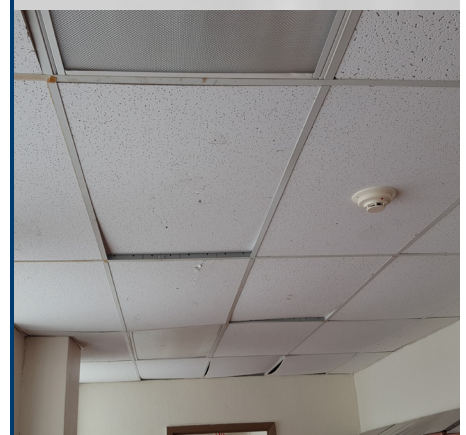
Stained and warped ceiling tiles

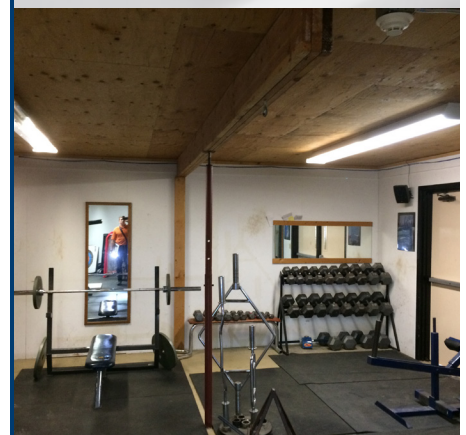
Unsupported beam by gym

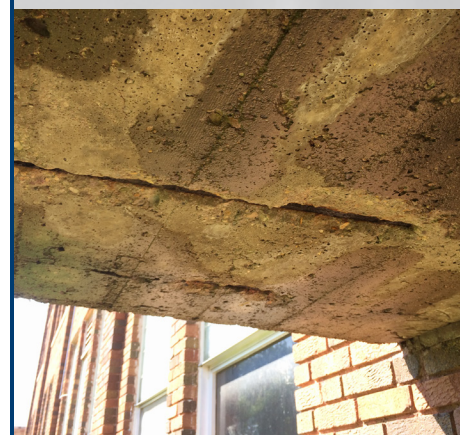
Exposed rebar at stairs

Replacement or repair of the stairs on the northeast corner of the East Wing is recommended to reduce the potential for failure as the exposed rebar continues to rust and weaken the concrete stairs.

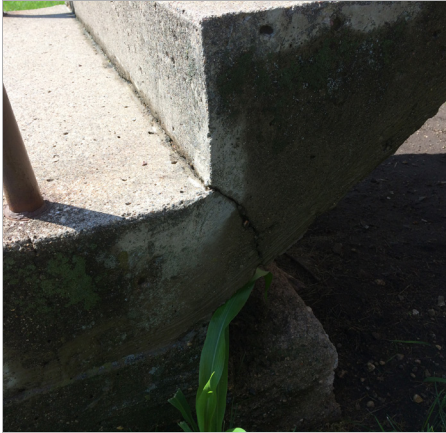
Concrete stair cracks

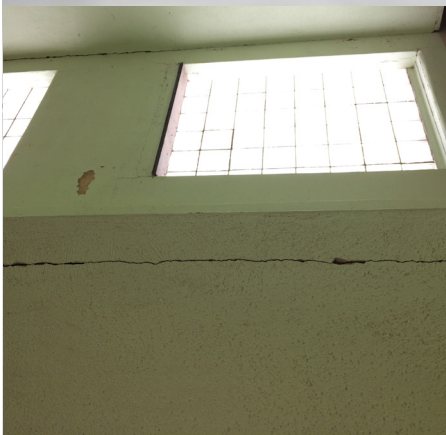
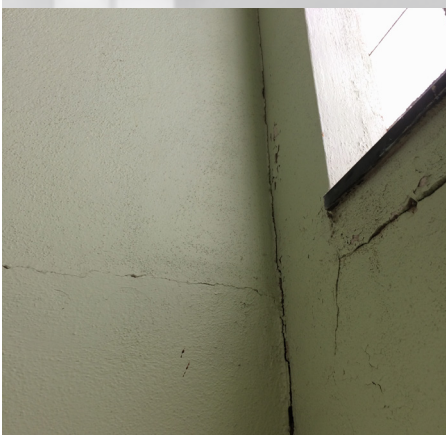
Plaster cracks in east wing

Plaster Cracks in east wing

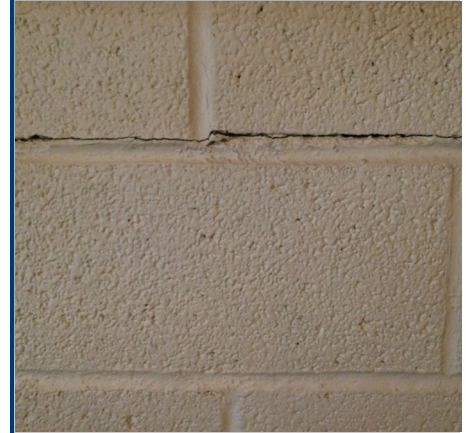
Stairstep cracks in auditorium

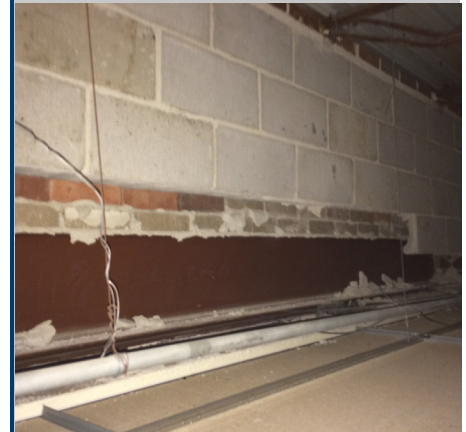
Missing CMU above steel beam

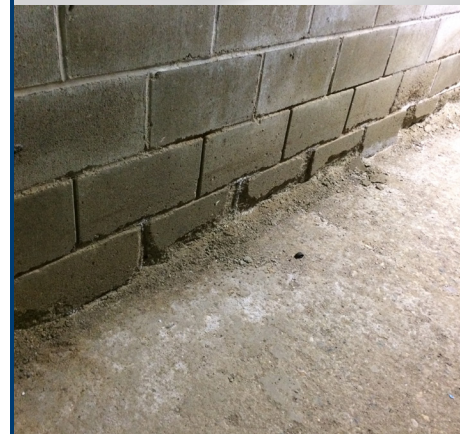
Deteriorating CMU wall in basement

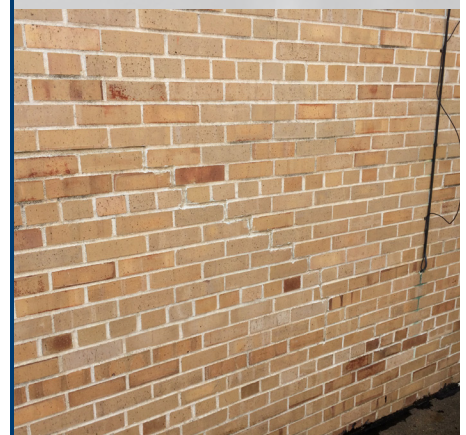
Stair step crack in brick façade

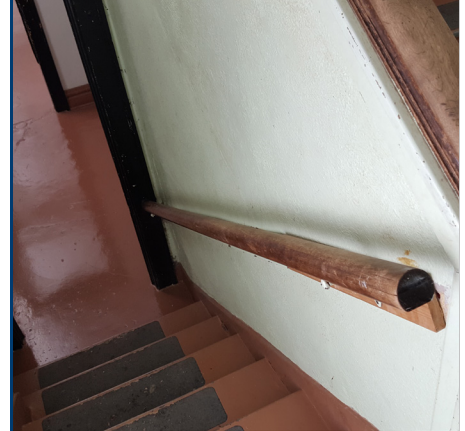
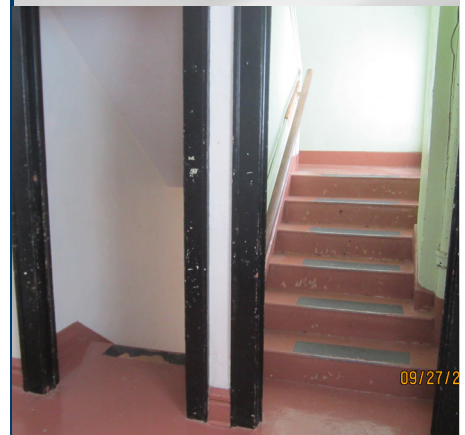
Noncompliant landings in exit stairways

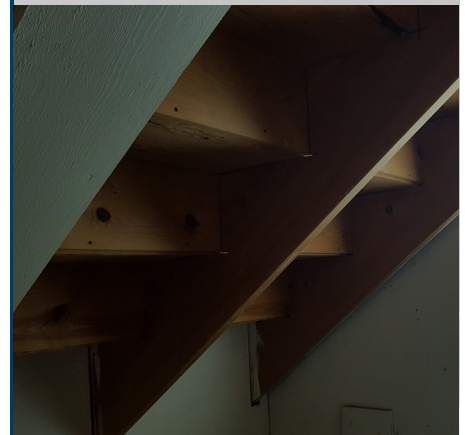
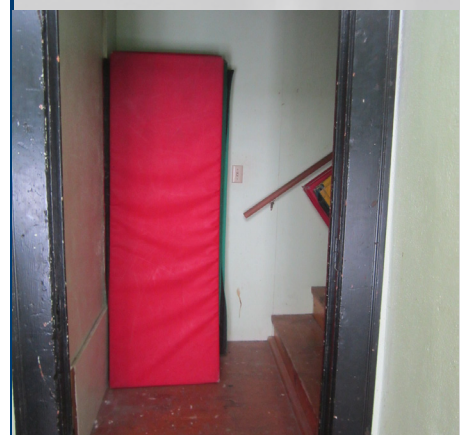
Noncompliant exit stairwell

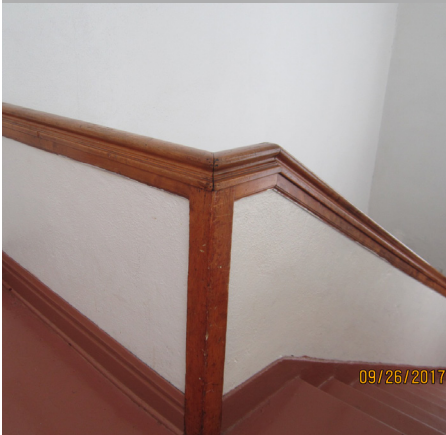
Noncompliant exit stairwell

Provide a second remote means of egress from the balcony and clear items from the egress path at the first floor stairway landing. Modify or replace handrails and guards to meet code requirements.

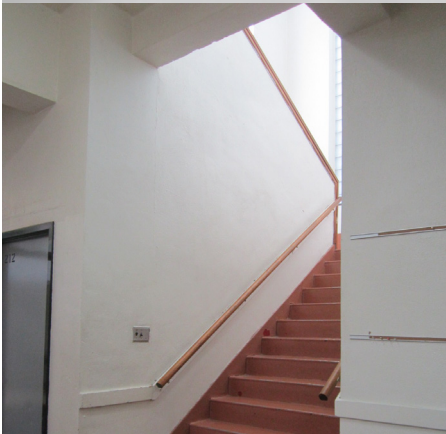
Noncompliant exit stairwell

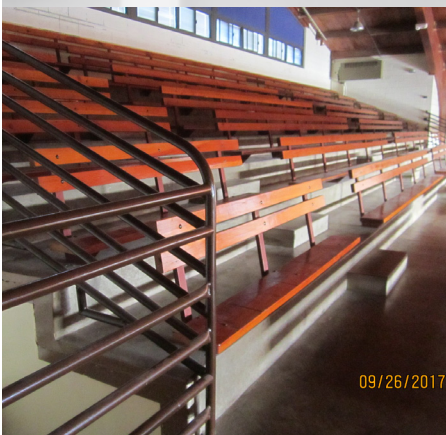
Noncompliant riser in exit stairs

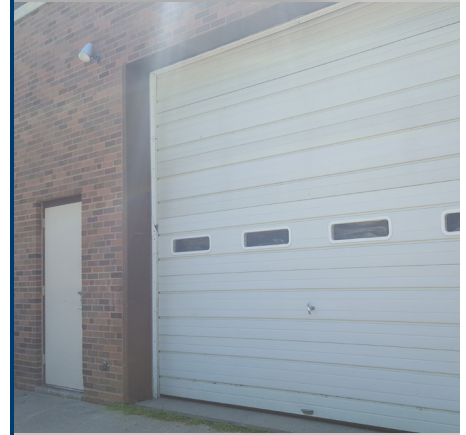
Elevation differences in stoops and sidewalks in exterior doors

The bituminous and concrete play area on the north side of the building is in poor condition and does not provide compliant ground surface conditions or accessible routes to and within play areas. The stoops at the doors which connect the play area with the building have noncompliant elevation differences.

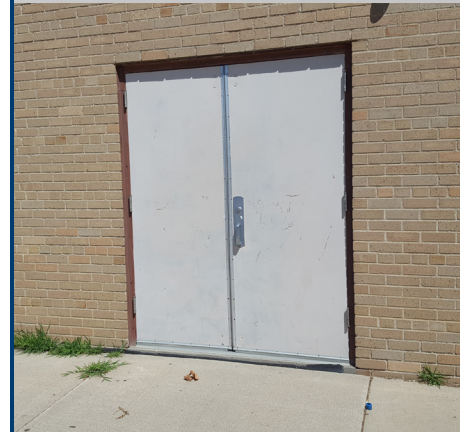
Elevation differences in stoops and sidewalks in exterior doors

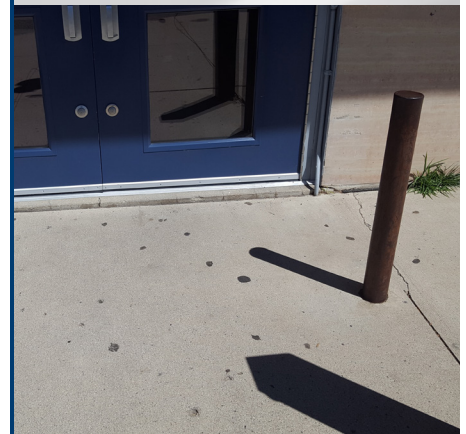
Elevation differences in stoops and sidewalks in exterior doors

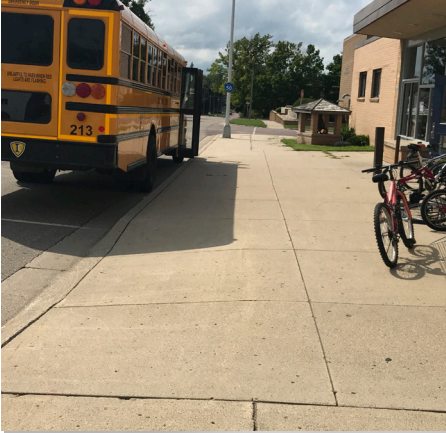
Noncompliant main entrance

The main entrance to the school is from the bus drop-off area on 4th Avenue North. A curb ramp provides access from the street to the sidewalk adjacent to the building. An accessible parking space sign is located around the corner on North Griffin Street, adjacent to a parallel parking space. A nearby curb ramp has significant cracking and sediment buildup. The main entrance doors are equipped with automatic doors with control switches, but there is an elevation difference of approximately one inch at the door sill. An additional accessible parking space sign is located on Cherry Street. It is also adjacent to a parallel parking space and there is no curb ramp to provide access to the adjacent sidewalk. These elements do not provide an accessible route or an accessible entrance in compliance with the 2010 Americans with Disabilities Act (ADA) Standards for Accessible Design or the 2015 Minnesota Accessibility Code.

Replace the existing noncompliant accessible parking spaces, curb ramps, sidewalk, stoop and door sill at the building's main entrance as required to meet accessibility standards.

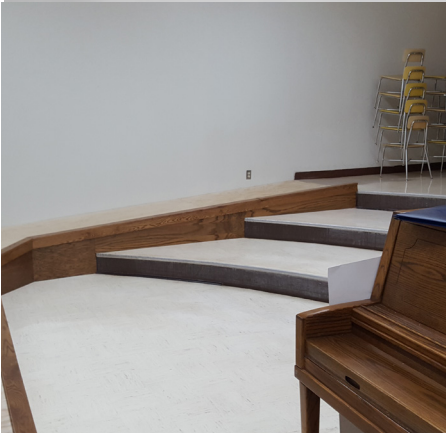
Lack of handrail on music room ramp

Modify or replace stairways and ramps to meet code requirements.

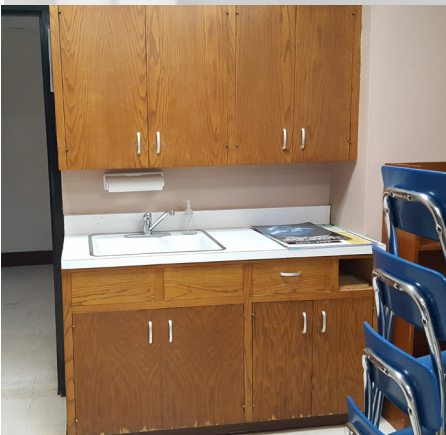
Sink with cabinets below, rather than clear floor space

Replace sinks and casework in classrooms as required to provide clear floor space and knee and toe clearance under the sinks. Install insulation on exposed pipes.

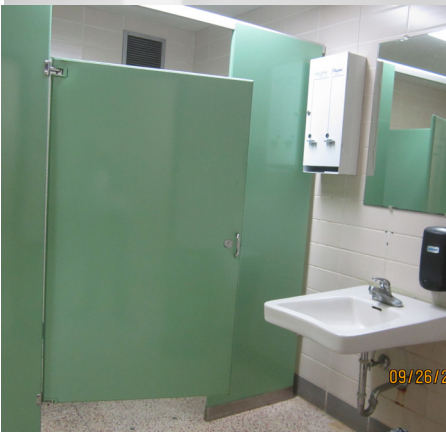
Noncompliant maneuvering clearance

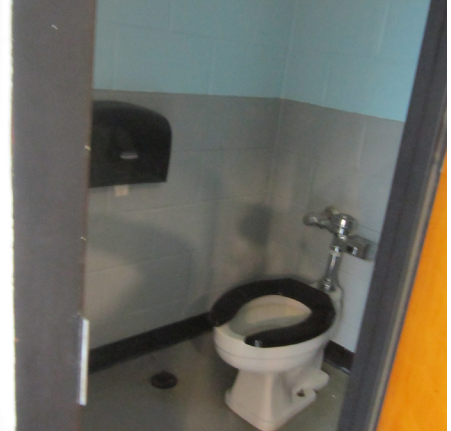
Noncompliant clearance and accessories

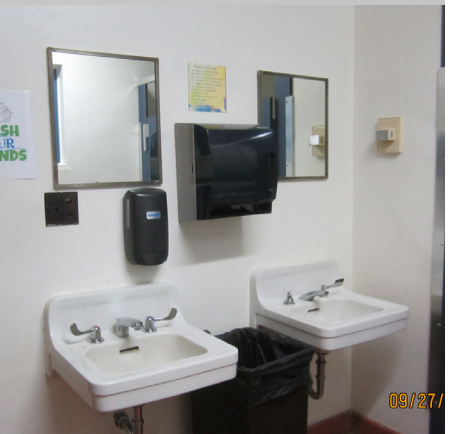
Noncompliant mounting heights in restroom

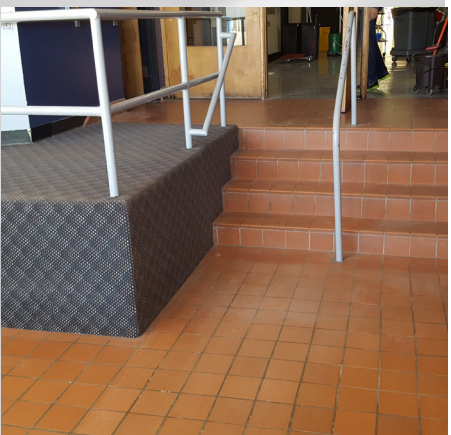
Noncompliant landings, handrails, guards and edge protection on ramps/stairs

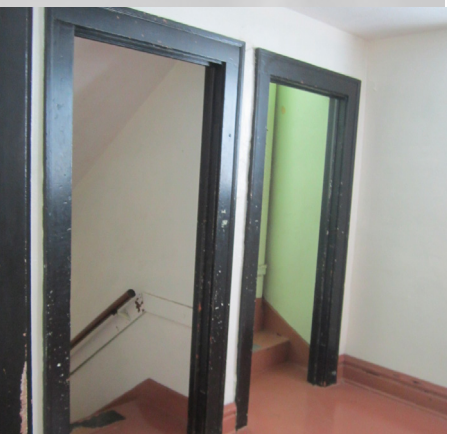
Noncompliant landings, and handrails on stairs

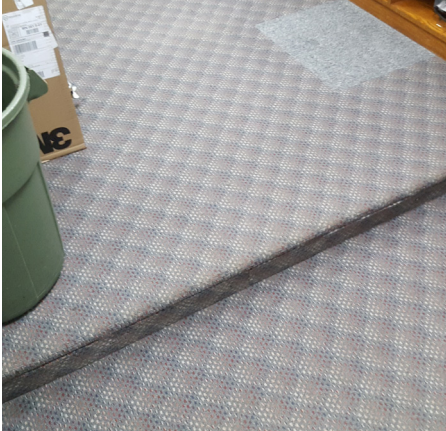
Noncompliant elevation change

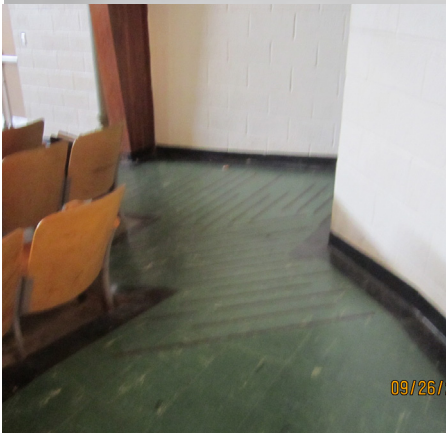
Noncompliant floor slope

Reconfigure auditorium and balcony floor and replace seating to comply with accessibility requirements.

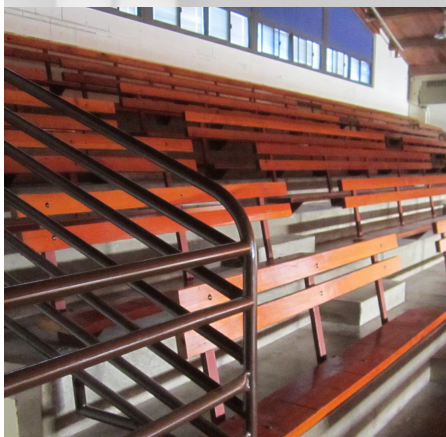
The auditorium and balcony floors and seating do not comply with accessibility requirements for means of egress, floor slope, stairways and ramps, handrails and guards, wheelchair seating and companion seating.

Noncompliant egress, stairways, handrails and guards; no accessible seating.

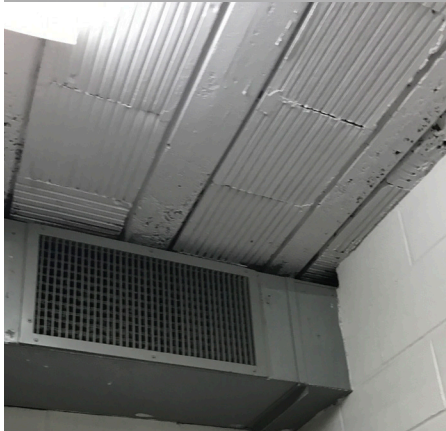
Dirty return and exhaust grilles

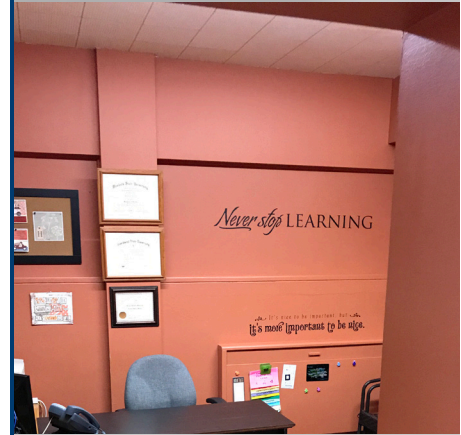
Office space lacking air movement

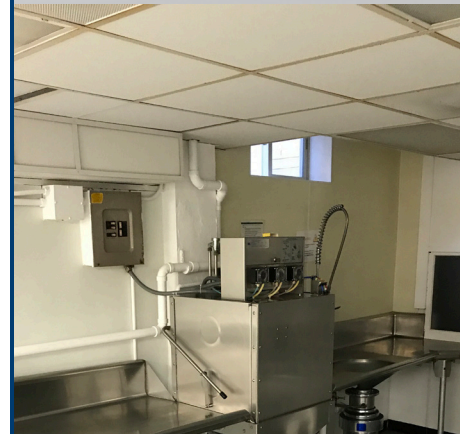
Dishwasher missing hood

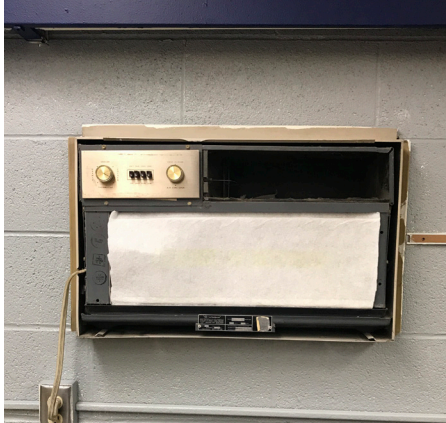
Window unit in need of replacement

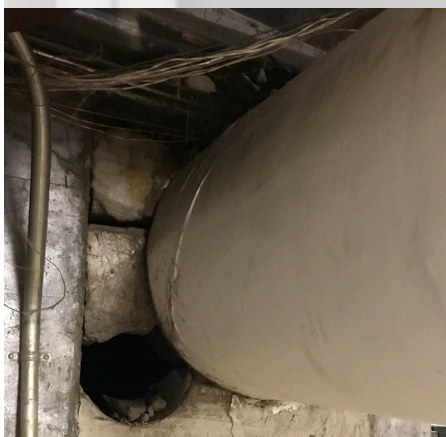
System Observations: The outside air intake louver is damaged. The structure around the boiler stack is deteriorating and falling apart. The large chemical storage room located just outside of the boiler room has a strong chemical odor and does not appear to have exhaust ventilation.

Structure around boiler flue

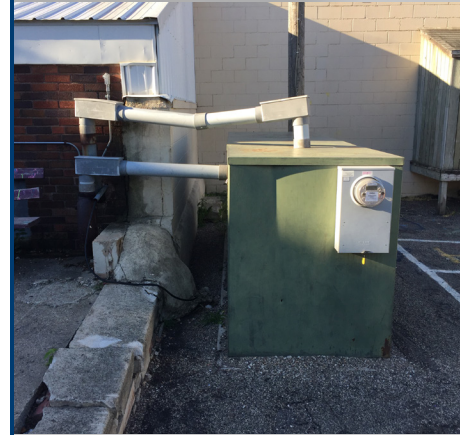
Main utility transformer

The PVC conduit coming out of the pad mounted transformer should be replaced with rigid steel conduit to provide proper protection for the secondary conductors from the transformer to the main disconnect switches.

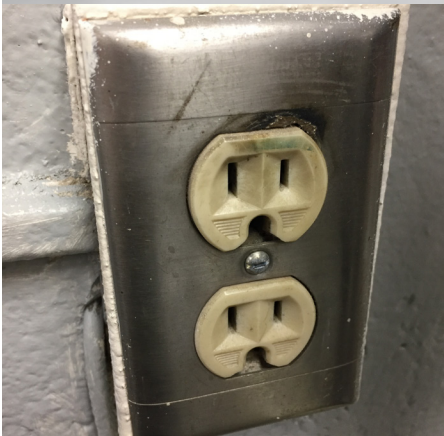
Receptacle with burn marks

One concerning item was a receptacle in a class room with what appears to be burn marks around the plug. The burn marks can be caused by many reasons including an overloaded circuit, loose wiring, or an old outlet. The outlet should be replaced and further investigation done into what is caused the burn marks.

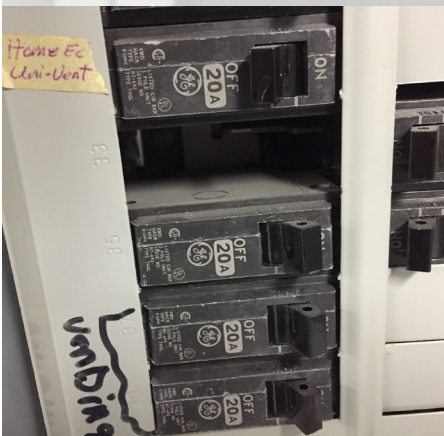
Branch panel missing blank space covers

It was observed that some of the branch panels in the hallway was missing blank space

covers and had exposed busing. New blank covers should be added to ensure the live busing is not accessible.

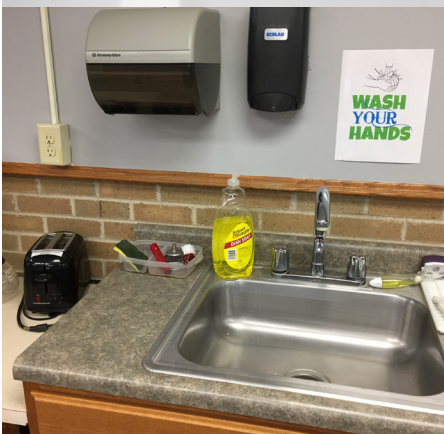
Non-GFCI receptacle near sink

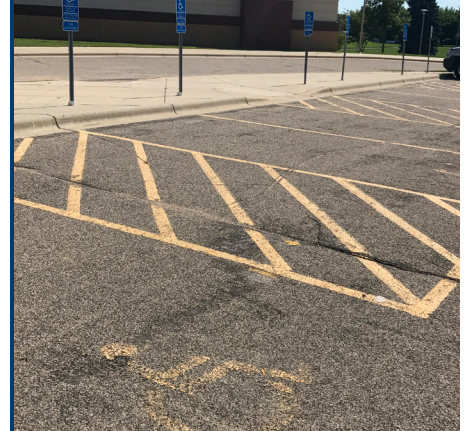
Faded pavement markings in parking lot A

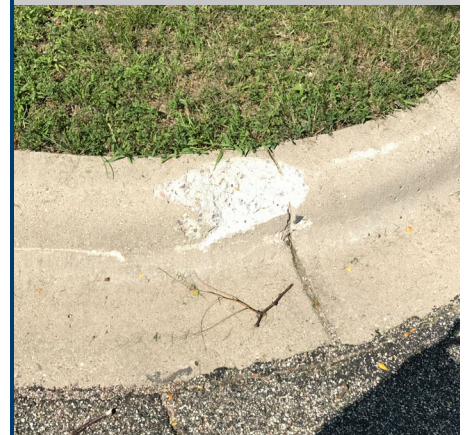
Minor scraping in curb

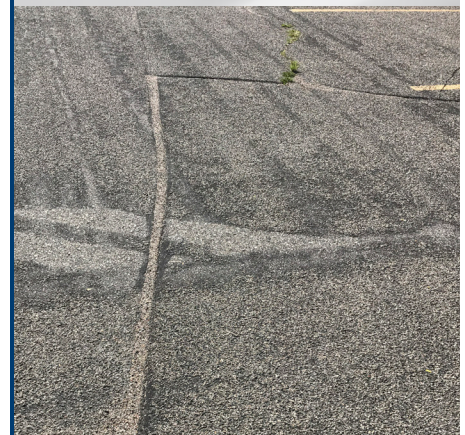
Exposed bituminous aggregate in parking lot A

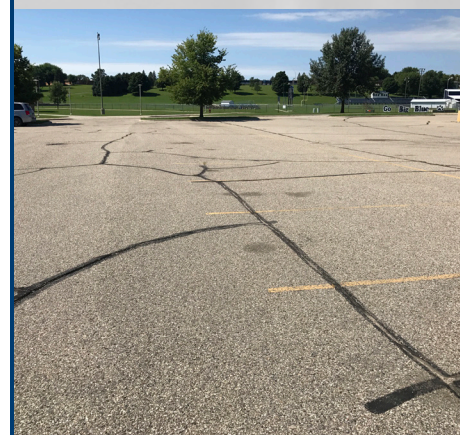
Cracks and potholes have formed and previous joints beginning to lose their seal in parking lot B

System Observation: The lot has received maintenance in previous years including crack fill, seal coat, and full-depth patching, however new cracks and potholes have formed and previous joints are beginning to lose their seal. The pavement received a PCI rating of 67 out of 100 which falls into the "good" category. The pavement markings throughout the parking lot and the circulation access are faded.

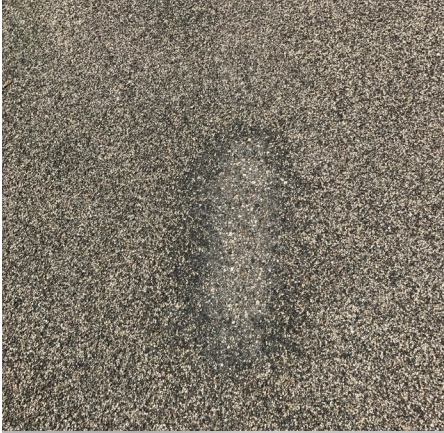
Exposed aggregate on bituminous pavement of parking lot B

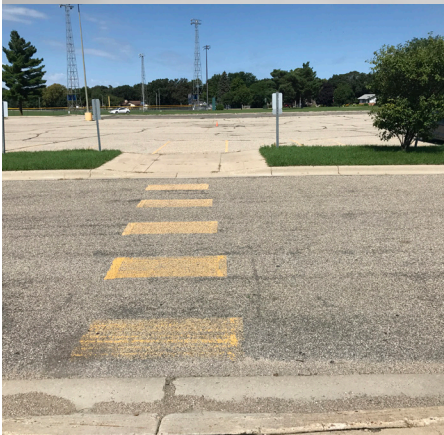
Faded crosswalk pavement markings in parking lot B's circulation areas

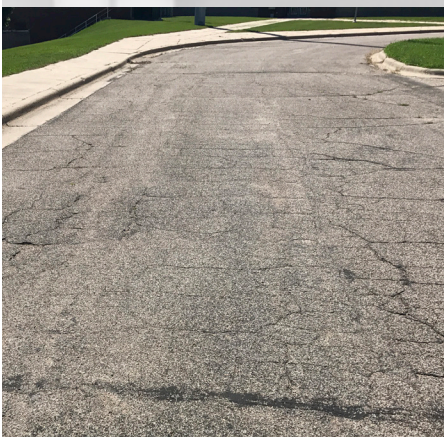
Alligator and block cracking along the northern portion parking lot B's circulation drive

Parking Lot B has a separated one-way circulation access. Traffic enters from the west on Dewey Street and exits north onto Springfield Parkway. The access appears to receive the same maintenance as the parking lot but exhibits major distresses. The access received a PCI rating of 44 out of 100 with severe alligator and block cracking along the northern pavement, indicating base failure. The access would be able to accommodate parked vehicle while maintaining continuous one-way traffic flow through.

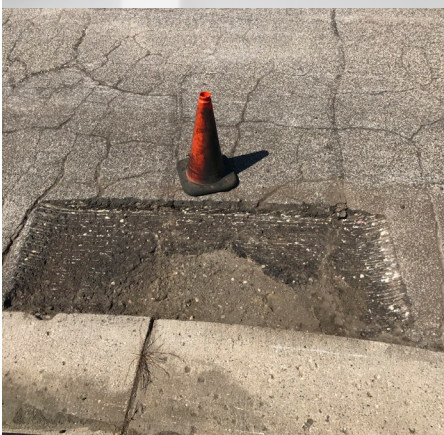
Patching of pavement being performed in circulation access of parking lot B

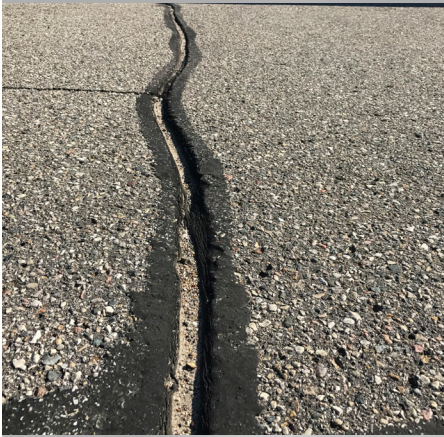
Previous joints losing seal in parking lot C

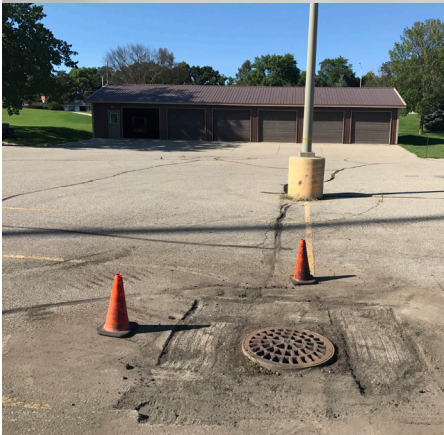
Patching in parking lot C

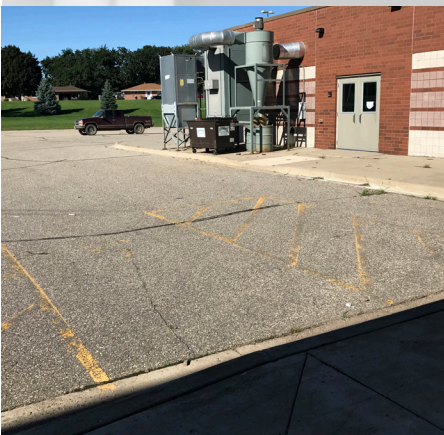
Faded pavement markings in parking lot C

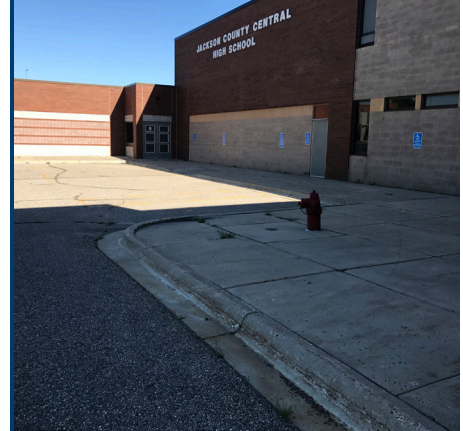
Sidewalk settling below curb

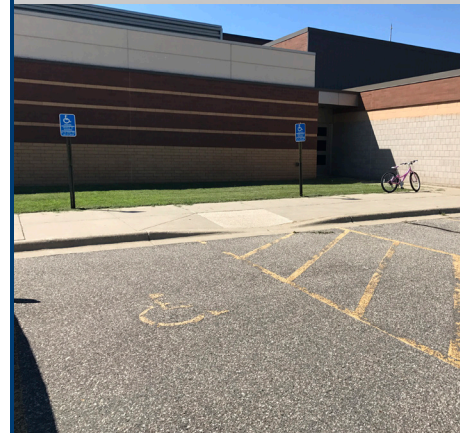
Faded pavement markings, no van accessible plaque at the van-accessible stall
