JACKSON COUNTY CENTRAL SCHOOL DISTRICT

2018 Facilities Assessment

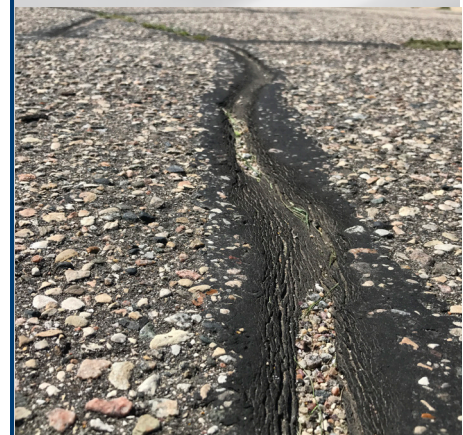
System Observation: The lot has received maintenance in previous years like crack fills, seal coats, and full-depth patch replacement at locations of severe cracking / potholes, however new cracks have occurred and previous joints are beginning to lose their seal. The pavement received a PCI rating of 74 out of 100 which falls into the "very good" category. The pavement markings throughout the parking lot were faded. Bituminous patching was being performed at the time of the site visit.

Previous joints losing seal and loss of aggregate in parking lot D

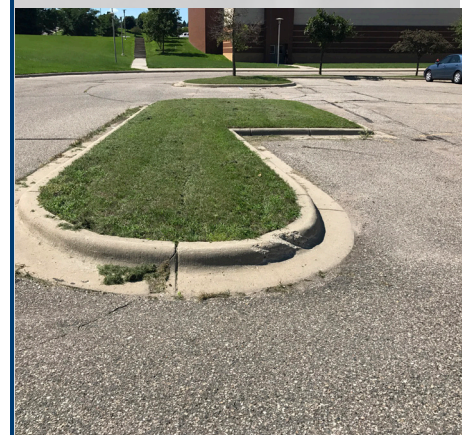
Cracking and scraping of the curb and gutter

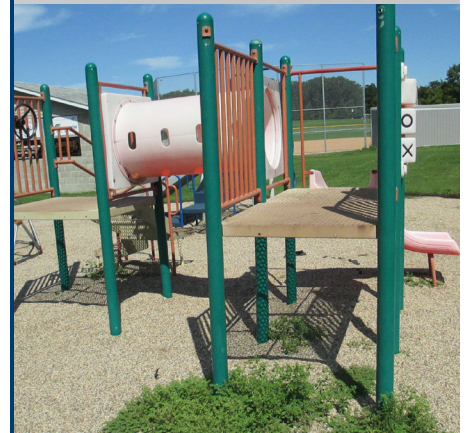
Rusted fasteners, warped platforms, faded paint, missing hardware in southernmost play unit

The equipment is aged and does not have an ADA accessible route. The southernmost play unit has rusted fasteners, warped platforms, faded paint, missing hardware, and a portion of the structure and guardrail are missing, decreasing the overall safety of the playground. The northernmost play structure has warped and rusted platforms. The geodesic dome climber is rusting at connection points.

System Recommendations: Based on current observations, the playground area and equipment do not meet current ADA standards, and several safety concerns were observed. The playground, including equipment, safety zones, materials, and accesses, should meet the standards and guidelines as outlined in the Playground Public Safety Standards and Guidelines. It is recommended that the southernmost play unit be removed and replaced with new compliant equipment. A new ADA compliant access should also be provided both to and within the playground area. All rusted and defective components and fasteners should be replaced.

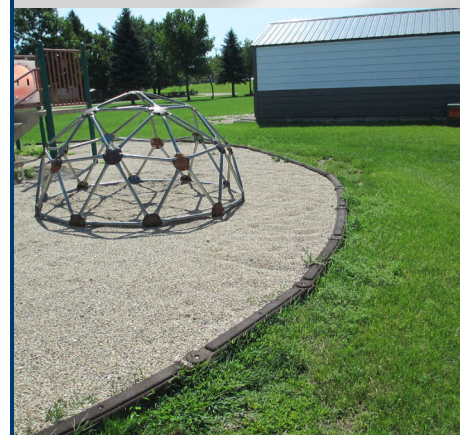
Rusted connections points in geodesic dome climber

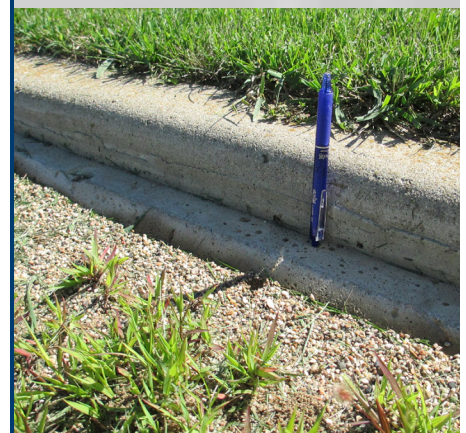
Weeds and loss of surfacing in landing pit

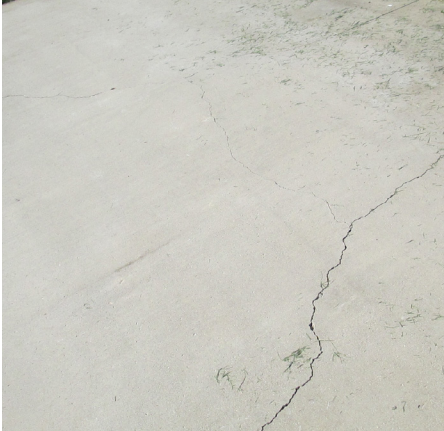
Cracks in pole vault concrete pad

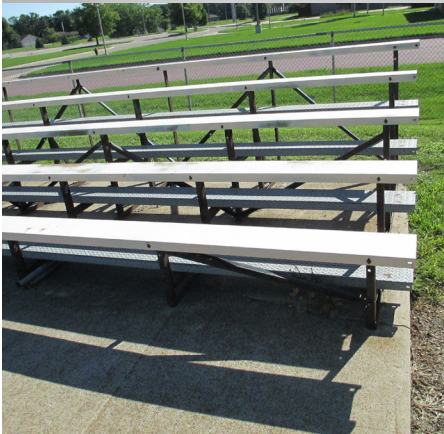
Rusting and missing end caps in bleachers

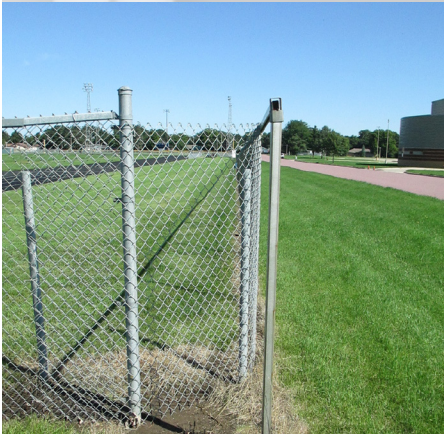
Southeast corner of track and field chain-link fencing

Fencing along the perimeter of the track facilities is in good condition, with only one section in the southeast corner needing replacement.

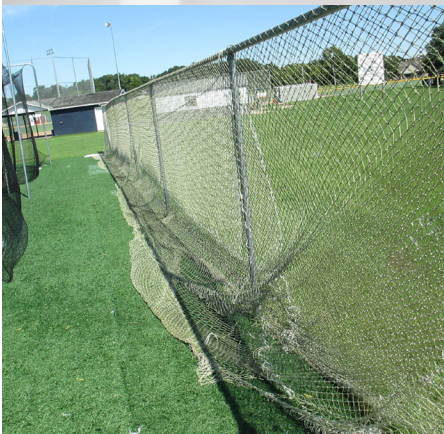
Holes in netting of adjacent batting cages

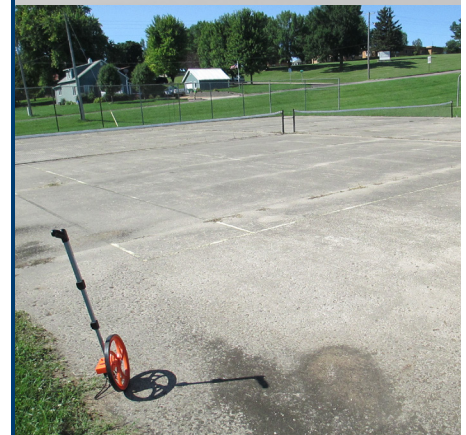
Discoloration and pitting throughout two tennis courts

System Recommendations: If competitive tennis is desired, remove the existing concrete tennis and basketball courts and replace with new bituminous tennis courts.

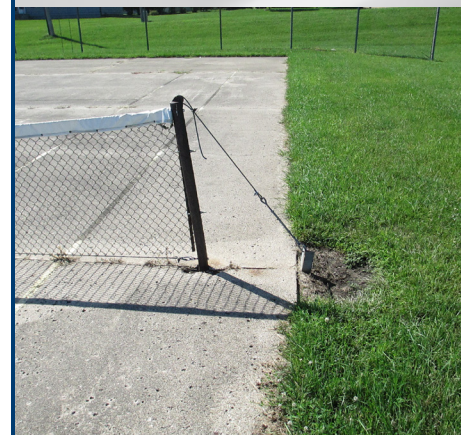
Rusted net posts and connections

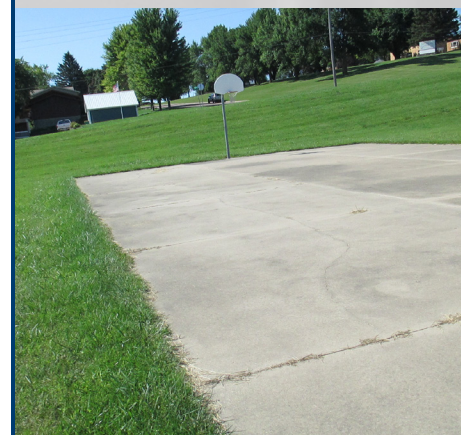
Discoloration and cracking throughout the pavement panels in basketball court

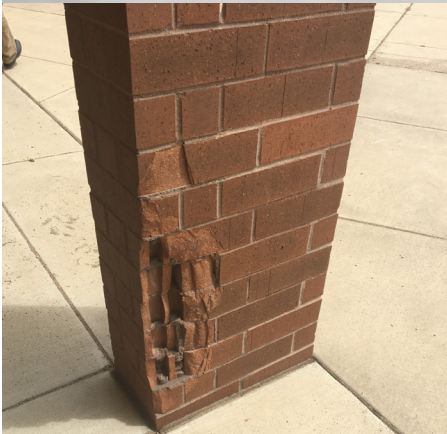
Brick column with damaged units

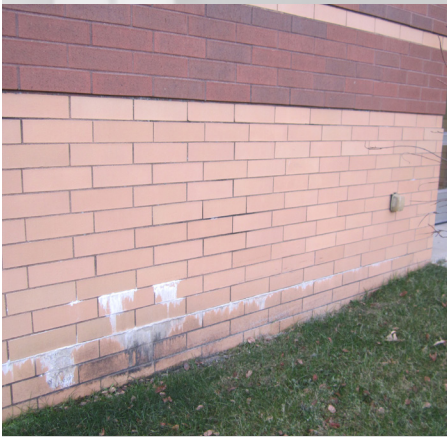
Brick wall with significant efflorescence

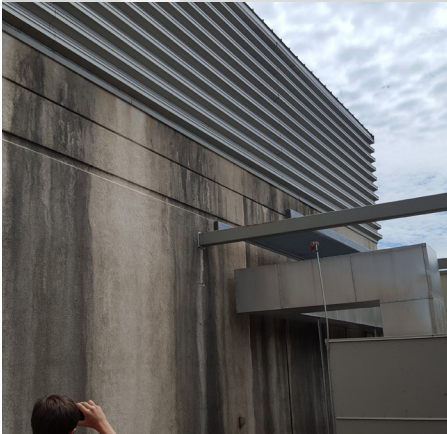
Stucco wall with severe staining and mold

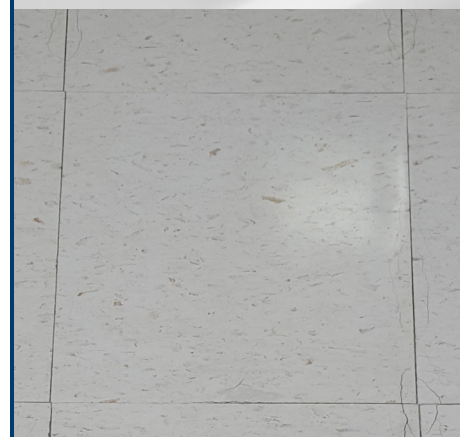
Vinyl composition tile with localized cracking and evidence of wear

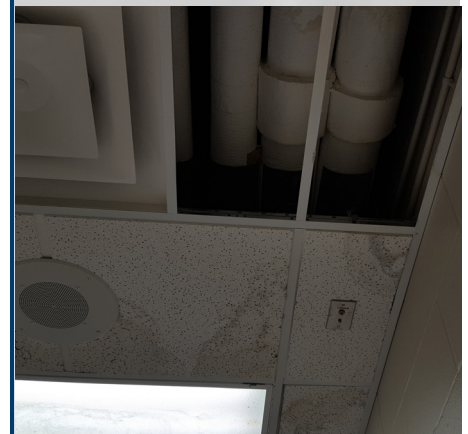
Ceiling with moisture damage

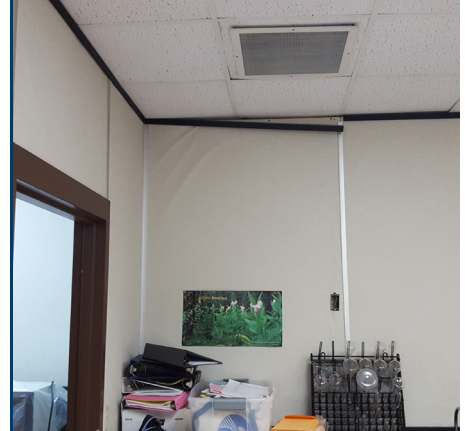
Damaged panel and trim

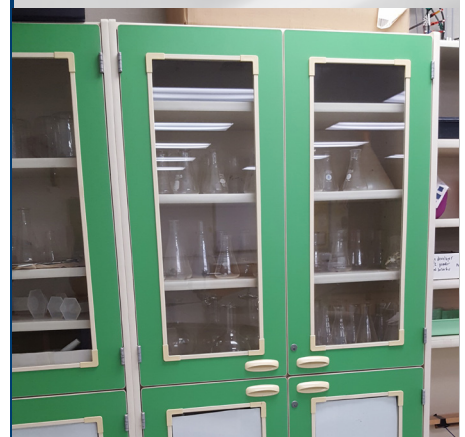
Casework with chipping and fading

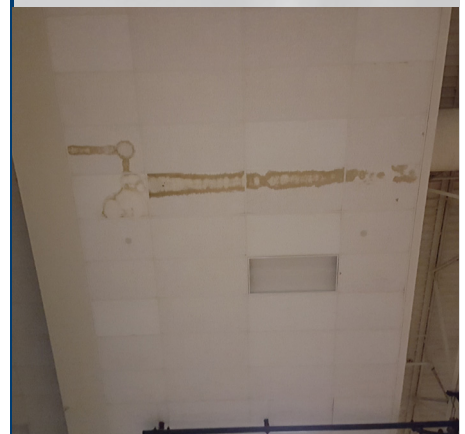
Ceiling tile with moisture staining

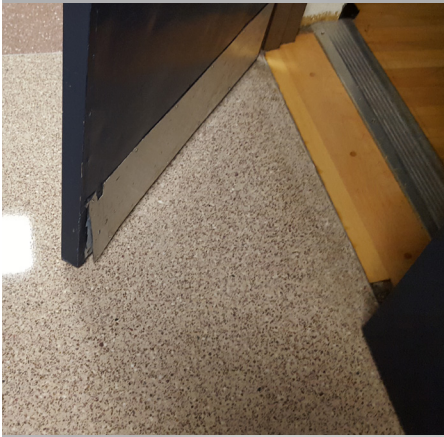
Door with dents and damaged kick plate

System Observation: Older doors have dents and damaged kick plates; newer doors are in very good condition.

System Condition: Fair (older gym); Good (newer gym)

System Recommendations: Replace damaged hollow metal doors.

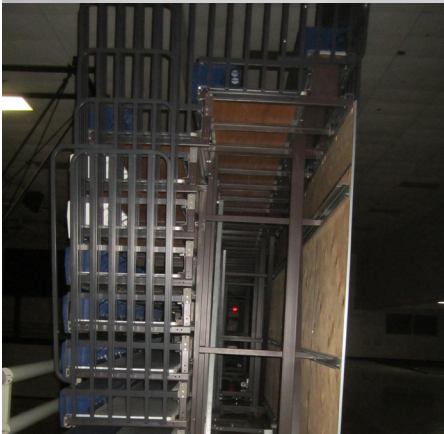
Telescopic seating system

System Observation: Telescopic seating system appears to be in very good condition; basketball hoops are mounted to structure above; drinking fountains are not accessible.

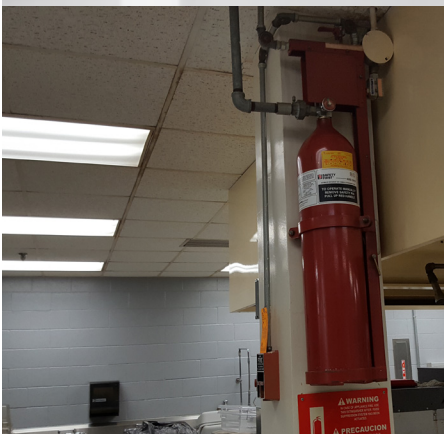
Noncompliant kitchen ceiling tile

System Condition: Poor

System Recommendations: Replace acoustical ceiling tile with code compliant surface.

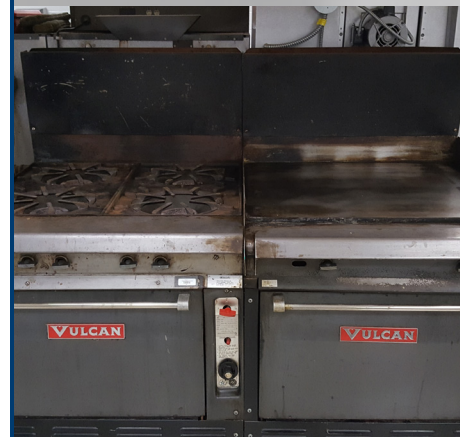
Stove units

System Observation: Cooking equipment appears to be in good condition with the exception of stove units.

System Recommendations: Replace stove units.

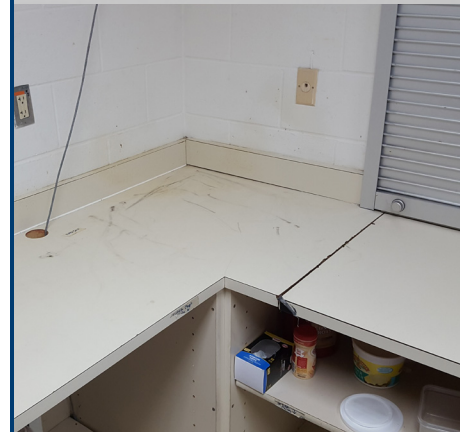
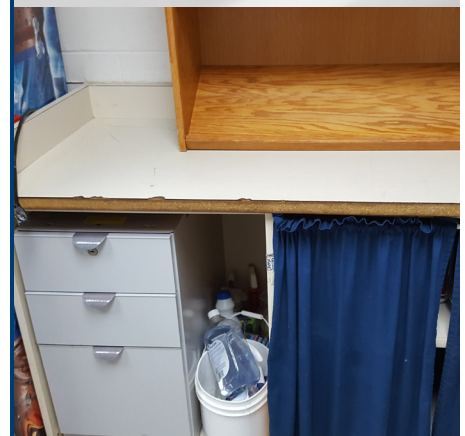
Damaged casework

System Observation: Casework has significant damage.

System Condition: Poor

System Recommendations: Replace casework.

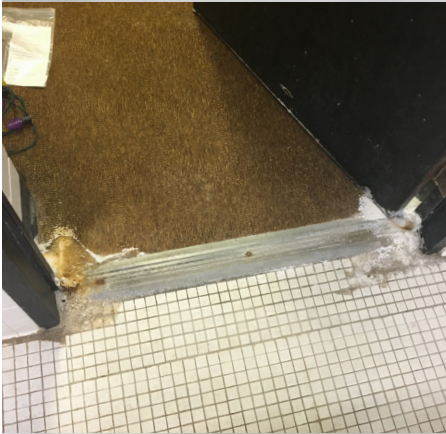
Chemically damaged carpet and tile

System Observation: Ceramic tile has scaling and discolored areas, and the carpet was damaged by chemicals.

System Condition: Poor

System Recommendations: Clean or replace ceramic tile and replace carpet.

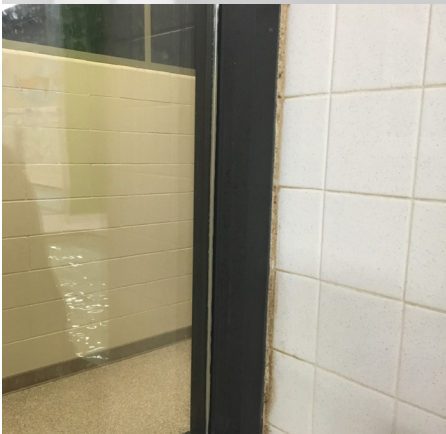
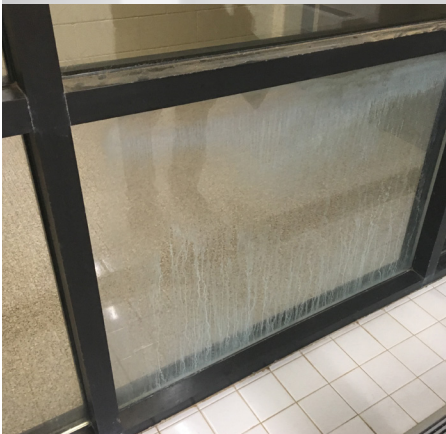
Degraded sealant joints in pool area

Broken seal in pool area window

System Observation: Ceramic tile generally in good condition; masonry has some peeling paint; window system has degraded sealant joints and one window has a broken seal.

System Condition: Fair

System Recommendations: Strip and repaint peeling masonry; reseal window system and replace damaged window.

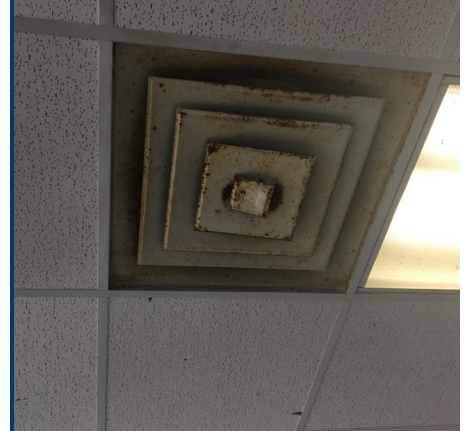
System Observation: Stained and damaged acoustical ceiling tile; and severely rusted diffusers.

System Condition: Fair

Rusted diffuser in pool area

System Recommendations: Replace damaged acoustical ceiling tile and rusted diffusers.

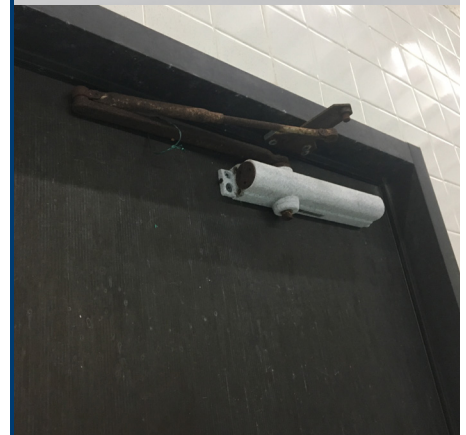
Rusted, damaged door in pool area

System Observation: Doors have damaged hardware and discoloration, corrosion and rusting.

System Condition: Poor

System Recommendations: Replace damaged doors and hardware.

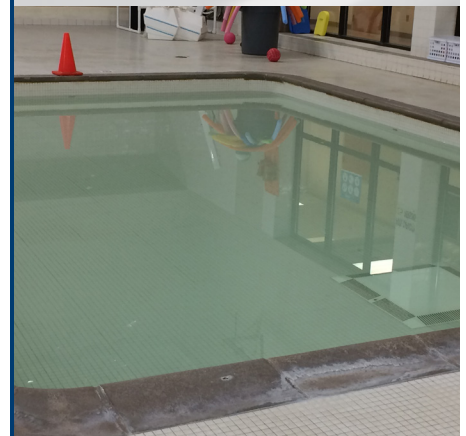
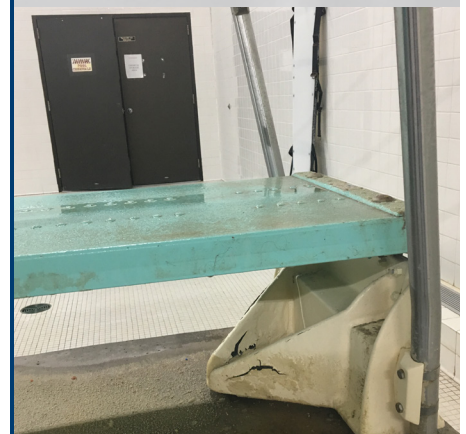
Surface corrosion around wading pool

Corrosion on diving board attachment to concrete base

System Observation: There is surface corrosion around wading pool and whirlpool; corrosion on diving board attachment to concrete base.

System Condition: Poor

System Recommendations: Clean deck areas around wading pool and whirlpool; repair diving board attachment.

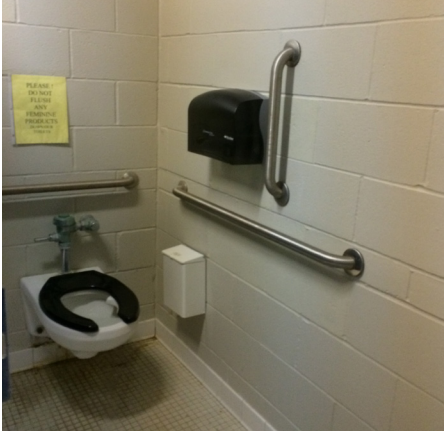
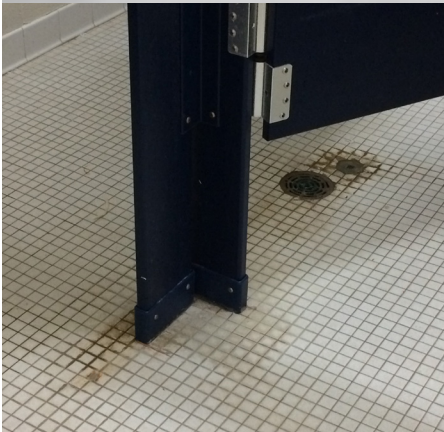
Stained ceramic tile floor

Restroom tile floors stained and cracking

System Observation: 1" x 1" ceramic tile floors are stained and have localized damage; vinyl composition tile floors are stained and cracking; older ceramic tile has some staining and joint discoloration; newer ceramic tile is in very good condition.

System Condition: Poor (older); Good (newer)

System Recommendations: Clean or replace 1" x 1" ceramic tile and vinyl composition tile; install ceramic tile in areas with sealed concrete.

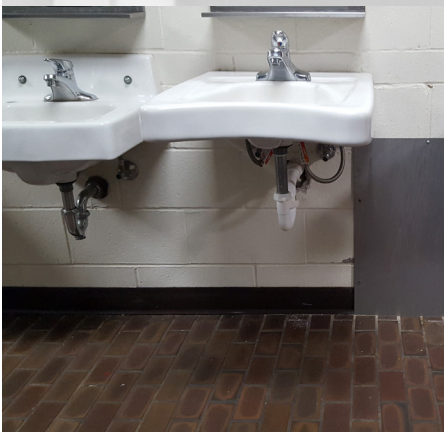
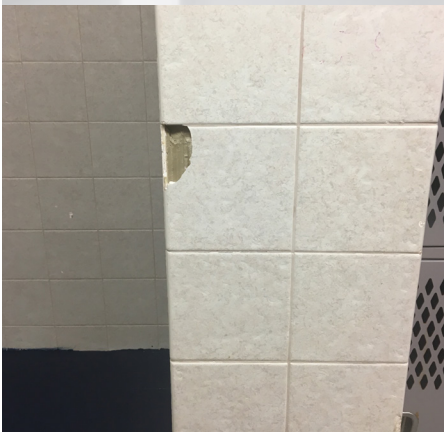
Damaged restroom floor and wall

Cracked tile in restroom

System Observation: Painted masonry is in good condition; ceramic tile and base is in good condition with some cracked tile in men's rooms,

System Recommendations: Repair cracked ceramic tile.

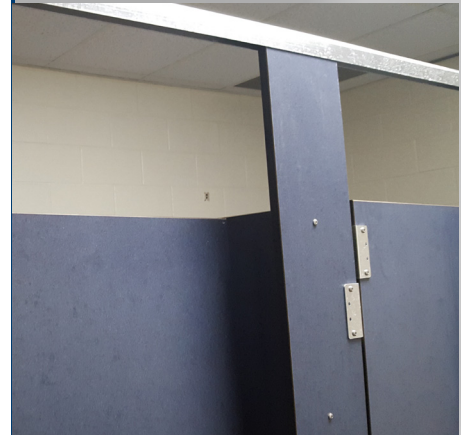
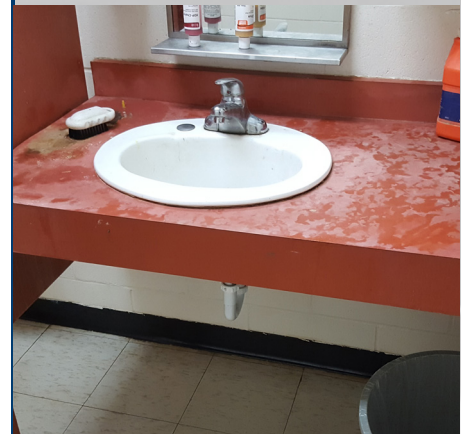
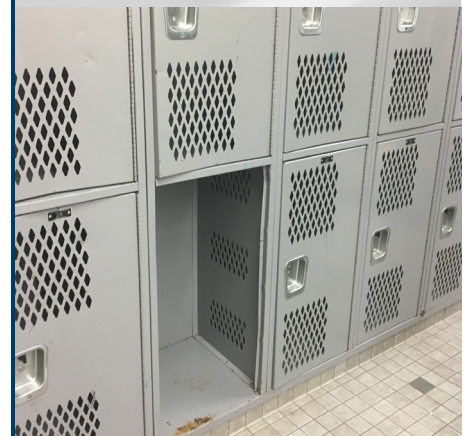
System Condition: Fair (older); Good (newer)

Restroom toilet partitions with damage and rusting

Restroom countertop damage

Damaged lockers

System Recommendations: replace damaged plumbing fixtures and accessories; replace damaged lockers, countertops and benches; verify sink heights for accessibility

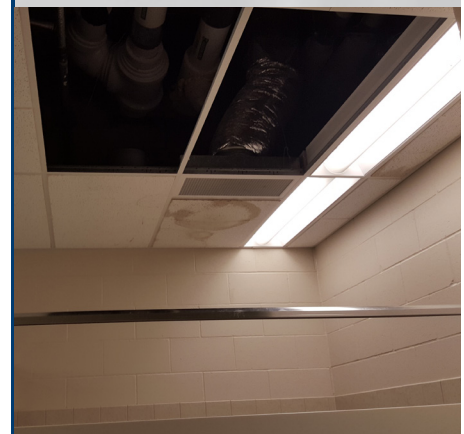
System Observation: Acoustical ceiling tile has some staining.

Damaged ceiling tiles

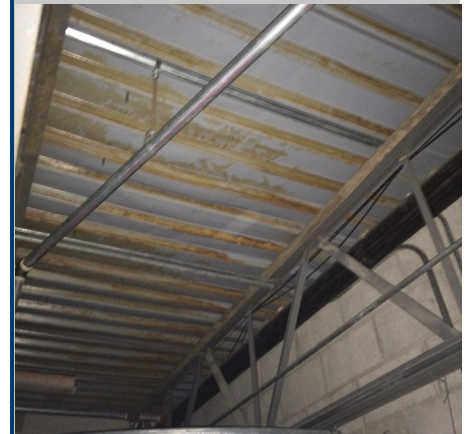
Rust on bottom of metal deck

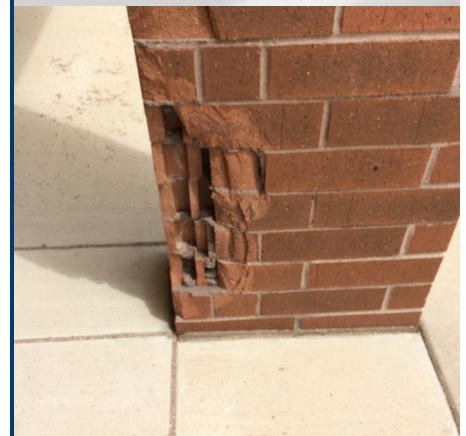
Damaged brick column at entrance

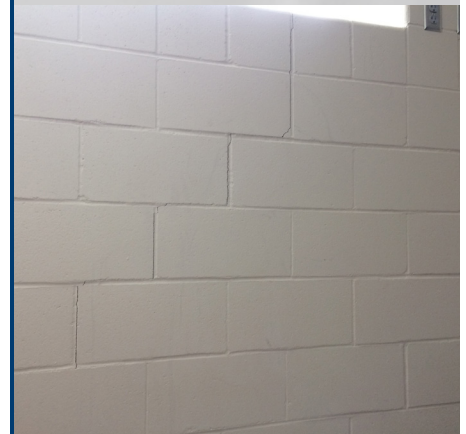
Stair step crack in CMU wall

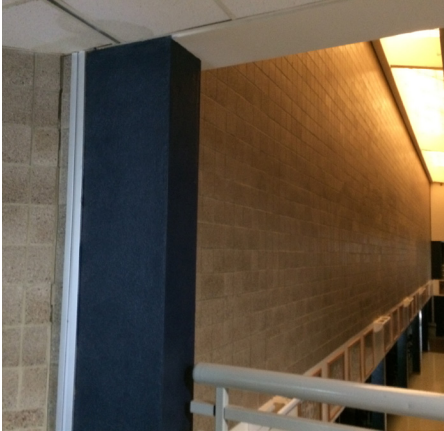
Cracked wall by track around Gym

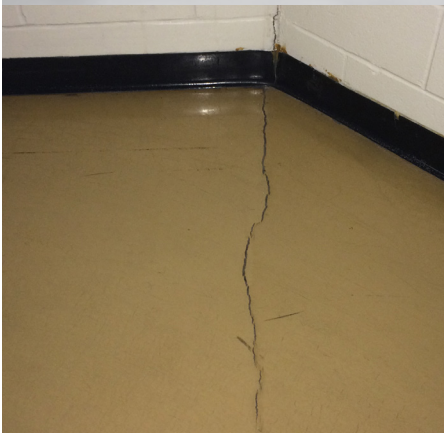
Cracked floor by track around Gym

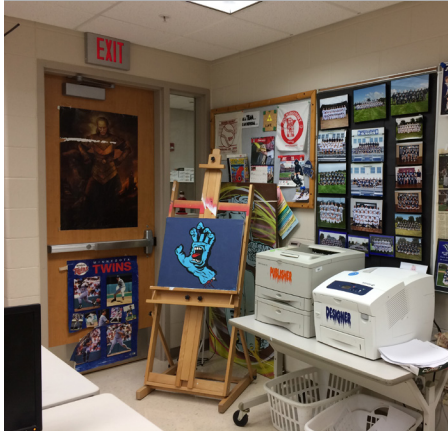
Partially blocked exit door in Graphics Lab

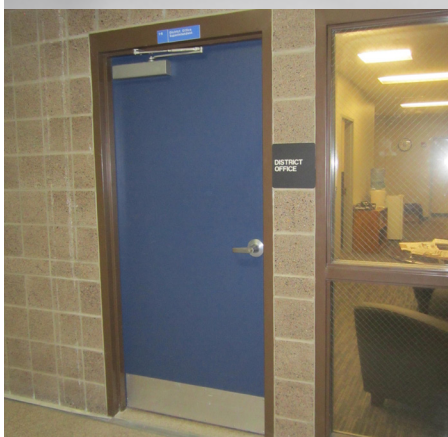
Noncompliant wired glass in sidelight

Wired glass in door sidelight

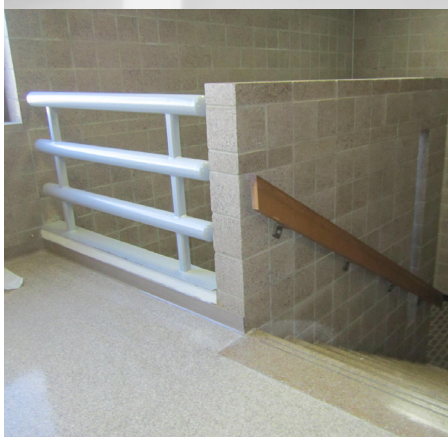
Noncompliant handrails and guards

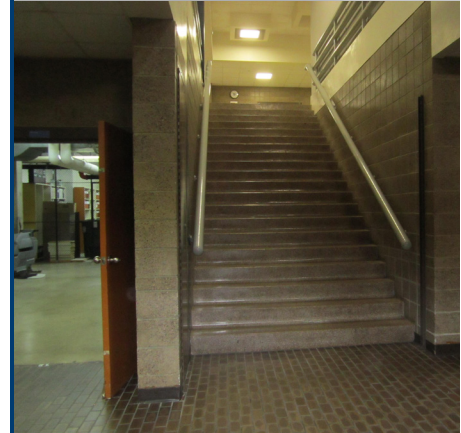
Handrails not extended properly at bottom and tops of stairwell

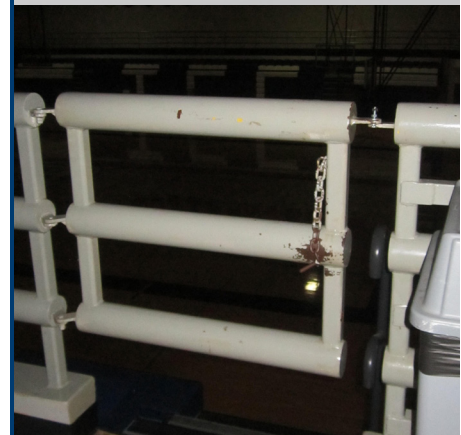
Noncompliant guard opening limitation

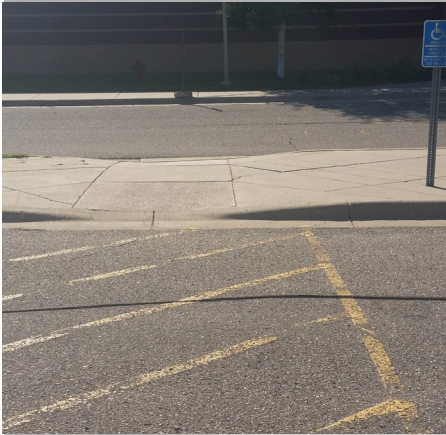
Noncompliant curb ramps and pedestrian crosswalk

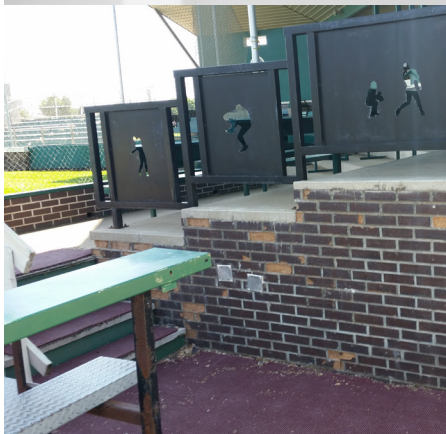
Noncompliant grandstand seating

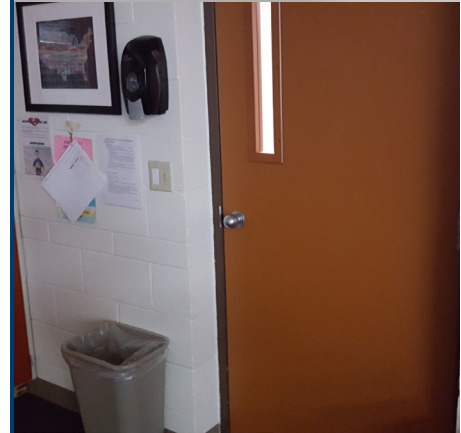
Noncompliant knob hardware and vision panel

Replace noncompliant knob hardware with handle locksets on classroom doors.

Replace noncompliant sidelights and doors with vision panels.

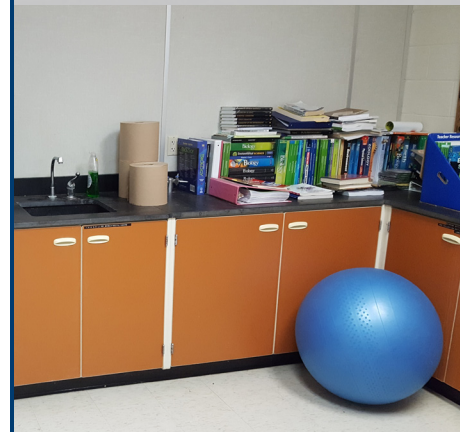
Noncompliant classroom sink

Replace sinks and casework in classrooms as required to provide clear floor space and knee and toe clearance under the sinks. Install insulation on exposed pipes.

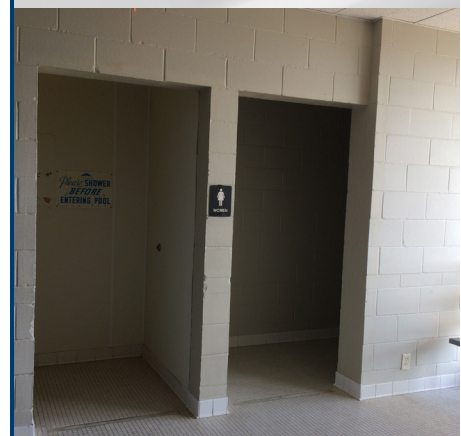
Noncompliant maneuvering clearances at entrance to restrooms and locker rooms

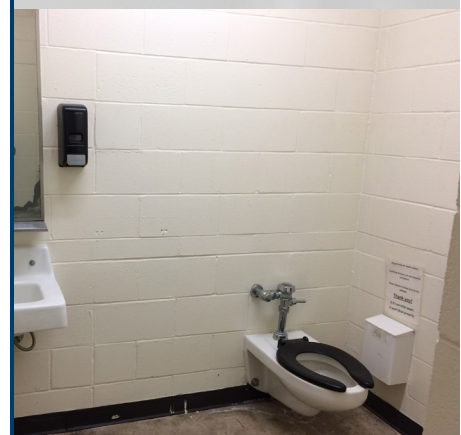
No grab bars and other accessories in restroom

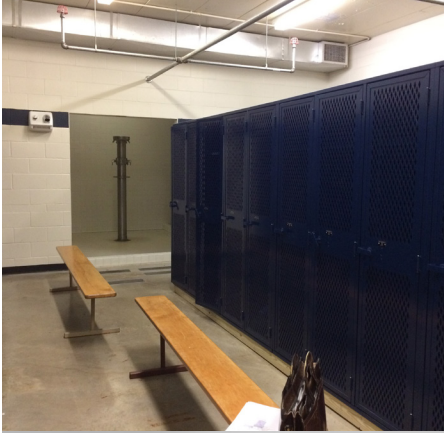
Noncompliant showers and benches

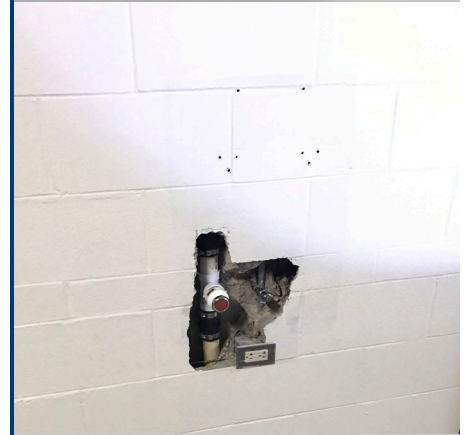
Missing electric water cooler

The drinking fountains are in poor condition and should be replaced. There is locations where the electric water cooler has been demolished. ISG recommends installing a high/ low electric water cooler with a water bottle fill station.

Replace broken electric water coolers.

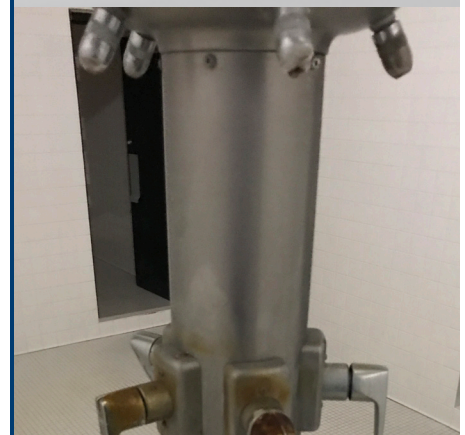
Leaking shower fixtures

The shower room fixtures for both the men's and women's locker rooms for the original gymnasium as well as the pool lockers are in poor condition. The showers leak and have broken heads and handles. ISG recommends replacing the shower fixtures.

Replace shower fixtures in locker rooms.

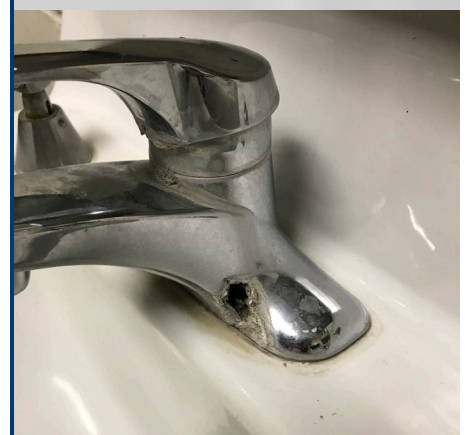
Broken faucet

The lavatories have faucets in poor condition. Replacing the fixture is recommended.

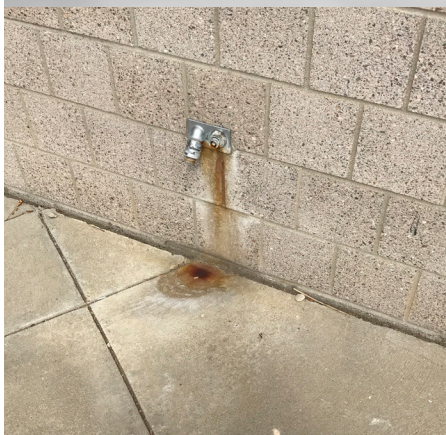
Leaking exterior hose bib

There is a hose bib that leaks. Replace existing hose bib to ensure the fixture doesn't leak.

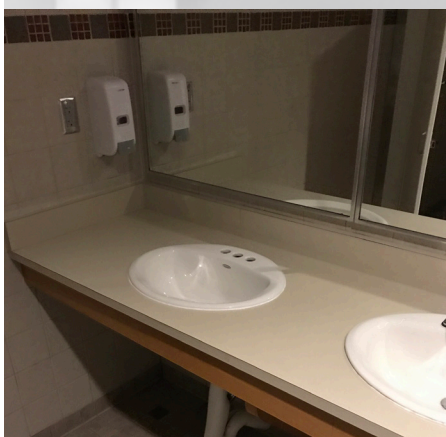
Missing faucet on lavatory

2004 Addition: The locker room located behind the auditorium is missing a faucet on the sink. Replacing the faucet to have a fully functional sink is recommended.

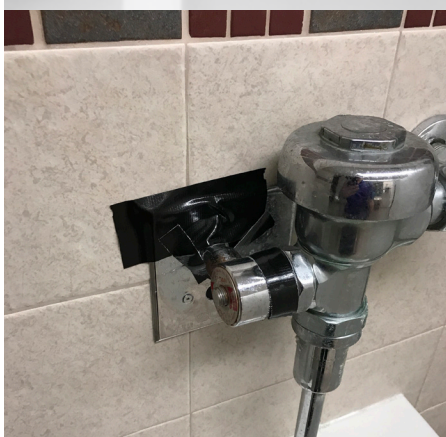
Broken flush valve on urinal

The men's restroom have urinals that were not operating. Replacing the battery on the flush valves is recommended to ensure the fixture is operating properly.

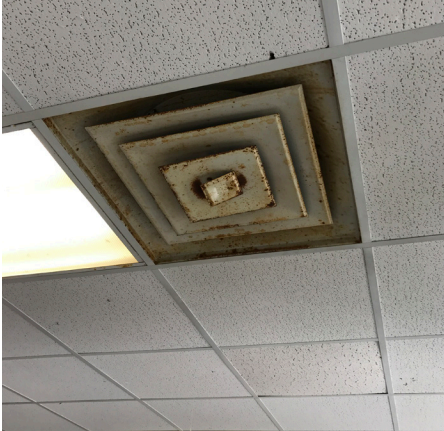
Rusted supply grille

The supply/return/exhaust grilles are dirty and rusted. They should be cleaned if dirty and replaced if rusted to ensure that proper airflow is going through the diffuser. The diffusers in the pool area need to be aluminum or plastic to ensure they won't rust. All supply/return/exhaust grilles throughout the building were very dirty.

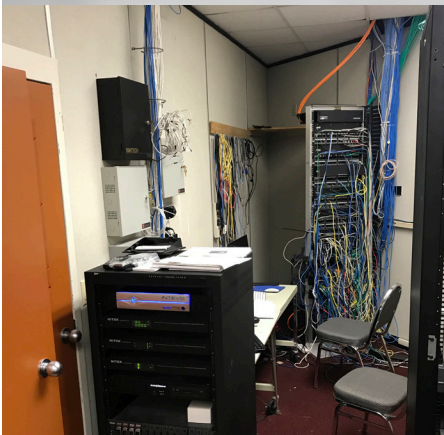
IT Room in need of dedicated cooling or exhaust

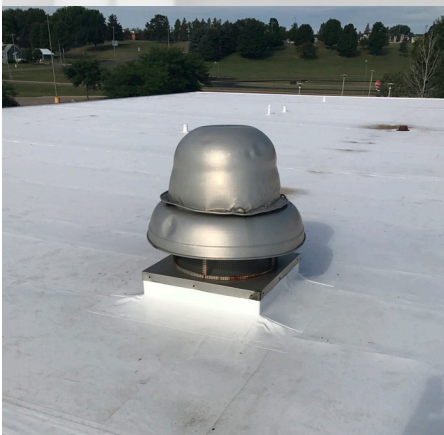
Exhaust fan in need of replacement

Exhaust fan 13 has a loose belt that should be replaced. Adding an auto belt tensioner is

recommended on all belt driven exhaust fans. This will extend the life of the belt.

Replace loose belt on exhaust fan 13.

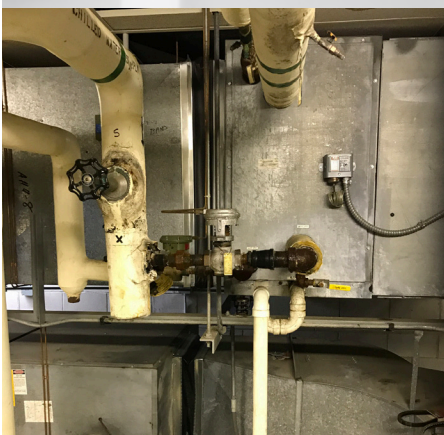
Uninsulated chilled water lines

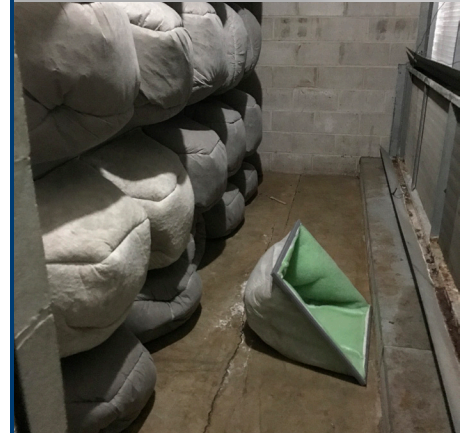
Dirty air handler unit

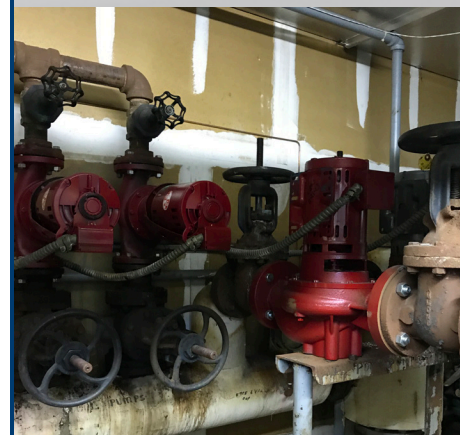
No RTU or AHU was found to have any form of vibration isolation present on the units. Being that the units are on the roof or suspended from the ceiling, it is highly recommended to install vibration isolation springs below the unit to ensure no vibration from the unit can transmit into the floor of the building.

No vibration isolation on pump

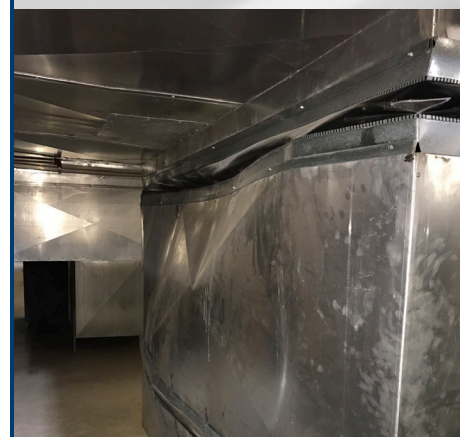
Bent and damaged ductwork

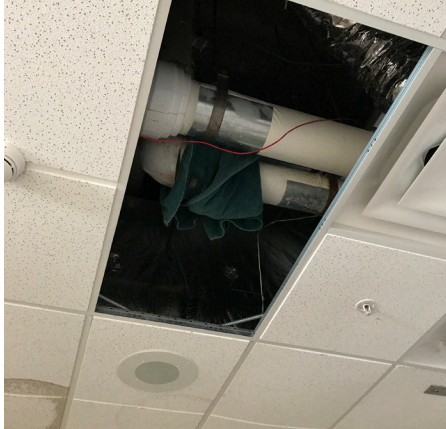
The insulation on the steam system is lacking. Various spots around the building the insulation is missing and should be replaced especially if the pipe is at elevations where students can accidentally touch the pipe. Not only is adding insulation going to help make the system more efficient but also safer as the pipe can get extremely warm. All steam pipe and fittings should be insulated.

Damaged insulation

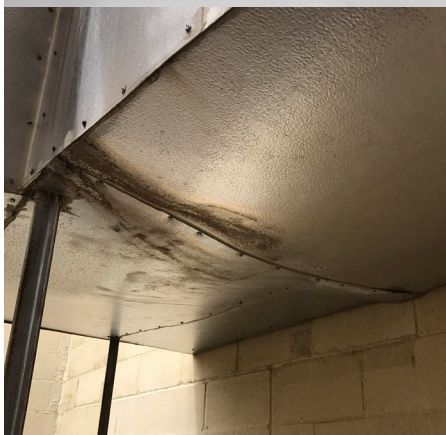
Damaged exterior insulation with standing water inside

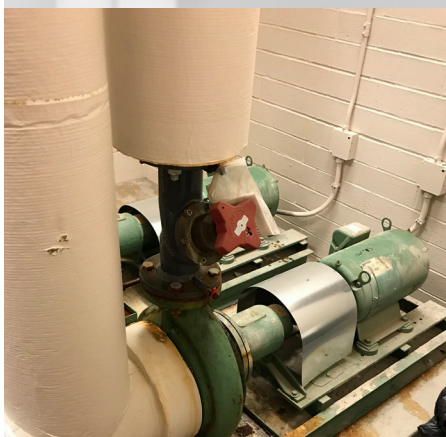
Uninsulated pipe and no vibration isolation

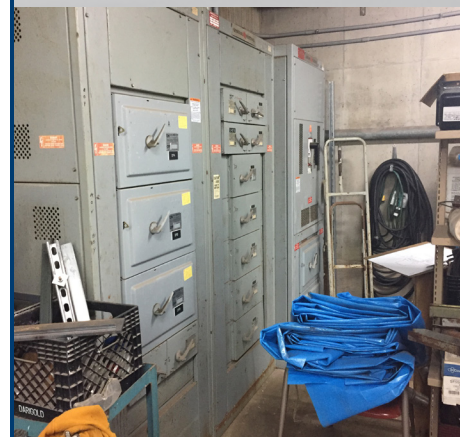
Main electrical gear without proper clearances

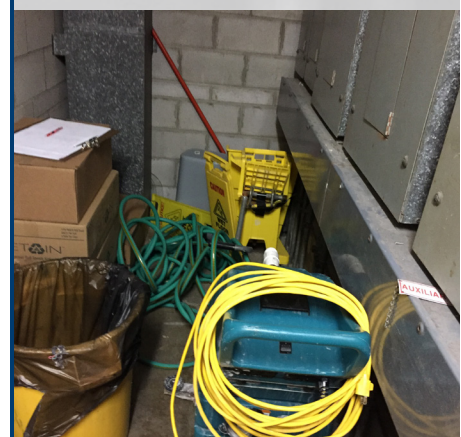
Branch panels without proper clearances

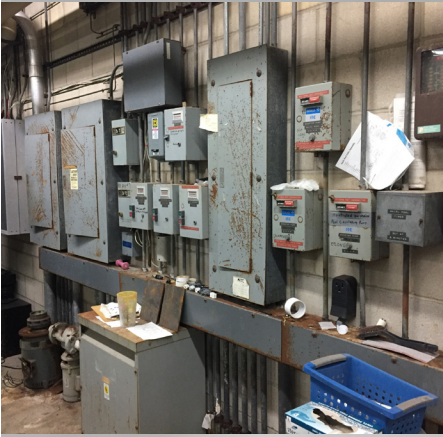
Rusted electrical equipment in pool mechanical room

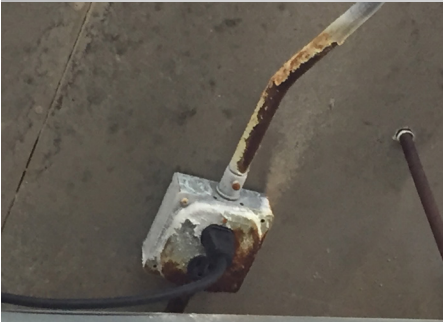
Rusted and corroded electrical device in pool mechanical room

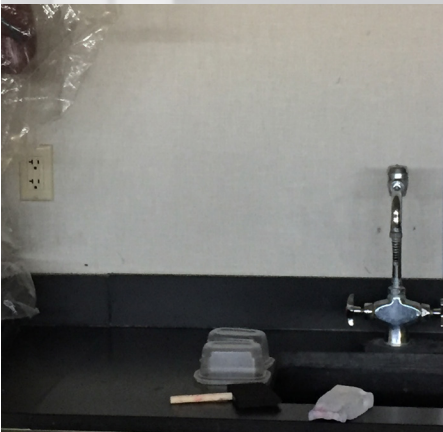
Non-GFCI receptacle near sink

It should be verified that all receptacles near sinks are provided with GFCI protection. An arc flash study should be performed on the facilities electrical systems, and labels added to electrical equipment with updated information that is required by the most recent edition of the National Electric Code.

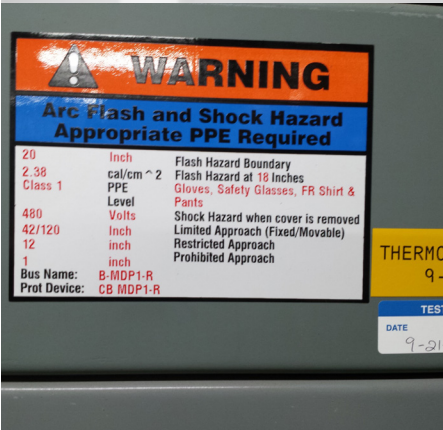
Typical Arc Flash Hazard label required by NEC

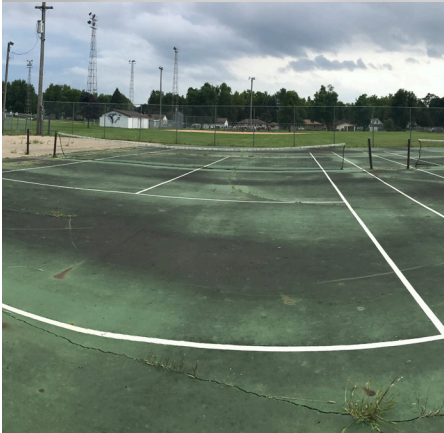
Areas of settlement, discoloration, and cracking in tennis court

System Observation: All three tennis courts are constructed of bituminous pavement, however only two of the courts have an acrylic surfacing. Large areas of discoloration indicate that multiple areas on the courts pond. Areas of settlement and cracking throughout all the courts were also noted. Significant base failure or major cracking was not noted during inspection.

System Condition: Fair

System Recommendations: Mill, overlay and resurface the tennis courts.

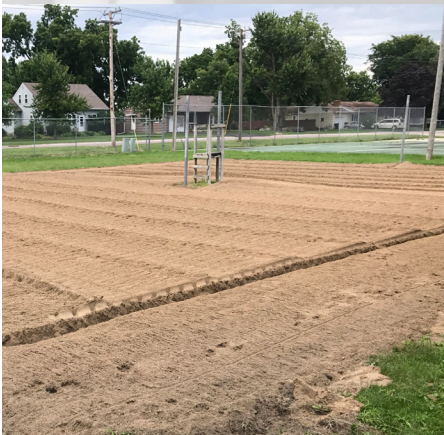
Weathered wooden line judge stands

System Observation: The sand volleyball court net posts are in good condition. The courts do not have an edging material to keep the sand from mixing with the surrounding grass. The wooden line judge stands are weathered but still appear to be structurally sound. A small shelter adjacent to the volleyball courts appeared to be in good condition with no roof defects noted, only some weathering of the wood.

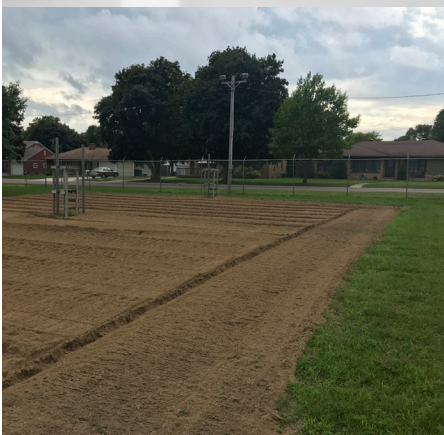
Lack of edging materials from sand and grass

System Recommendations: Standard maintenance and inspection should be performed on the athletic facilities. It is recommended to provide an edging material to reduce on surface loss of the court.

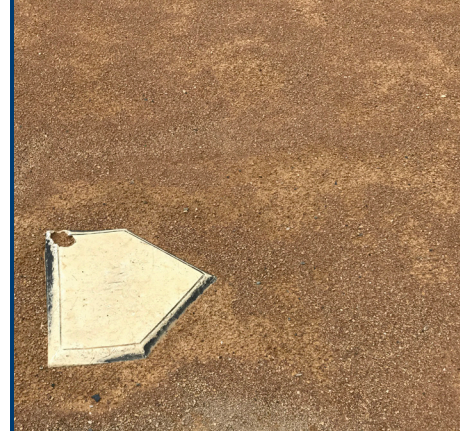
System Observation: The softball field has an all aglime infield with grass outfield. The aglime surfacing is in fair condition although grass and weeds have begun to grow near the edges. The bases are worn and home plate has a hole in it. Both dugouts have chain link walls with concrete floors and wood benches. The concrete is pitting, but still intact and the benches are weathered but in a usable condition.

Hole in home plate of softball field

System Recommendations: Standard maintenance and inspection should be performed on the athletic facilities. It is recommended to replace the worn out deficient bases and the missing wood panels behind the home plate. Add fencing along first base line to protect players from on-site obstructions.

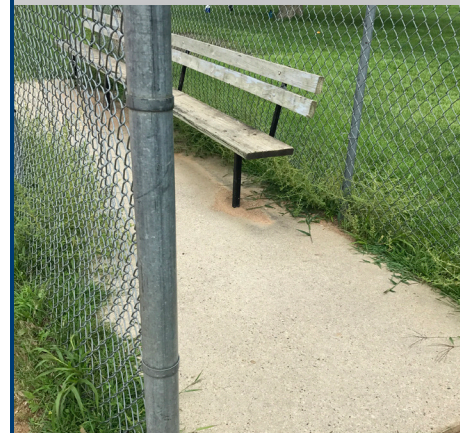
Pitting concrete, weathered but usable benches

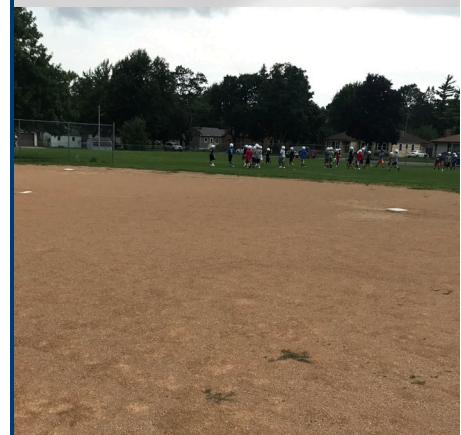
The first and third base line fencing only extends to the edge of the infield. The fencing has been warped in areas, but is still in fair condition. There is a wood backstop in the area behind home plate to help protect the fencing although two of the wood panels are missing.

First and third base fencing only extends to edge of infield

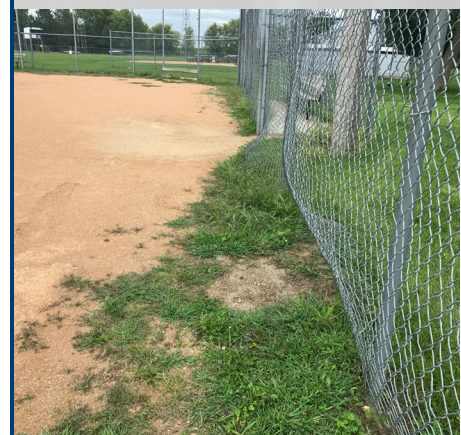
Warped fencing

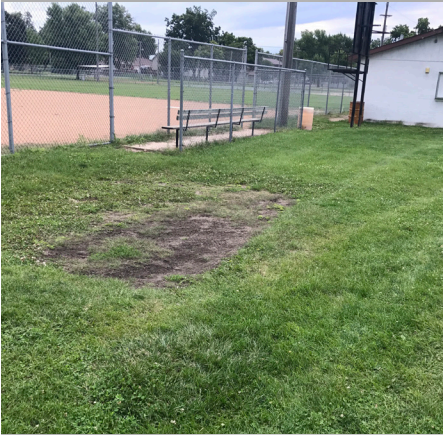
No spectator bleachers were observed at the time of the site inspection. Behind the backstop fencing, the ground was visibly worn and had no vegetation at the location where the bleachers would be located, indicating that the bleachers are shared throughout the site.

Worn ground behind backstop fencing

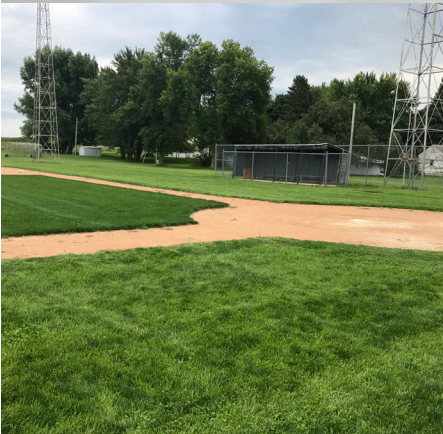
Aglime surfacing loss near grass edges

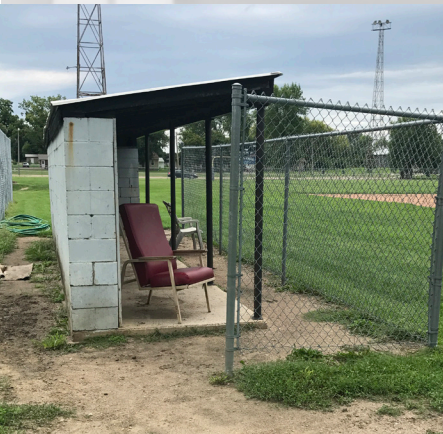
Lack of permanent benches or bat racks in third base dugout of baseball field

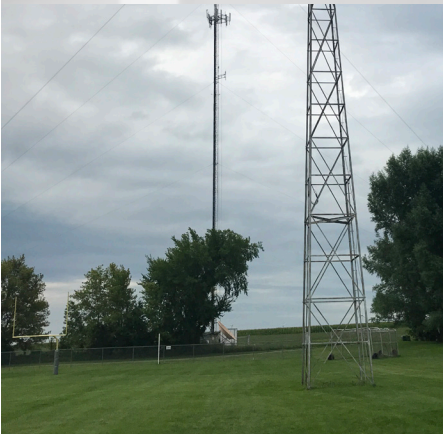
Lack of protection from light towers

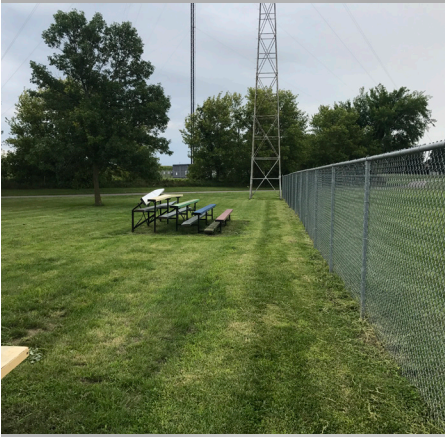
Warped and broken bleachers adjacent to press box

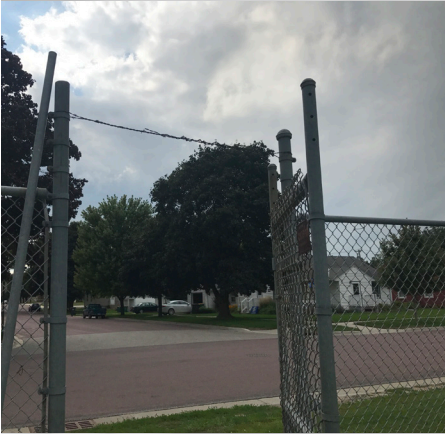
Barbed wire top in fencing

System Recommendations: Remove the remaining barbed wiring and repair the top rail and mesh of deficient fencing.

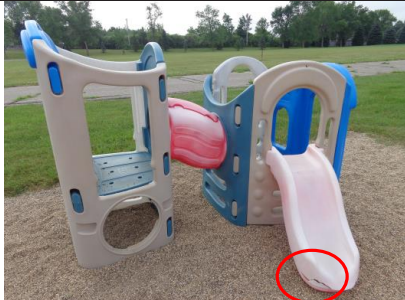
3	A piece of asphalt was found on the playground.

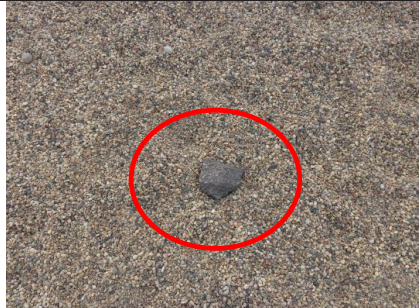
3	Litter was found on the playground. Consider installing trash receptacles to reduce the chance of litter accumulation on the playground.

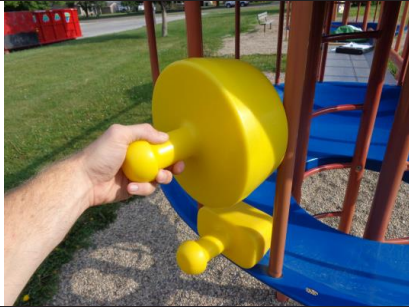
Priority	Hazard	Photo
1	The pea rock surfacing material is approximately two to three inches throughout the play area. Pea rock should be maintained at a minimum depth of nine inches throughout the play area and raked to prevent pack down. Grass and weeds were also observed growing throughout the play area.	N/A
1	The opening between the bars on the south dome creates a head entrapment hazard.

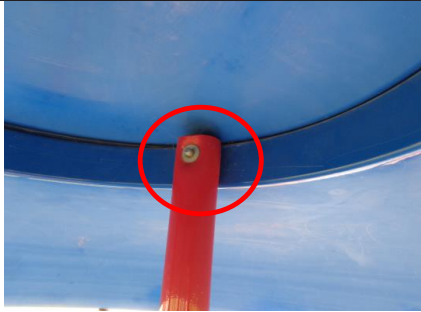
2	There are bolts with more than two threads exposed inside the dome roof creating a protrusion hazard. No more than two threads should be exposed on any bolt.
