JACKSON COUNTY CENTRAL SCHOOL DISTRICT

2018 Facilities Assessment

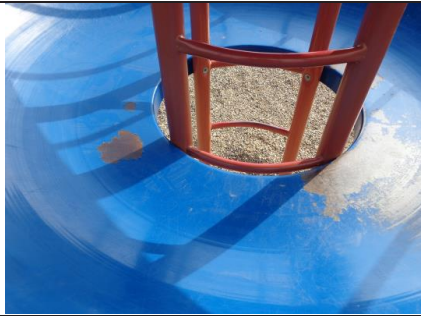
3	The paint is starting to chip on the base of the dome.

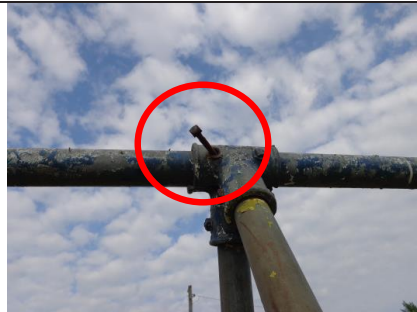
2	The front and rear use zones of both swing sets are not wide enough. Belt swings should have a use zone that is a minimum distance of two times the distance from the protective surfacing to the pivot point.	N/A
2	There is a loose protruding bolt on the metal swing set.

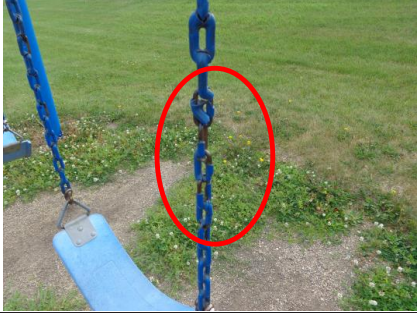
3	The plastic coating is cracking on the chains of the blue swing set.

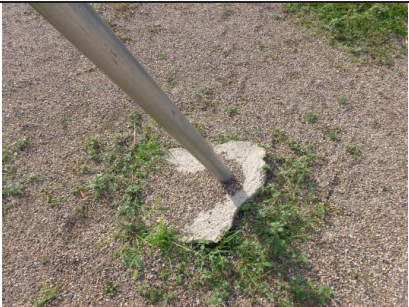
1	The concrete footers are exposed on the slide. Footers should be covered with an appropriate amount of surfacing material.

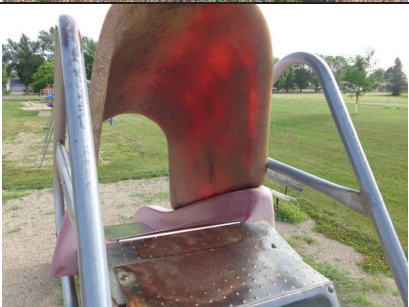
1	The guardrail at the top of the slide is not sufficient to prevent falls. Protective barriers are used on playgrounds when the platform fall height is greater than 48 inches on playgrounds for 5 to 12-year olds. The slide platform height requires a protective barrier with a top edge measuring 38 inches or higher from the platform and a bottom edge measuring less than 3.5 inches from the platform with an infill. The placement of the bottom edge and infill needs to be done without creating an entrapment hazard.

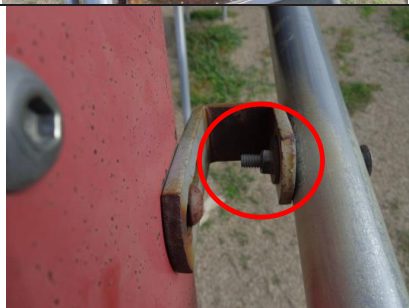
1	There are more than two threads exposed on bolts near the slide entry creating an entanglement hazard. Slides should have a 21-inch non-entanglement zone in all directions.

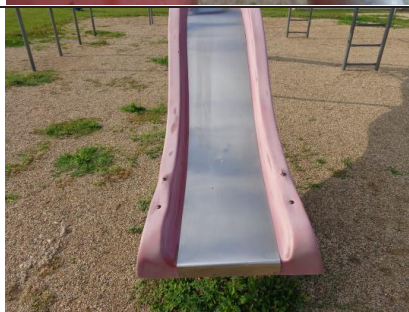
2	The slide has a metal sliding surface. Metal surfaces are not recommended on slides as they create a potential burn hazard when exposed to direct sunlight.

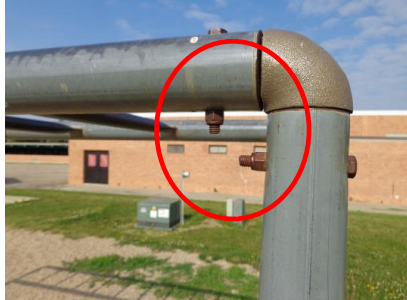
2	There are bolts with more than two threads exposed on the horizontal ladder creating a protrusion hazard. No more than two threads should be exposed on any bolt.

Bolts and other protrusions should be minimized by replacing the bolt, adding a nut, or tightening the fastener. If the protrusion increases in diameter from the initial surface, it should be replaced. "S" hooks should be closed so there is no gap or space greater than 0.04 inches, approximately the thickness of a dime.

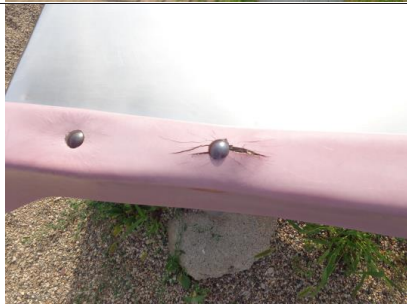
3	The fiberglass is cracking round the bolt at the bottom of the slide.

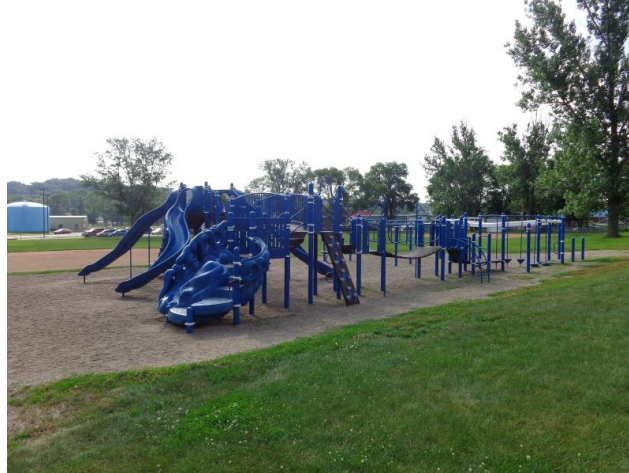
Riverside Elementary – Blue Composite Structure

Priority	Hazard	Photo
1	The pea rock surfacing material is approximately one to three inches throughout the play area. Pea rock should be maintained at a minimum depth of nine inches throughout the play area and raked to prevent pack down. Grass and weeds were also observed growing throughout the play area.	N/A
1	The guardrails on the north and south steps of the west rock climber access platform are not sufficient to prevent falls. Protective barriers are used on playgrounds when the platform fall height is greater than 48 inches on playgrounds for 5 to 12-year olds. The access platform height requires a protective barrier with a top edge measuring 38 inches or higher from the platform and a bottom edge measuring less than 3.5 inches from the platform with an infill. The placement of the bottom edge and infill needs to be done without creating an entrapment hazard.

Surfacing material should be replenished to maintain an appropriate depth. CPSC recommends 3-6 inches of loose-fill (e.g. gravel), one layer of geotextile cloth, and a minimum of 9 inches of loose-fill material such as shredded rubber, pea gravel, or wood mulch/chips. Concrete, asphalt, and hard-packed earth are strongly discouraged.

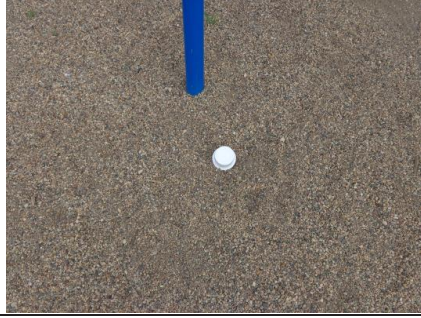
Priority	Hazard	Photo
3	The southeast sidewinder slide has an exit height of 16 inches above the pea rock surfacing. Slides greater than four feet tall should have an exit height between seven and 15 inches above the protective surfacing. The exit height should be re-measured after surfacing material is replenished.	N/A
3	The northeast slide has an exit height of 19 inches above the pea rock surfacing. Slides greater than four feet tall should have an exit height between seven and 15 inches above the protective surfacing. The exit height should be re-measured after surfacing material is replenished.	N/A
3	Litter was found on the playground. Consider installing trash receptacles to reduce the chance of litter accumulation on the playground.

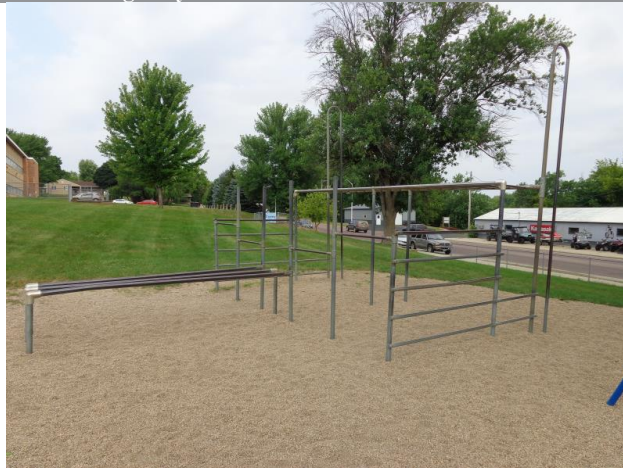
Riverside Elementary – Metal Jungle Gym

Priority	Hazard	Photo
1	The pea rock surfacing material is approximately one to three inches throughout the play area. Pea rock should be maintained at a minimum depth of nine inches throughout the play area and raked to prevent pack down. Grass and weeds were also observed growing throughout the play area.	N/A
3	The horizontal ladder is 89 inches above the surfacing material. Upper body climbing equipment should have a maximum height of 84 inches above the playground surfacing material. The height should be re-measured after pea rock surfacing material is replenished.	N/A
3	One of the parallel bars is bent.

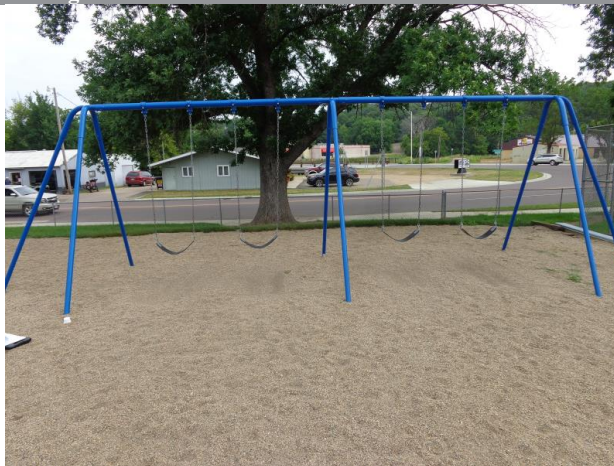
Riverside Elementary – Swing Set

Priority	Hazard	Photo
1	The pea rock surfacing material is approximately one to three inches throughout the play area. Pea rock should be maintained at a minimum depth of nine inches throughout the play area and raked to prevent pack down.	N/A
1	Tree branches are within the swing use zone on the east side. Playground equipment should have at least 84 inches of clearance from overhead wires and branches.

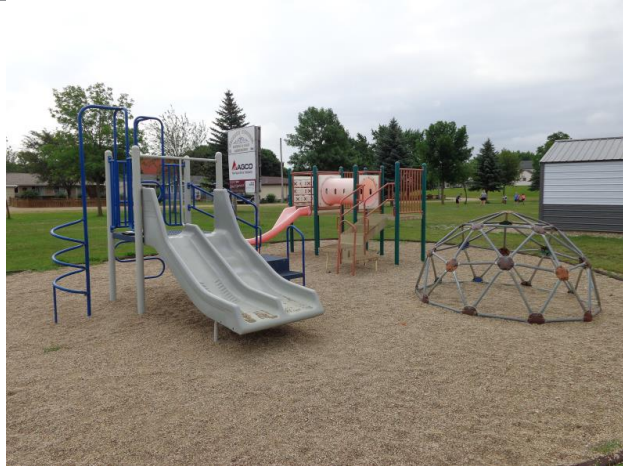
Softball Fields

Priority	Hazard	Photo
1	The pea rock surfacing material is approximately one to two inches throughout the play area. Pea rock should be maintained at a minimum depth of nine inches throughout the play area and raked to prevent pack down. Grass and weeds were also observed growing throughout the play area.	N/A
2	The playground equipment does not have adequate use zones. Equipment should have a minimum use zone of 6 feet in all directions without overlapping.	N/A
2	There is a missing piece of equipment on the south end of the green and red structure creating a fall hazard. A guardrail should be installed to protect against falls.

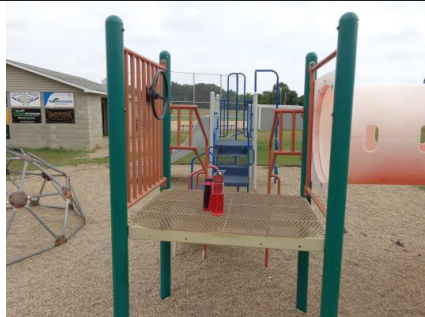
2	There are sharp edges around the bolt holes near the missing piece of equipment on the red and green structure.

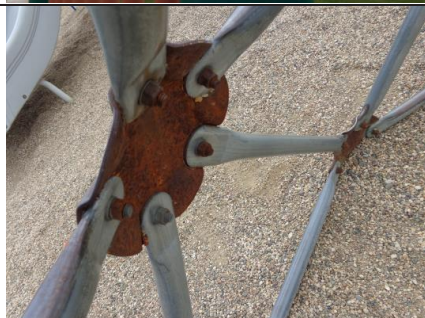
3	There is rust on the dome climber connection pieces.	N/A

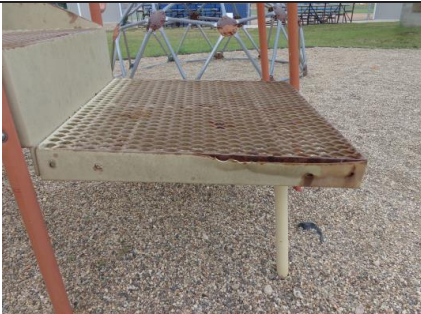
3	The protective coating is chipping off the platforms on the blue and red/green play structures resulting in rusted metal.

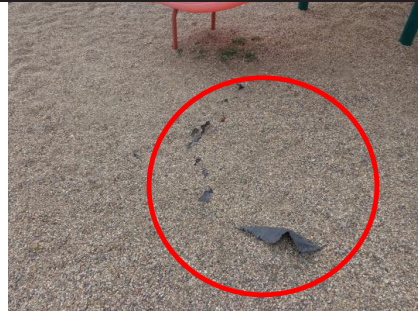
Priority	Hazard	Photo
3	The black plastic underlayment for the surfacing material is exposed creating a trip hazard.
